FEDERAL ENERGY REGULATORY COMMISSION FIELD INSPECTION REPORT

Date July 8, 2025

Project Northern Natural Gas Company
Northern Lights 2025 Expansion Project
Freeborn, Washington, and Houston Counties, Minnesota; and Monroe
County, Wisconsin
Docket No.: CP24-60-000
Authority: 7(c)

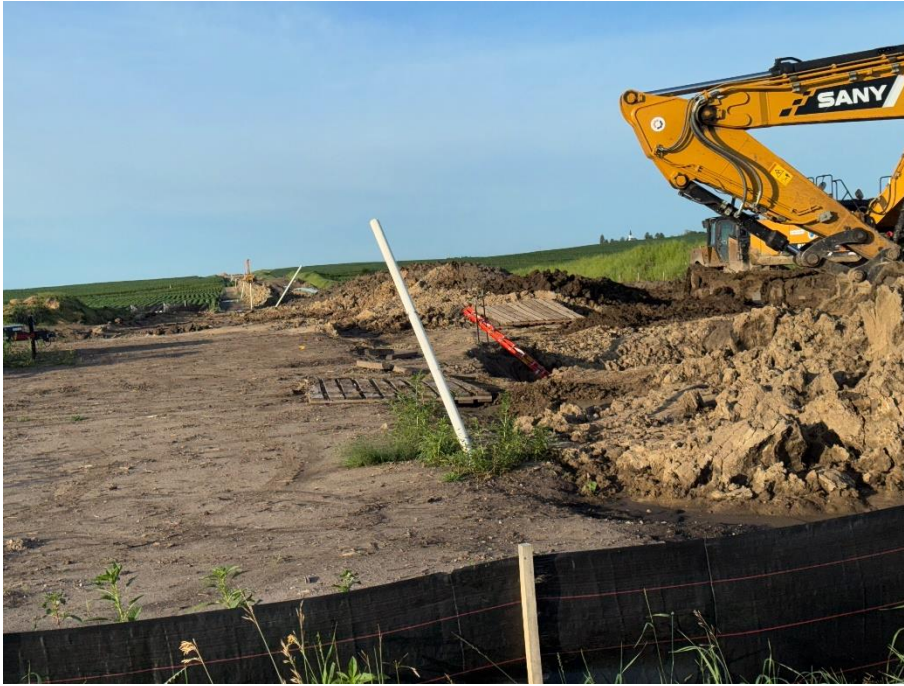
Photo No.: 1

The inspection began at milepost (MP) 34.2, where construction was slowed due to recent heavy rainfall that made soil conditions too wet to work, according to NNG (Photo No. 1). At MP 33.19, a short section of pipe was installed, but the ditch was filled with water and work was stopped until the ROW dried out, according to NNG (Photo No. 2). At MP 32.0, pipe segments were strung and welded, but work was stopped until ROW conditions were drier, according to NNG (Photo No. 3). No active construction was observed at a valve site at MP 31.2, where the excavation was filled with water (Photo No. 4). No environmental concerns were observed at MP 31.2 at the anticipated tie-in to the existing pipeline.

Assessment: Acceptable

Comments: Agricultural ROW, Lake Mills to Albert Lea E-line. NNG reported that construction was underway, but excessive rain had slowed progress and that the ROW was too wet to work. The ROW was stable with no erosion, off-ROW impacts, or other environmental concerns identified.

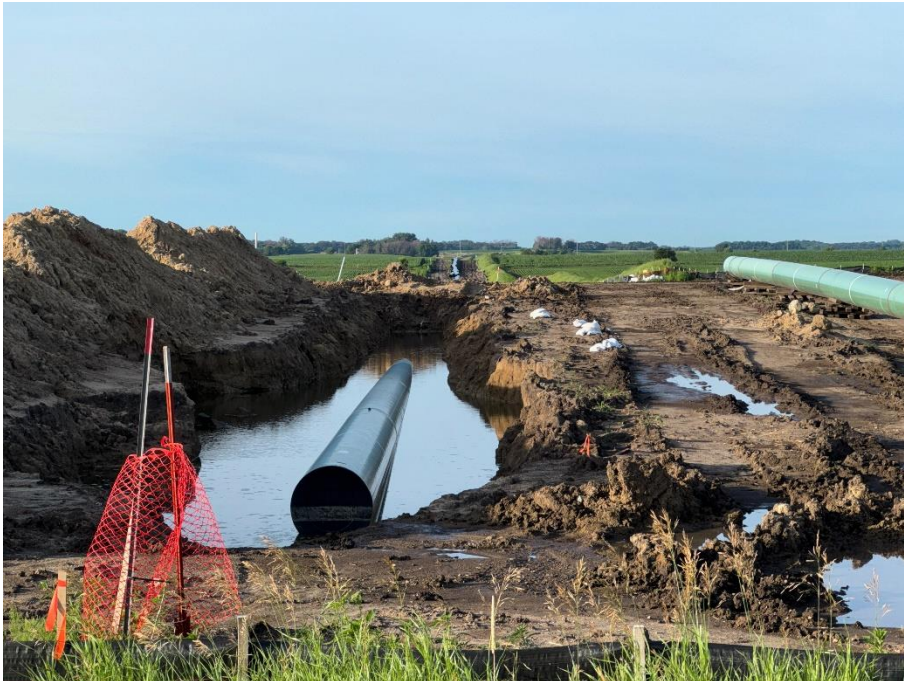
Photo No.: 2

Assessment: Acceptable

Comments: Agricultural ROW, Lake Mills to Albert Lea E-line. A short section of pipe was installed, but the ditch was filled with water and work was stopped until the ROW dried out, according to NNG. The ROW was stable with no erosion, off-ROW impacts, or other environmental concerns were identified.

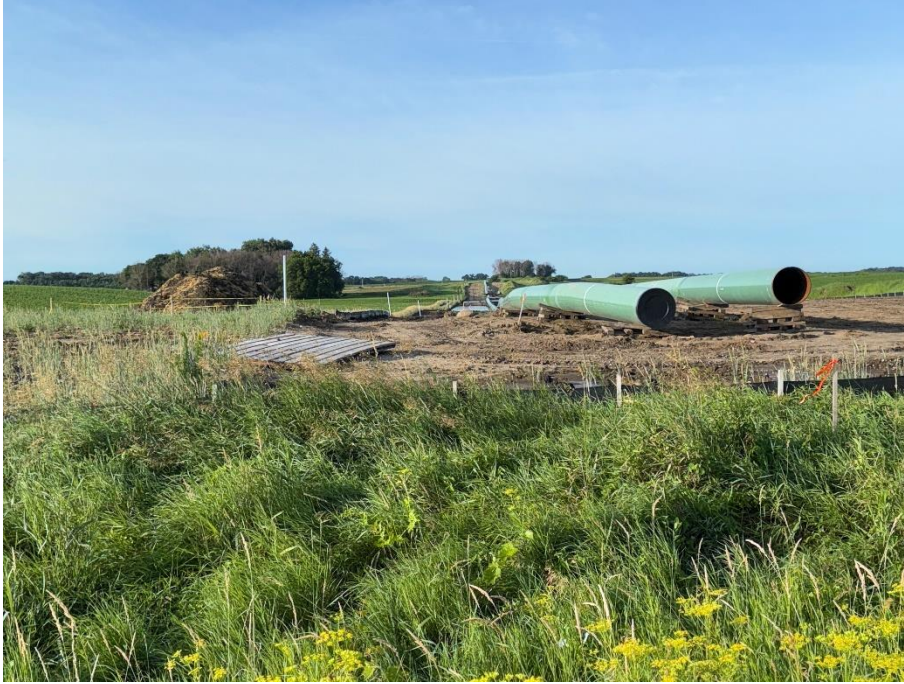
Photo No.: 3

Assessment: Acceptable

Comments: Agricultural ROW, Lake Mills to Albert Lea E-line. Pipe segments were strung and welded, but work was stopped until ROW conditions were drier and water was no longer ponding in low areas, according to NNG. The ROW was stable with no erosion, off-ROW impacts, or environmental concerns identified.

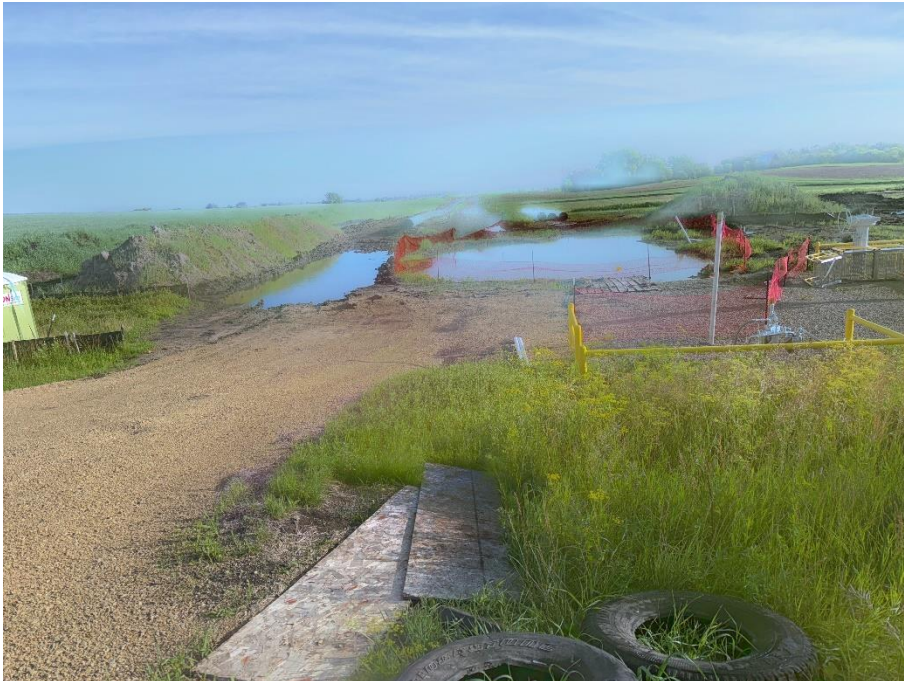
Photo No.: 4

Assessment: Acceptable

Comments: Agricultural ROW, Lake Mills to Albert Lea E-line. No active construction was observed at a valve site. An excavation at the valve site was filled with water. The ROW was stable with no erosion, off-ROW impacts, or environmental concerns identified.

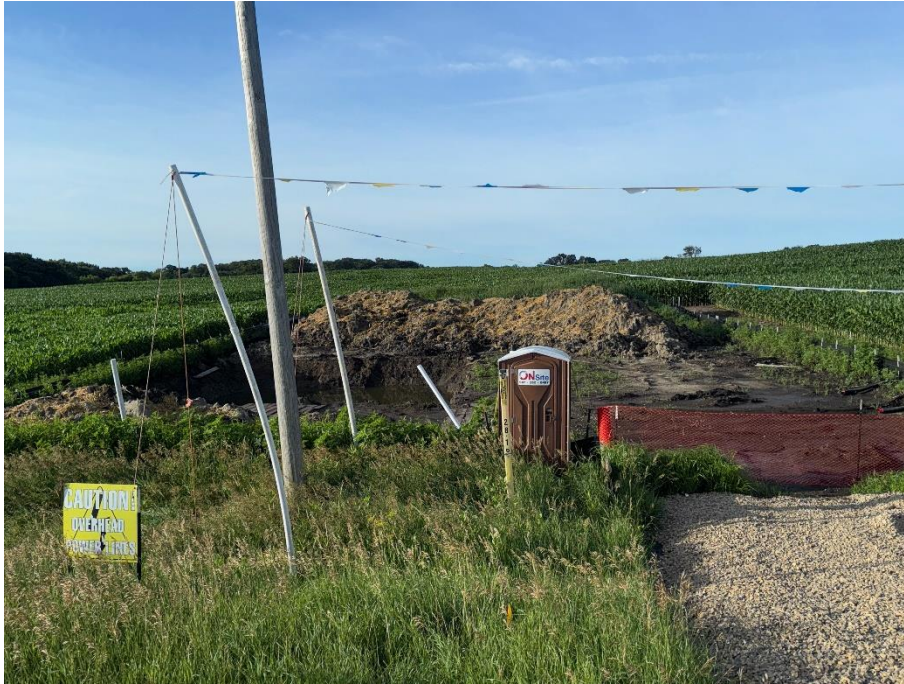
Photo No.: 5

Assessment: Acceptable

Comments: Agricultural ROW, Lake Mills to Albert Lea E-line. The end of the construction ROW. An excavation was lined on the bottom with equipment mats in preparation for a stopple that was expected to be installed at the tie-in to the existing pipeline. The ROW was stable with no erosion, off-ROW impacts, or environmental concerns identified.

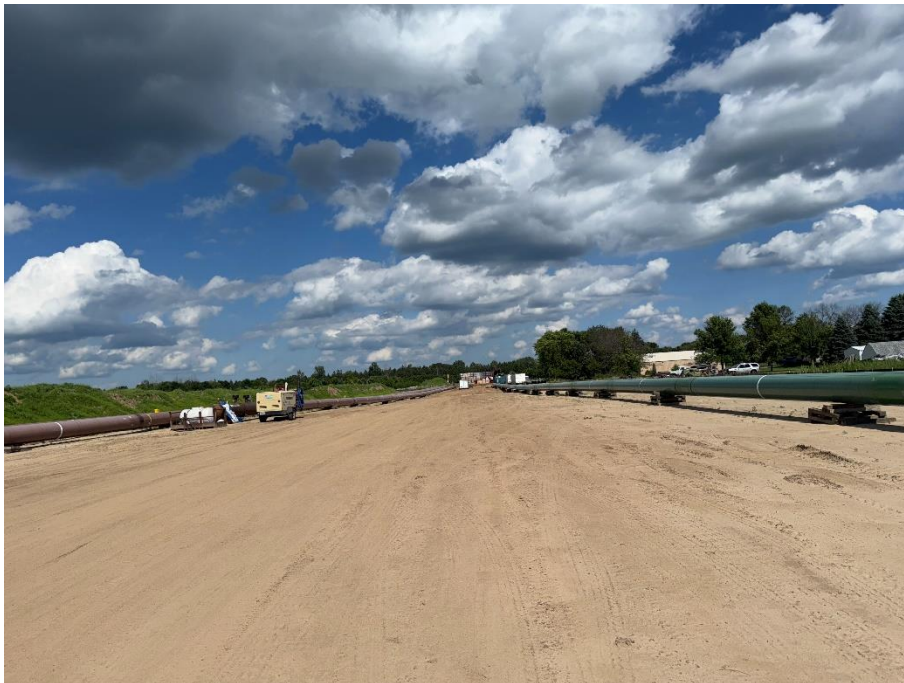
Photo No.: 6

At MP 3.2 along the Elk River 3rd Branch Line ROW, two pipeline strings were welded and ready to be installed, including one pipeline string that will be installed along a horizontal directional drill (HDD) crossing (Photo No. 6). Topsoil was graded, stockpiled, and stabilized with vegetation. At MP 3.3 the pipe was installed under a roadway via road bore crossing, but the trench box was filled with water from recent rains. A drill pad and sound barrier were observed nearby (Photo No. 7). Pipe for the HDD pullback string was staged and ready to be welded at MP 1.9. Equipment mats and other ECDs were installed (Photo Nos. 8 and 9). The pipeline was lowered into the ground and mostly backfilled near MP 1.0. An open excavation remained at the tie-in, which was surrounded with orange exclusion fence. The topsoil stockpile was surrounded with silt fence and partially stabilized with vegetation (Photo No. 10). At all locations inspected, the ROW was stable with no erosion, off-ROW impacts, or environmental concerns identified.

Assessment: Acceptable

Comments: Open and Forested ROW, Elk River 3rd Branch Line. Two pipeline strings were welded and waiting to be installed – including one for the directional drill crossing. Topsoil was graded, stockpiled along the ROW, and stabilized with vegetation. The ROW was stable with no erosion, off-ROW impacts, or environmental concerns identified.

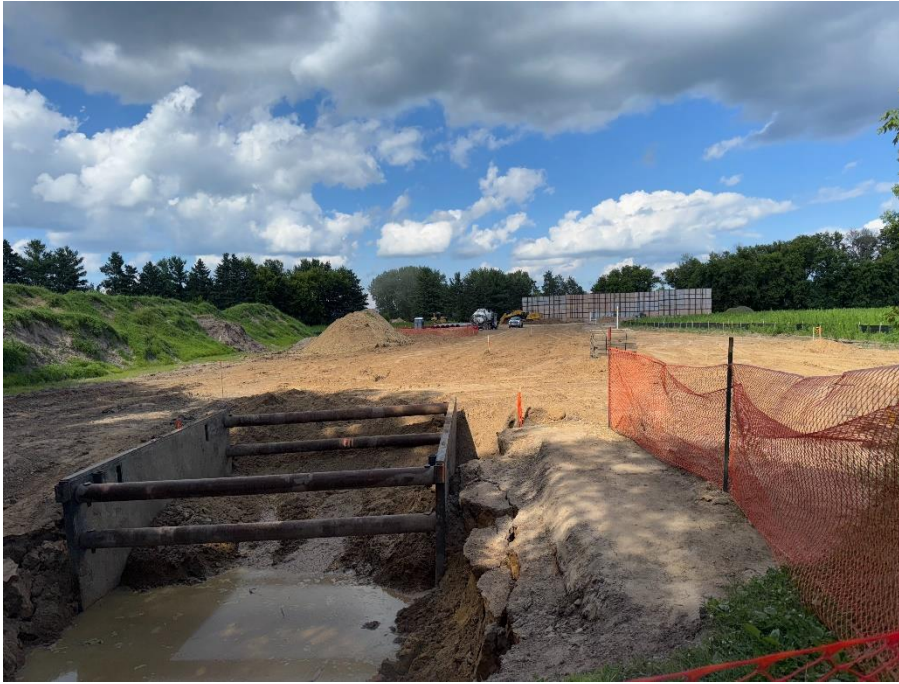
Photo No.: 7

Assessment: Acceptable

Comments: Open and Forested ROW, Elk River 3rd Branch Line. The pipe was installed at the road bore crossing. The trench box was filled with water from recent rains. A drill pad with sound barrier was observed in the distance. The ROW was stable with no erosion, off-ROW impacts, or environmental concerns identified.

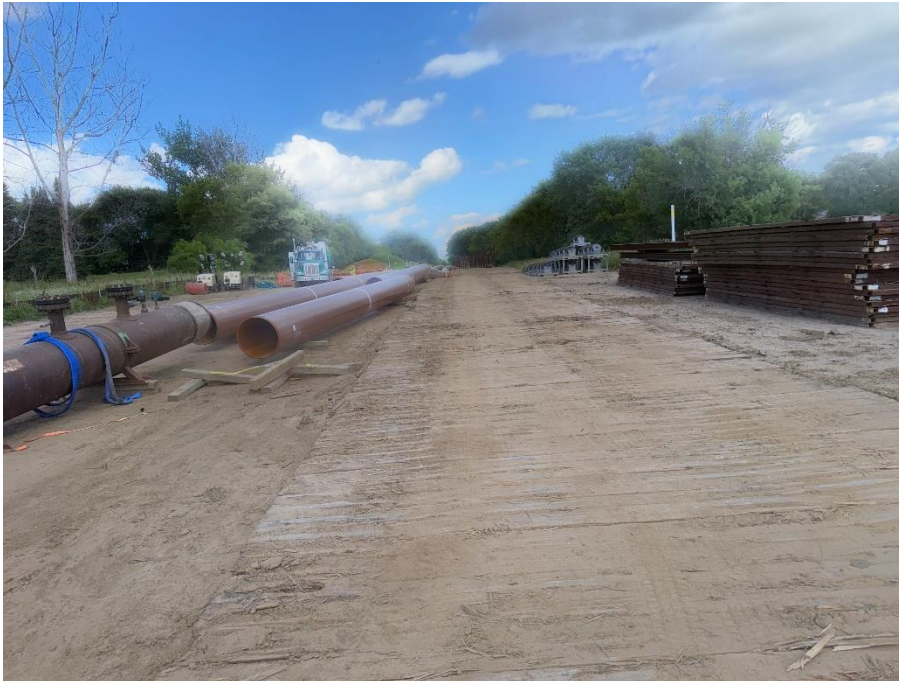
Photo No.: 8

Assessment: Acceptable

Comments: Forested and Open ROW, Elk River 3rd Branch Line. Pipe for the HDD pullback string was ready to be welded. Equipment mats were installed, and the ROW appeared to be stable with no erosion, off-ROW impacts, or environmental concerns identified.

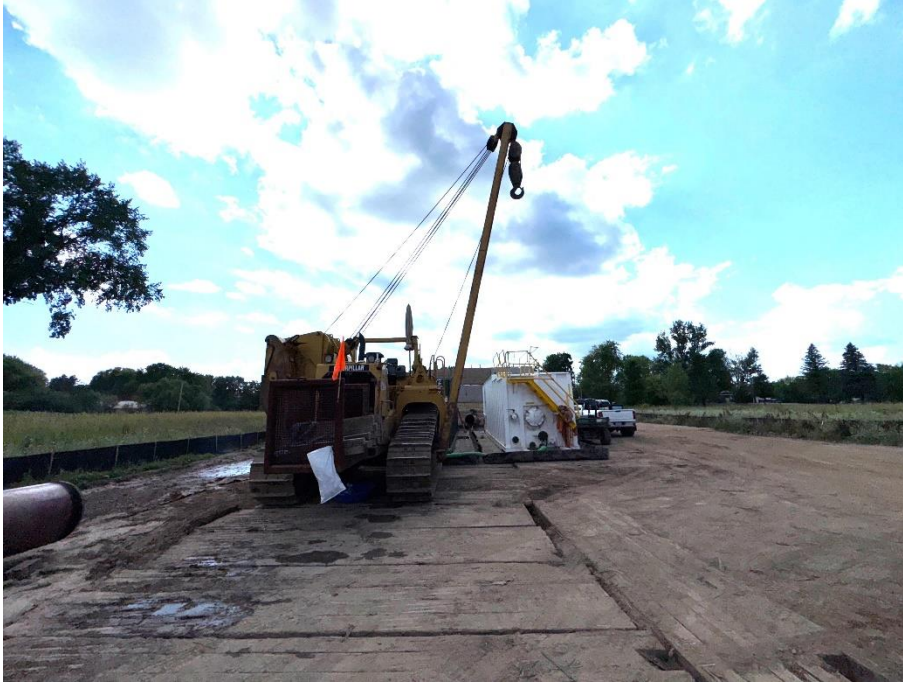
Photo No.: 9

Assessment: Acceptable

Comments: Open ROW, Elk River 3rd Branch Line. A side boom, water tank, and generator were staged at the hydrostatic test site for the of the HDD crossing pipeline. No off-ROW impacts or environmental concerns were identified.

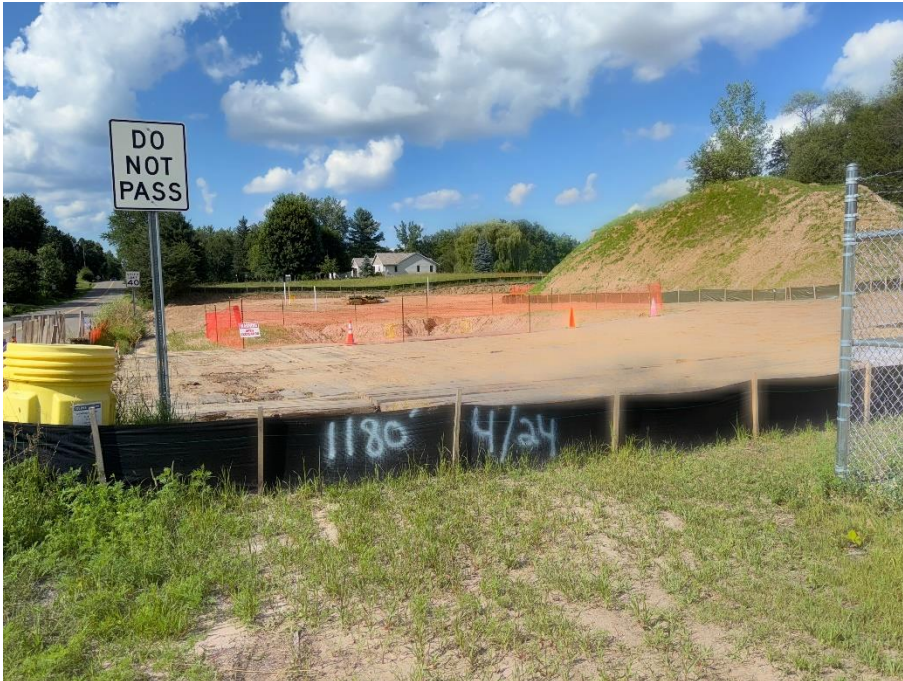
Photo No.: 10

Assessment: Acceptable

Comments: Open and Forested ROW, Elk River 3rd Branch Line. The pipeline was lowered into the ground and mostly backfilled. An open excavation remained at the tie-in – which was surrounded with orange exclusion fence. The topsoil stockpile was surrounded with silt fence and partially stabilized with vegetation and stable. There The ROW was stable with no erosion, off-ROW impacts, or environmental concerns identified.

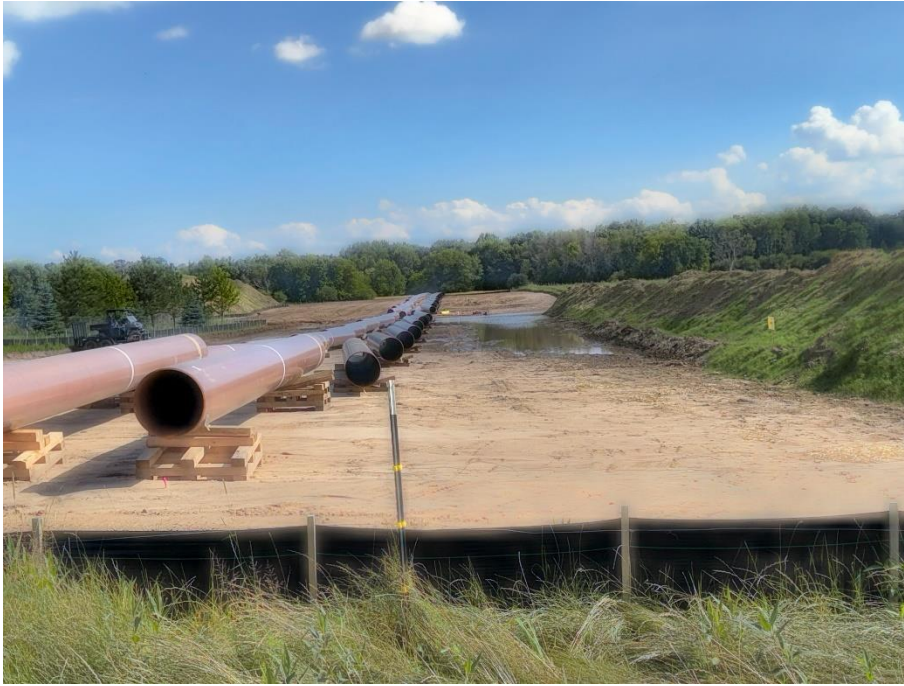
Photo No.: 11

Assessment: Acceptable

Comments: Open ROW, Farmington to Hugo C-Line. Topsoil was graded and stabilized with vegetation, and pipe was strung along the ROW. Silt fence was installed along the ROW limits. The site was stable with no environmental concerns identified.

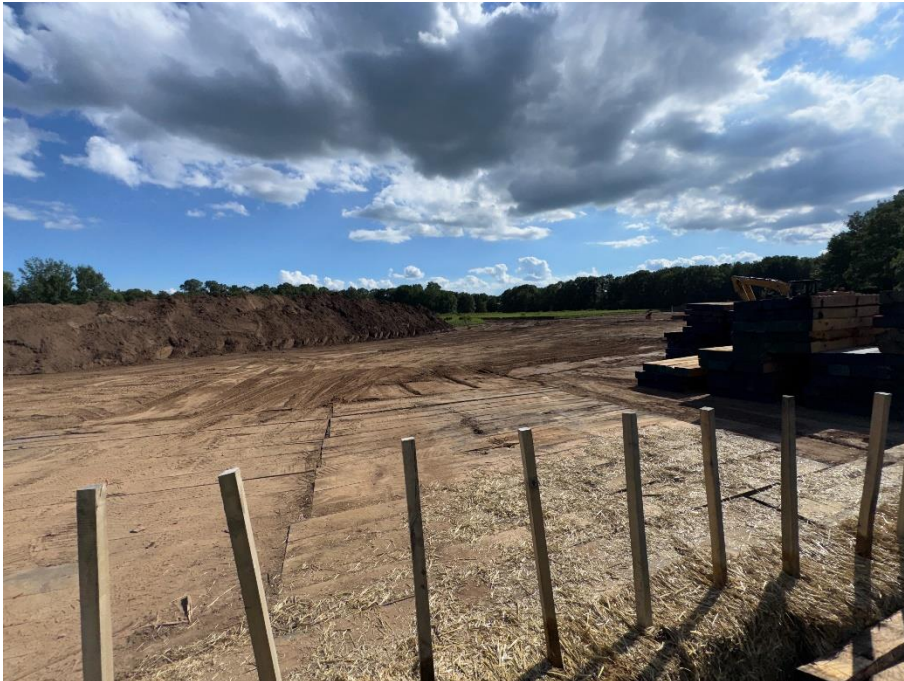
Photo No.: 12

Assessment: Acceptable

Comments: Forested and Open ROW, Farmington to Hugo C-Line. The ROW was graded, and topsoil was stockpiled along the edge of the ROW. Part of the workspace was stabilized with equipment mats and hay bales. The site was stable with no environmental concerns identified.

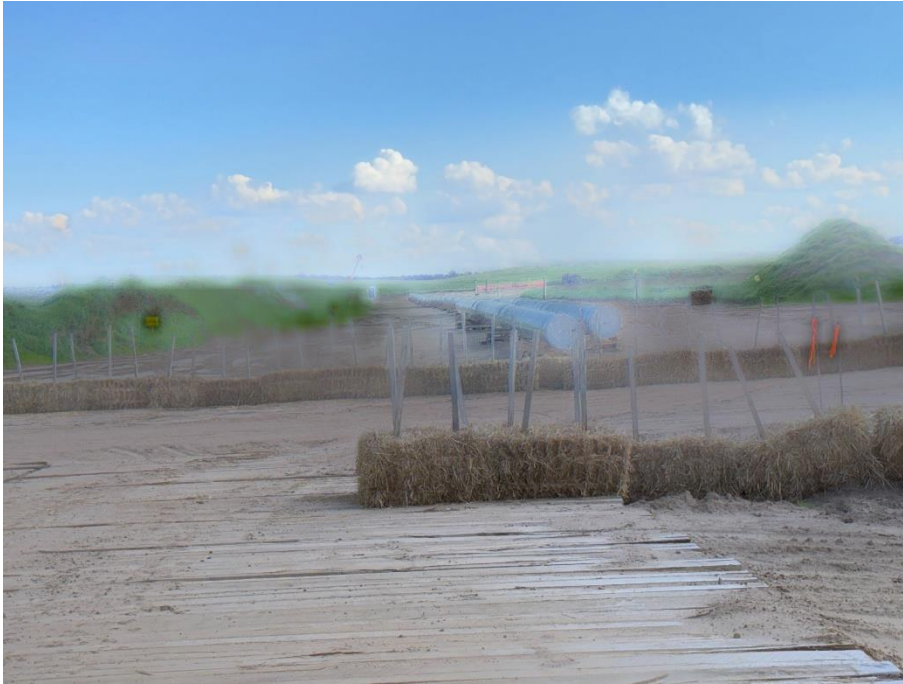
Photo No.: 13

Assessment: Acceptable

Comments: Open ROW, Farmington to Hugo C-Line. The ROW was graded, and topsoil was stockpiled and stabilized with vegetation. Equipment mats and hay bales were installed at the access road. The site was stable with no environmental concerns identified.

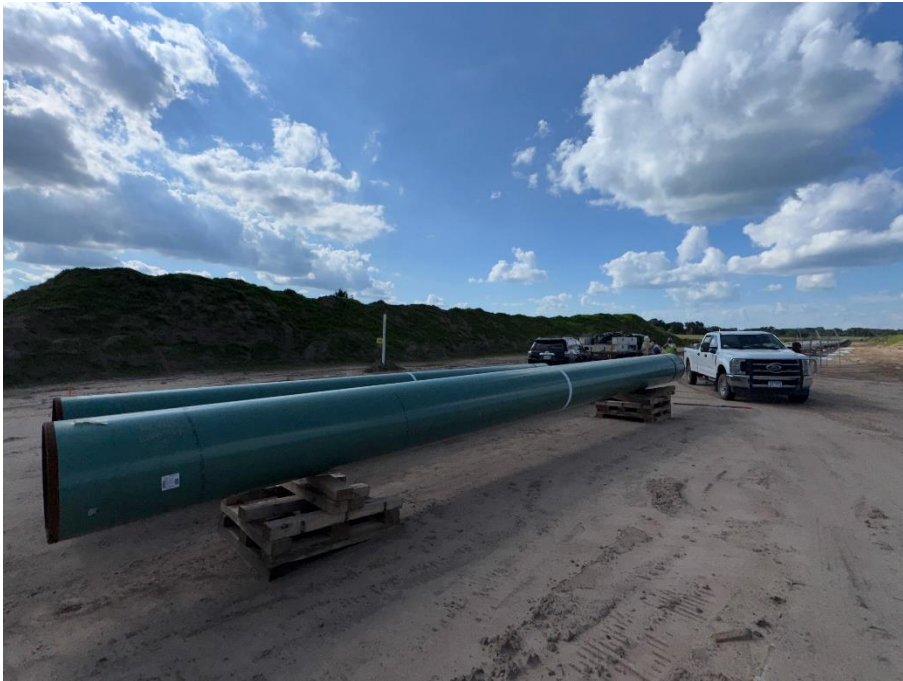
Photo No.: 14

Assessment: Acceptable

Comments: Open ROW, Farmington to Hugo C-Line. Two joints of pipe had been stacked by the access near a road crossing. The ROW was graded, and topsoil was stockpiled and seeded. The site was stable with no environmental concerns identified.

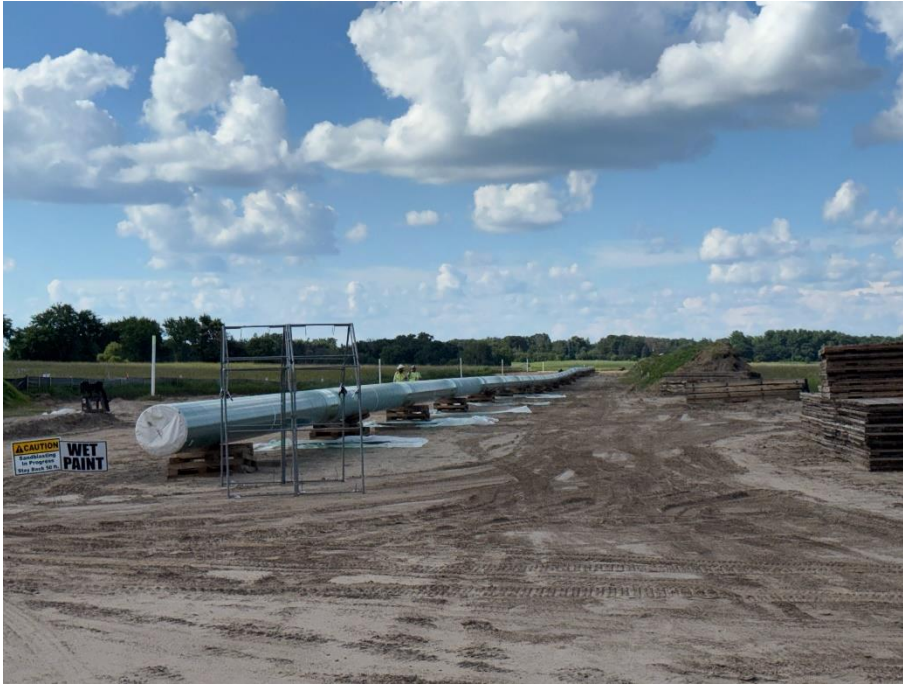
Photo No.: 15

Assessment: Acceptable

Comments: Open/Pasture ROW, Farmington to Hugo C-Line. The pipeline string was welded, and a crew was sandblasting and painting the welded pipe joints. Plastic was placed on the ground to catch the sandblast media and paint overspray. The ROW was stable with no erosion, off-ROW impacts, or other environmental concerns identified.

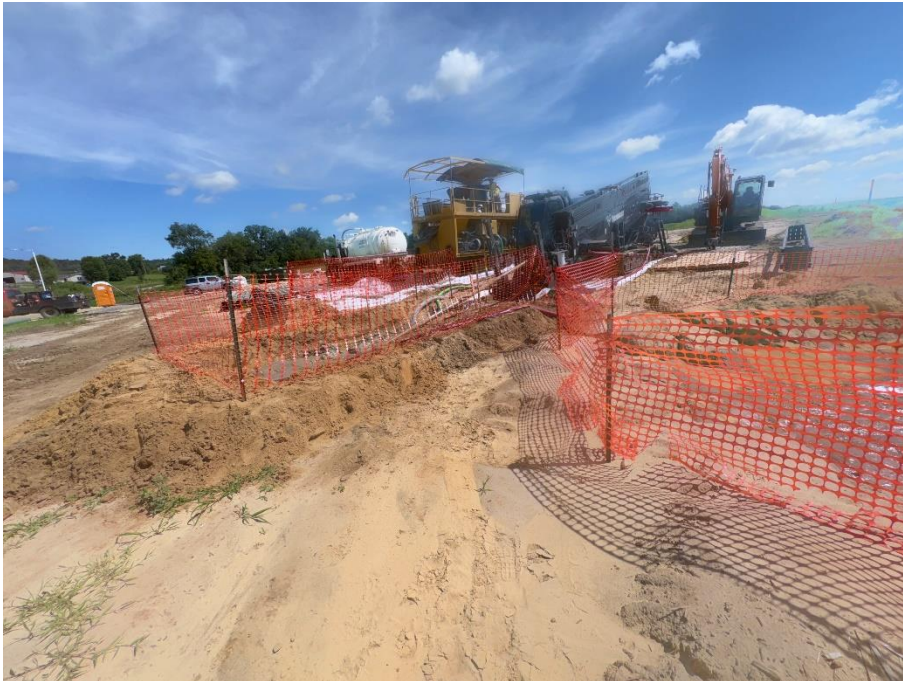
Photo No.: 16

NNG reported that crews were making repairs along the ROW following two weeks – and 13 inches – of rain. Despite the heavy rainfall, no significant erosion, off-ROW impacts, or other environmental concerns were observed. At MP 3.5 along the Tomah Branch Lind Loop, an active HDD crossing was in progress. NNG reported that there was an inadvertent release of drilling mud estimated to be 100 gallons, but the drilling mud was contained (Photo No. 16). At MP 2.5, the ROW, and an extra workspace for an expected HDD road crossing, was graded and temporary ECDs were installed (Photo No. 17). A timbe pile within the ROW limits was scheduled to be removed, according to NNG. At MP 2.54, NNG reported that Baltimore oriole chicks had fledged and left their nest, so the tree that the birds were nesting in, which was on the ROW, was removed (Photo No. 18). The working side of the ROW from MP 2.5 was stabilized with equipment mats, and topsoil was stockpiled and stabilized with vegetation (Photo No. 19). An existing valve site at the end of the Project area (approximately MP 2.2) was scheduled to be removed, according to NNG. An excavation to expose the underground valve piping was in progress, but was delayed due to the heavy rains, according to NNG (Photo No. 20). Otherwise, the valve site was stable. At all locations inspected, the ROW was stable; with no erosion, off-ROW impacts, or environmental concerns identified.

Assessment: Acceptable

Comments: Open ROW, Tomah Branch Line. An active HDD crossing was observed during the inspection. NNG reported that there was an inadvertent release of drilling mud. NNG stated that approximately 100 gallons of drilling mud was released, but that the drilling mud was contained.

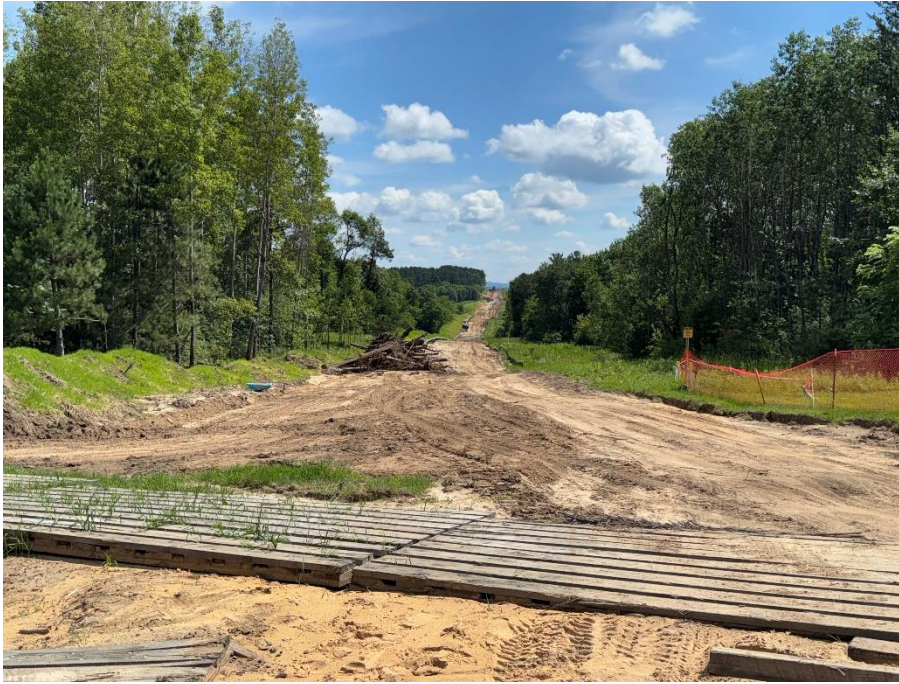
Photo No.: 17

Assessment: Acceptable

Comments: Forested and Residential ROW, Tomah Branch Line. The ROW, and the extra workspace for an expected HDD crossing under the county road, was graded and temporary ECDs were installed. NNG stated that the timber pile seen in the middle ground of the photo was schedule to be removed. NNG further reported that crews were making repairs along the ROW following two weeks of rain, with over 13 inches of rainfall recorded. The site was stable with no environmental concerns identified.

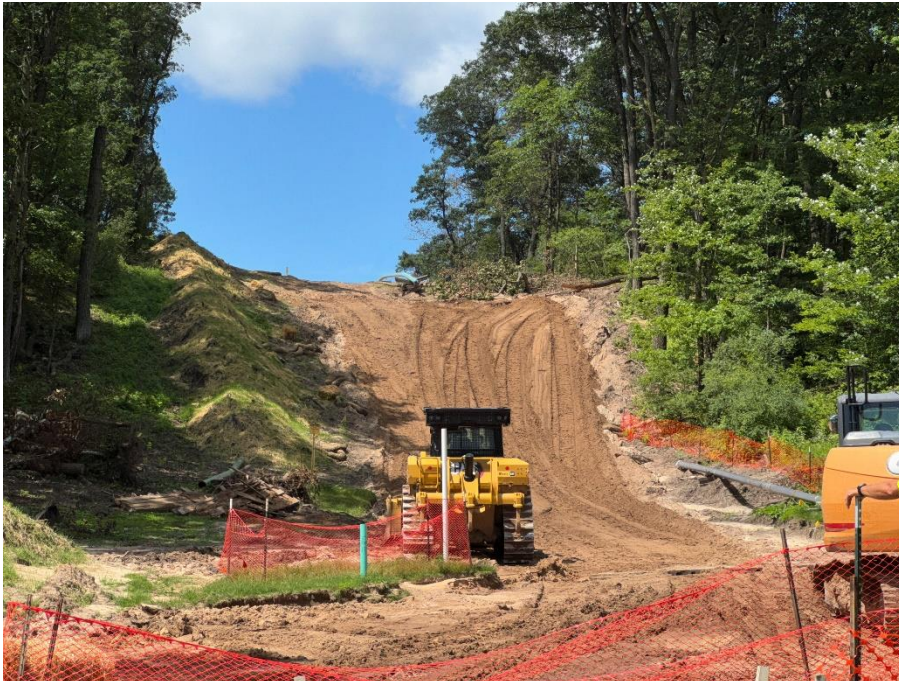
Photo No.: 18

Assessment: Acceptable

Comments: Residential, Open, Forested, and Agricultural ROW, Tomah Branch Line. NNG reported that Baltimore oriole chicks had fledged and left their nest, so the tree that the birds were nesting in, which was on the ROW, was removed. The ROW was graded and topsoil was stockpiled and stabilized with seed and mulch. Grading was underway. The ROW was stable with no erosion, off-ROW impacts, or other environmental concerns identified.

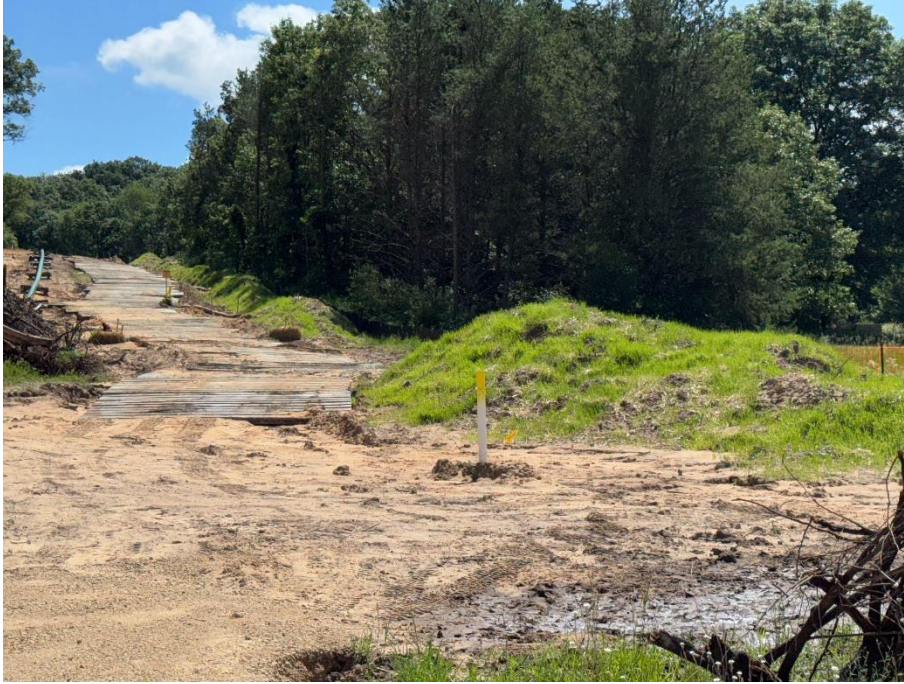
Photo No.: 19

Assessment: Acceptable

Comments: Open, Forested, and Agricultural ROW, Tomah Branch Line. The working side of the ROW was stabilized with equipment mats, and a pipe string was welded and set on skids. Topsoil was stockpiled and stabilized with vegetation. The ROW was stable with no erosion, off-ROW impacts, or environmental concerns identified.

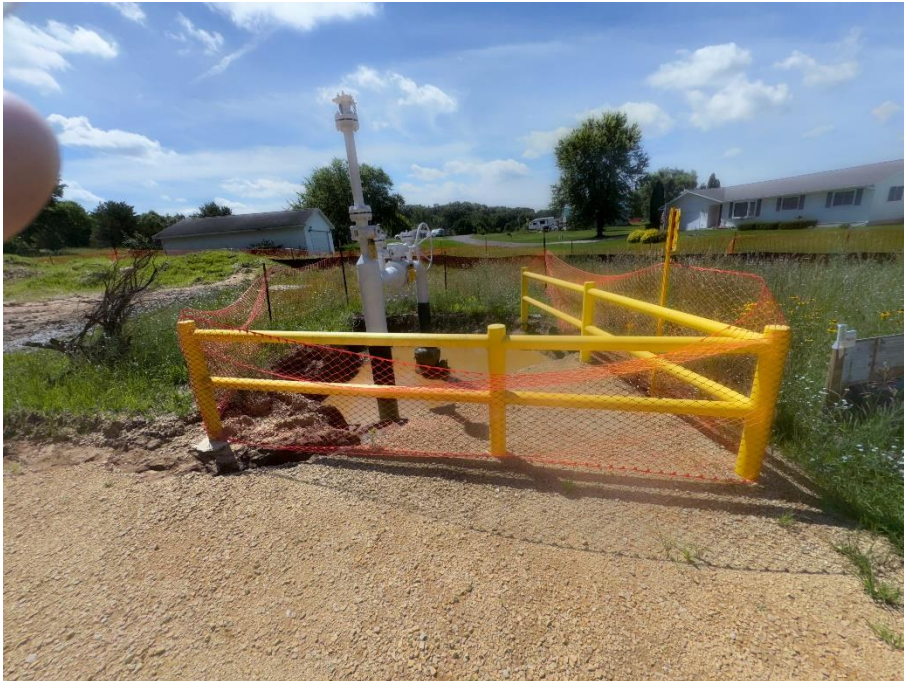
Photo No.: 20

Assessment: Acceptable

Comments: Open and Agricultural ROW, Tomah Branch Line. An existing valve site at the end of the project area was scheduled to be removed, according to NNG. An excavation to expose the valve was in progress, but was delayed due to heavy rains, according to NNG. The valve site was stable with no erosion, off-ROW impacts, or environmental concerns identified.
