FEDERAL ENERGY REGULATORY COMMISSION FIELD INSPECTION REPORT

Date August 26 and 27, 2025

Project Northern Natural Gas Company
Northern Lights 2025 Expansion Project
Freeborn, Washington, and Houston Counties, Minnesota; and Monroe
County, Wisconsin
Docket No.: CP24-60-000
Authority: 7(c)

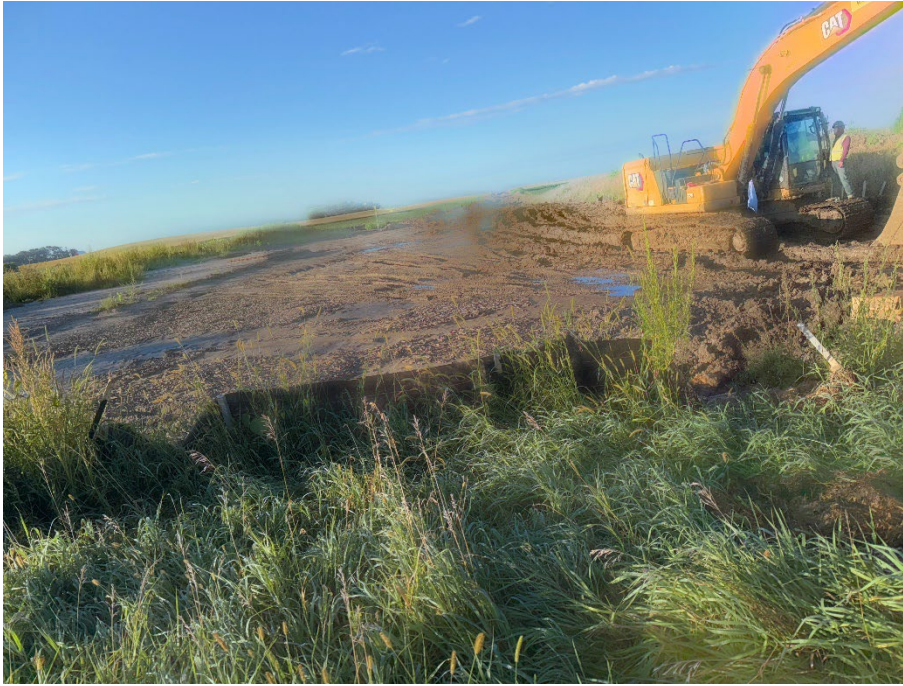
Photo No.: 1

The inspection began at milepost (MP) 34.2, where the pipeline was installed; however, due to saturated soils, no cleanup or restoration work could yet be done (Photo No. 1). At MP 32.19 pipe was installed, and the trench was backfilled. The excavation for the road crossing tie-in was full of water (Photo No. 2). At MP 34.2, the mainline tie-in was exposed, and the excavation was full of water (Photo No. 3). No erosion, off-ROW impacts, or other environmental concerns were observed.

Assessment: Acceptable

Comments: Agricultural ROW, Lake Mills to Albert Lea E-line. The rains had cleared, but much of the ROW remained wet, with saturated soil and ponding along low-lying areas. Silt fence along the edge of the ROW was being maintained and functioning as designed. No off-ROW impacts or other environmental concerns were identified.

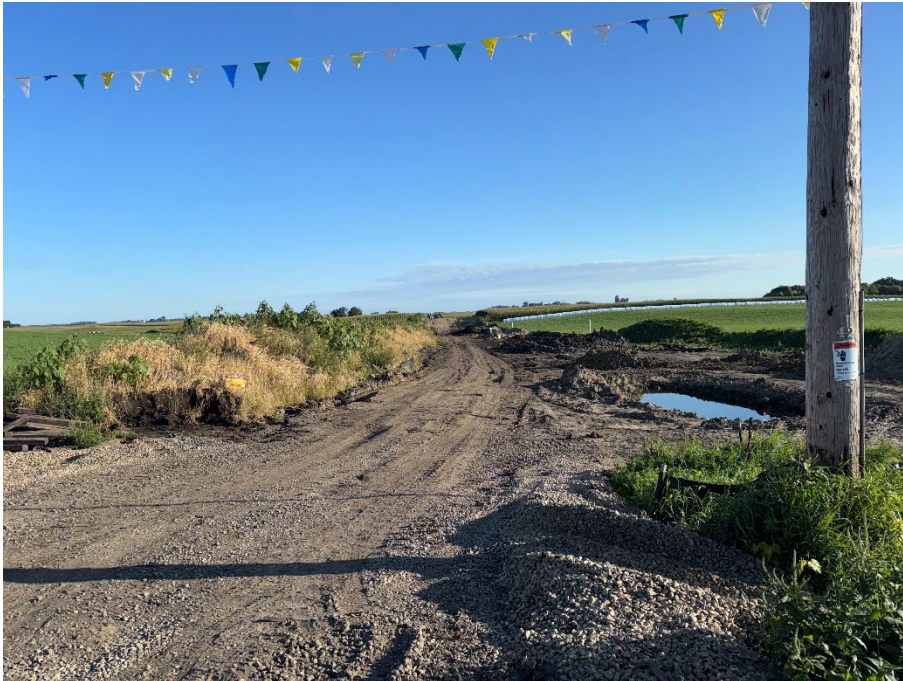
Photo No.: 2

Assessment: Acceptable

Comments: Agricultural ROW, Lake Mills to Albert Lea E-line. The pipeline was installed through this section. Beyond the hill in the distance, there was ponding, and the pipe had not yet been installed. Topsoil piles were stabilized with vegetation. The excavation for the road crossing tie-in was filled with water. No off-ROW impacts or other environmental concerns were identified.

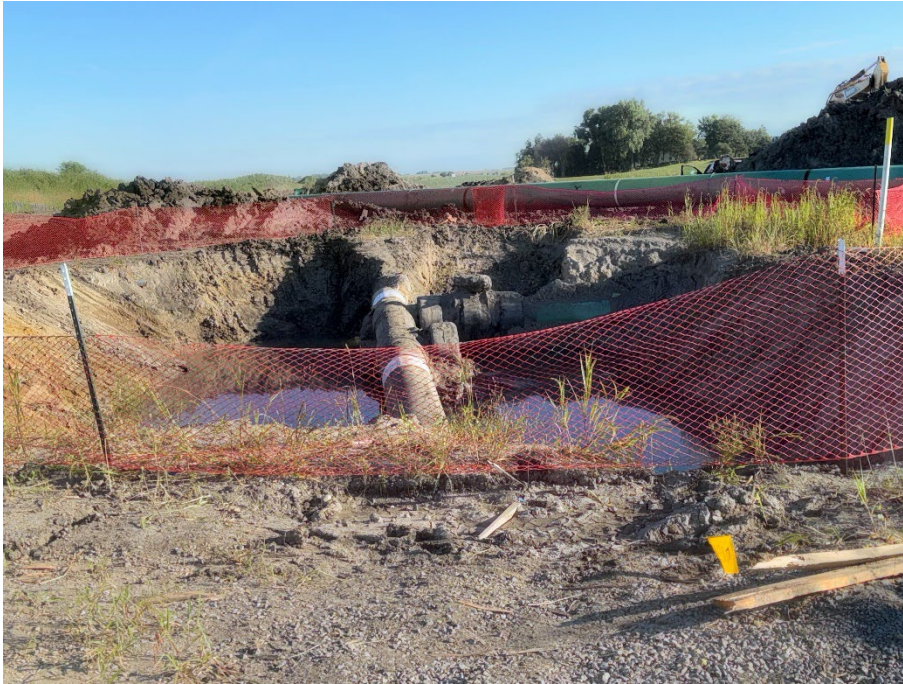
Photo No.: 3

Assessment: Acceptable

Comments: Agricultural ROW, Lake Mills to Albert Lea E-line. The tie-in excavation was holding water, but the walls appeared stable. Orange exclusion fence was in place around the excavation. Pipeline was strung and welded, ready to be installed once conditions allowed. No off-ROW impacts or other environmental concerns were identified.

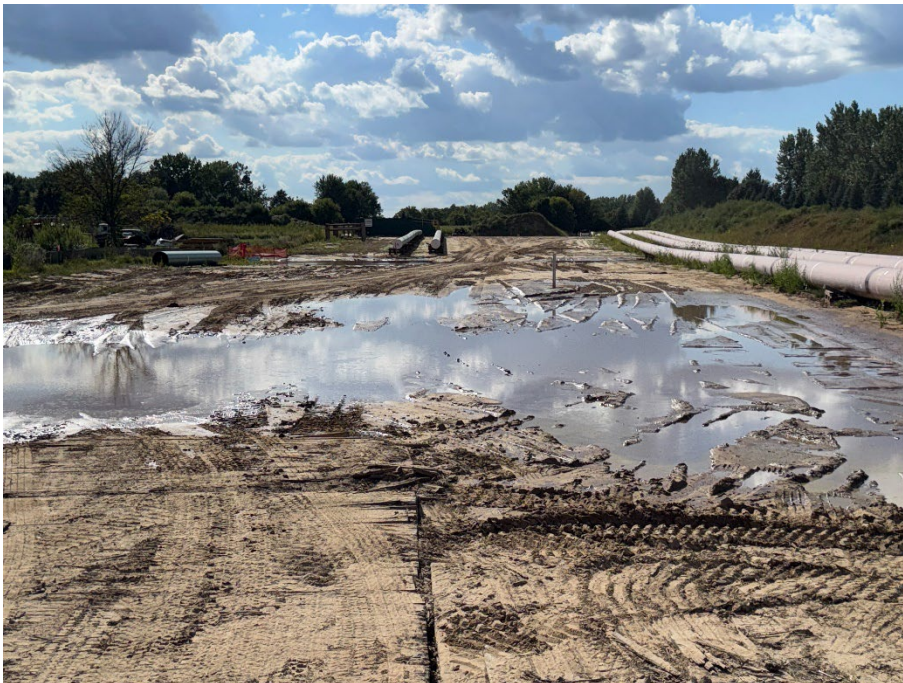
Photo No.: 4

Overall, conditions along the ROW were good, and much of the pipeline was installed. HDD crossings were in progress, but progressing slowly. Additional HDD rigs were being mobilized to the Project to complete the crossings. At MP 3.05, the pipeline was installed, and the trench was backfilled. Two HDD pullback pipe strings were welded and ready for installation (Photo No. 4). At MP 3.05, an active

Assessment: Acceptable

Comments: Open and Forested ROW, Elk River 3rd Branch Line. The ROW was holding water from recent rains. HDD pullback pipe strings were staged along the ROW, ready for installation. Topsoil piles were stabilized with vegetation. ECDs were maintained and functioning as designed. No off-ROW impacts or environmental concerns were identified.

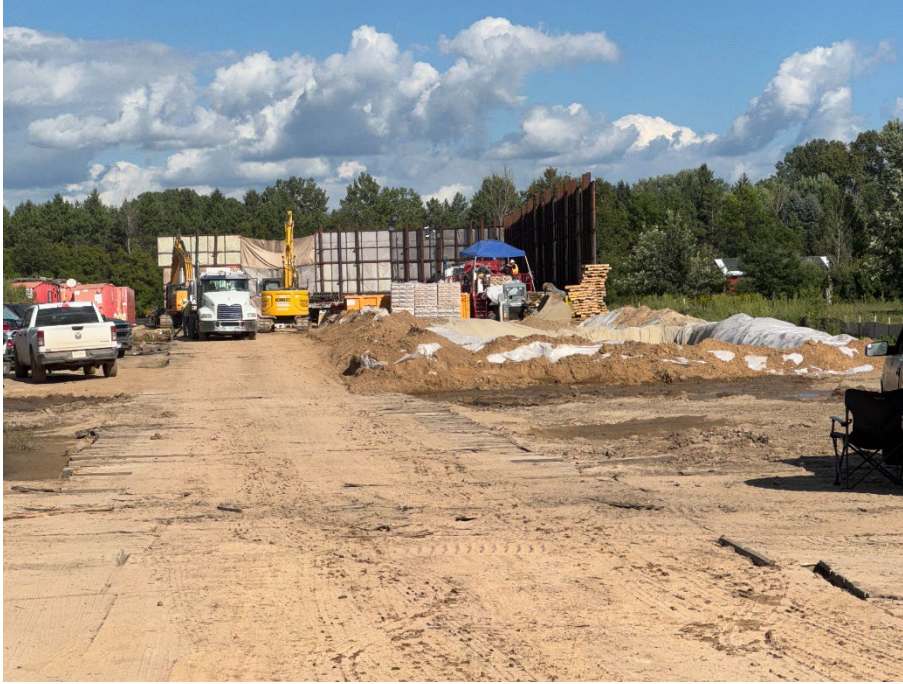
Photo No.: 5

HDD crossing was making the final ream pass (Photo No. 5). The site was stabilized with equipment mats, and a sound barrier wall was in place. At MP 2.4 two HDD pullback pipe strings remained in place, ready for installation (Photo No. 6); and pipe was staged for welding and installation to tie into the completed HDD crossing (Photo No. 7). At MP 1.0, the HDD drill pad was stabilized with equipment mats, and a sound barrier was in place (Photo No. 8). The topsoil pile was moved to fit the drill pad and reseeded for stabilization. Additional silt fence was installed, and the site was stable. At all locations inspected, the ROW was stable with no erosion, off-ROW impacts, or environmental concerns identified.

Assessment: Acceptable

Comments: Open and Forested ROW, Elk River 3rd Branch Line. The active HDD site was stabilized equipment mats, and a sound barrier wall was in place. The ECDs surrounding the site were maintained and functioning as designed. The drill pad was stable with no off-ROW impacts or environmental concerns identified.

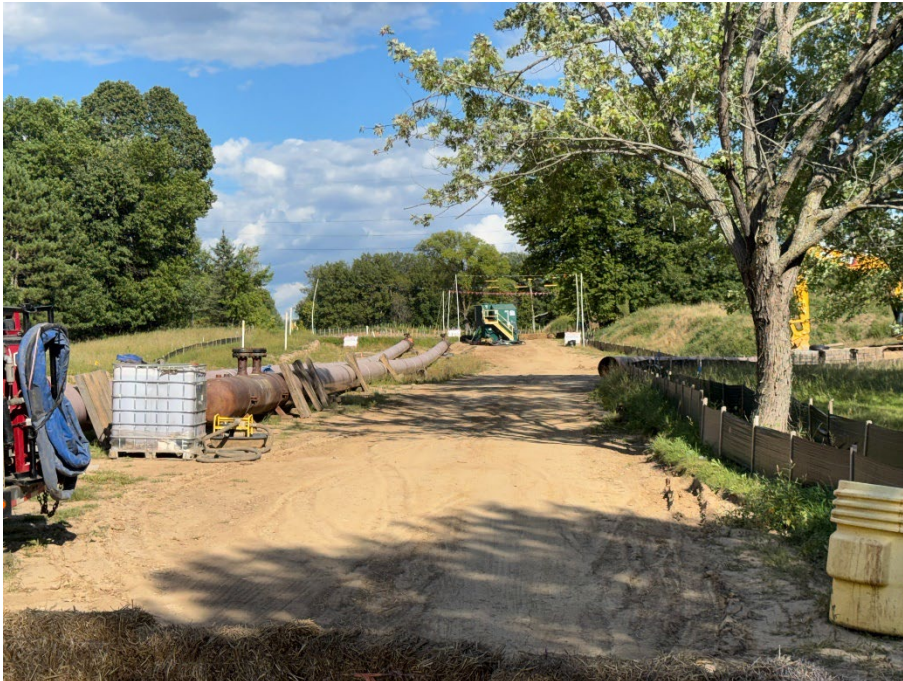
Photo No.: 6

Assessment: Acceptable

Comments: Open and Forested ROW, Elk River 3rd Branch Line. Two HDD pullback pipe stings were hydrostatically pressure tested and ready for installation. The ROW was stable with no erosion, off-ROW impacts, or environmental concerns identified.

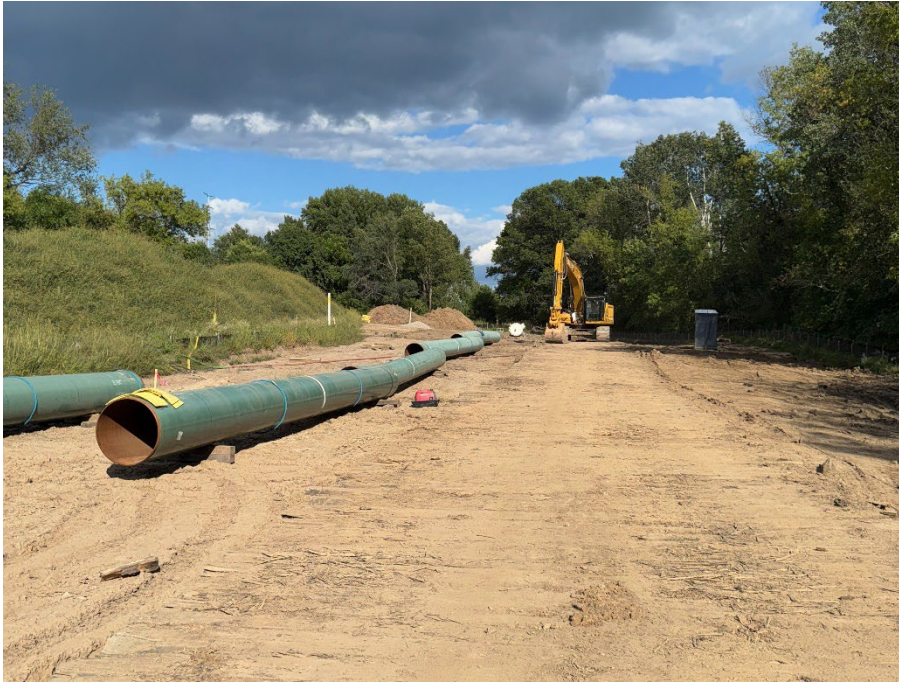
Photo No.: 7

Assessment: Acceptable

Comments: Open and Forested ROW, Elk River 3rd Branch Line. Pipe was staged for welding and installation to tie into the completed HDD crossing. The topsoil pile was stabilized with vegetation. Silt fence was maintained and functioning as designed. The ROW was stable with no erosion, off-ROW impacts, or environmental concerns identified.

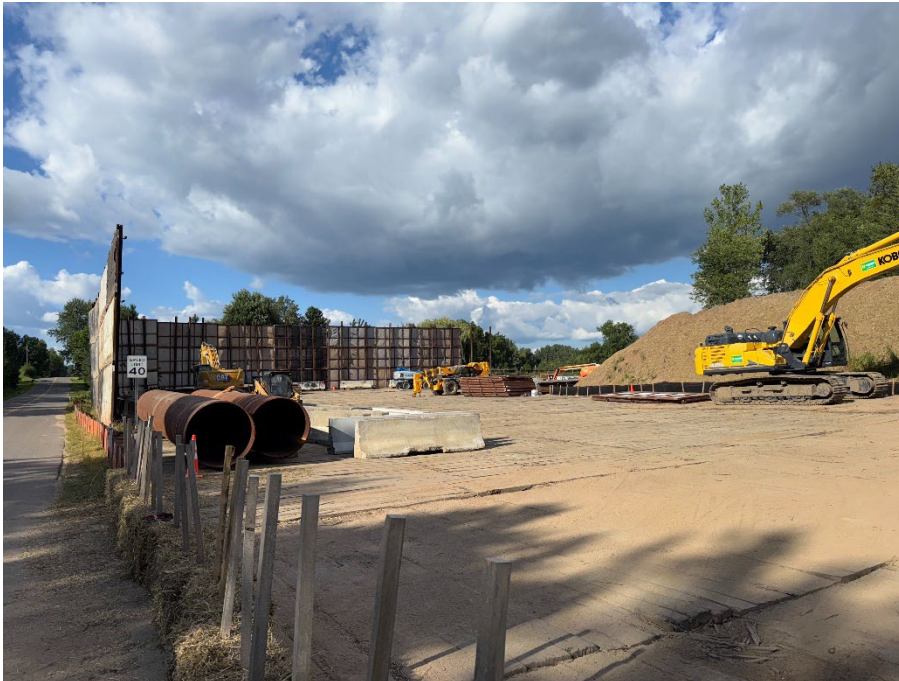
Photo No.: 8

Assessment: Acceptable

Comments: Forested and Open ROW, Elk River 3rd Branch Line. The HDD pad was stabilized with equipment mats, and a sound barrier wall was in place. The topsoil pile was moved to fit the drill pad and reseeded for stabilization. Additional silt fence was installed, and the site was stable. No erosion, off-ROW impacts, or environmental concerns were identified.

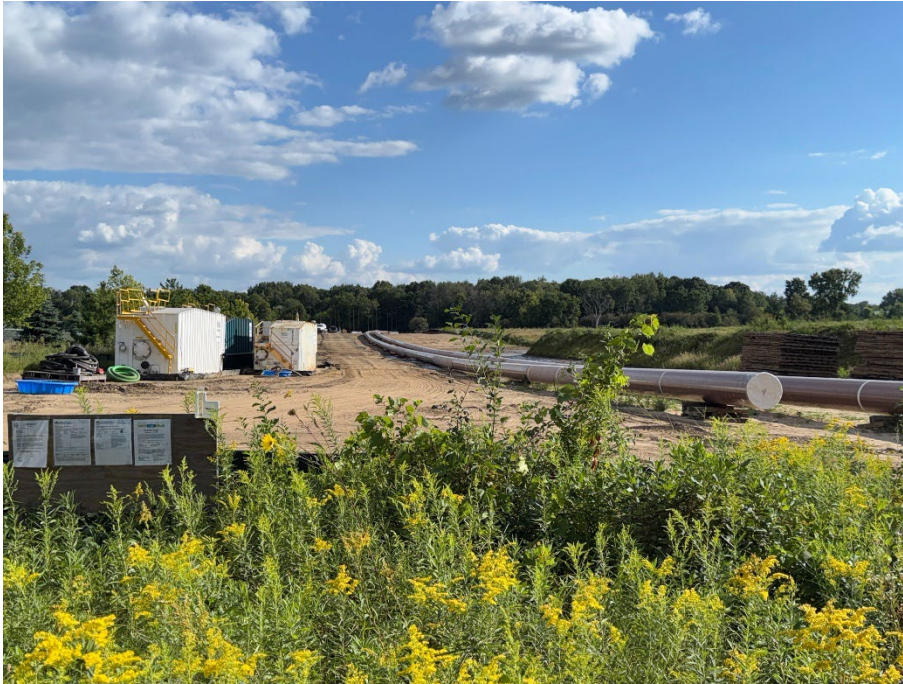
Photo No.: 9

At the ROW kickoff, adjacent to the CS, two HDD pullback pipe strings remained in place (Photo No. 9). Additional HDD rigs were mobilized to expedite the crossings. Drill pads at both MP 0.1 and MP 0.55 were stabilized with equipment mats, and sound barrier walls were in place (Photo Nos. 9 and 10). At MP 1.82, the pipeline was installed, the trench was backfilled, and restoration was completed on half of the ROW where revegetation was progressing (Photo Nos. 11 and 12). The adjacent side of the ROW remained in use as the travel lane to the mainline tie-in site. At MP 0.22, an inadvertent release of drilling mud happened during the inspection. Silt fence was installed around the return, and a vacuum truck was mobilized to the location for cleanup (Photo No. 13). The vacuum truck was parked on-ROW on equipment mats (Photo No. 14). At all locations inspected, erosion control devices (ECDs) were properly installed and maintained, topsoil stockpiles were stabilized with vegetation, and the ROW was stable with no erosion, off-ROW impacts, or environmental concerns identified.

Assessment: Acceptable

Comments: Open ROW, Farmington to Hugo C-Line. An HDD pullback pipe string was welded and staged for installation. Hydrostatic pressure testing water tanks remained at the edge of the ROW. The spoil pile was stabilized with vegetation. Maintained silt fence lined both edges of the ROW. No off-ROW impacts or environmental concerns were identified.

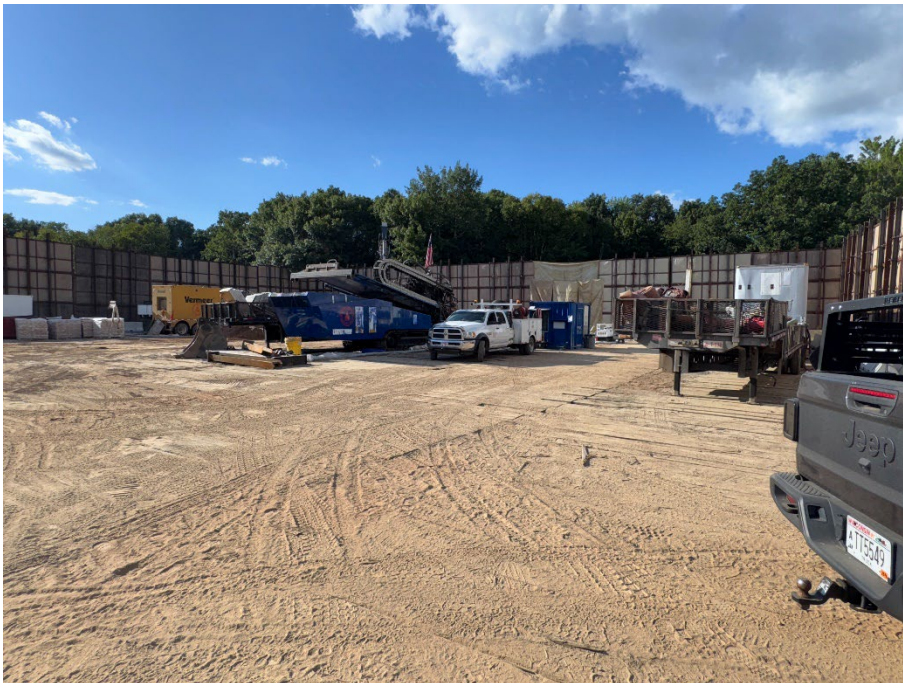
Photo No.: 10

Assessment: Acceptable

Comments: Open and Forested ROW, Farmington to Hugo C-Line. The active drill site was stabilized with equipment mats, and sound barrier walls were in place. The HDD crossing had an inadvertent release at MP 0.22 (see Photo No. 13). The drill pad was stable with no off-ROW impacts or environmental concerns identified.

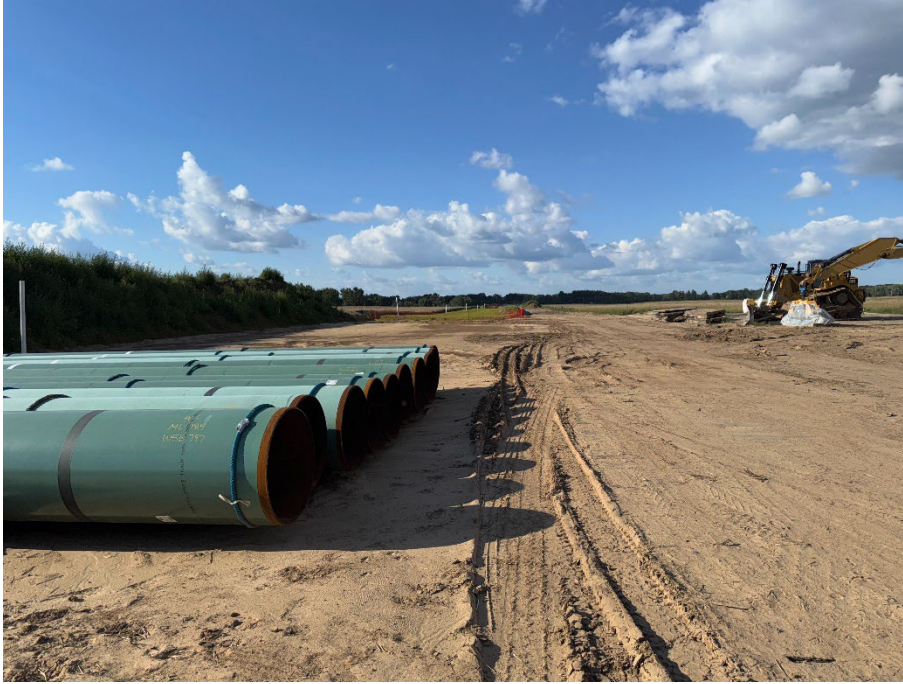
Photo No.: 11

Assessment: Acceptable

Comments: Open ROW, Farmington to Hugo C-Line. The pipeline was installed from this point to the tree line in the distance. Pipe was staged for the HDD crossing beneath the trees. Silt fence was maintained along the edge of the ROW. The ROW was stable, with no environmental concerns identified.

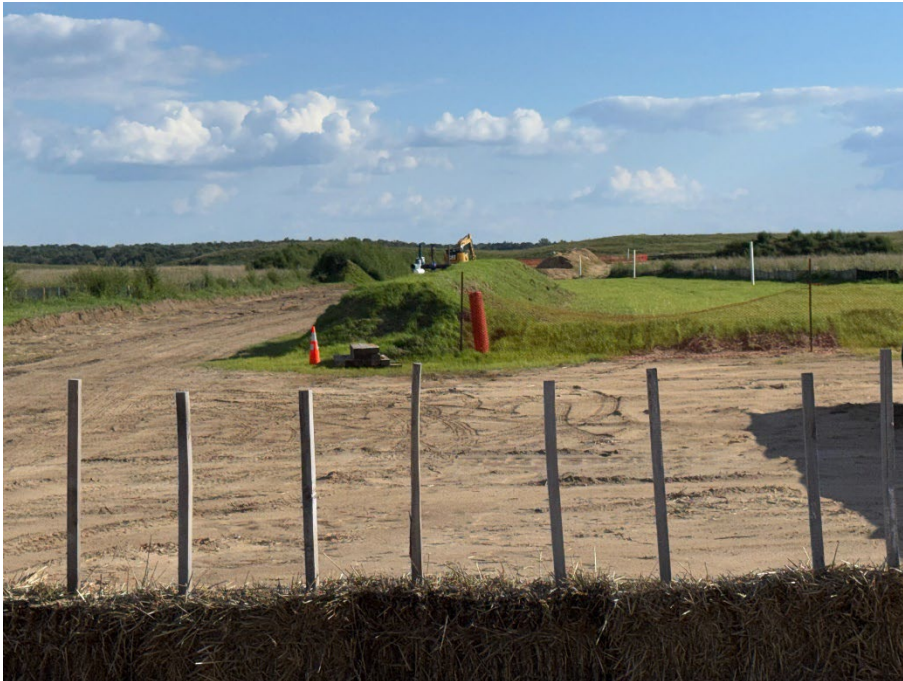
Photo No.: 12

Assessment: Acceptable

Comments: Open ROW, Farmington to Hugo C-Line. Half of the ROW was restored, and revegetation was progressing well. The travel lane remained in place for access to the mainline tie-in site. Topsoil piles were vegetated and stable. Entrance to the ROW off the farm road was blocked with moveable straw bales. The location was stable with no environmental concerns identified.

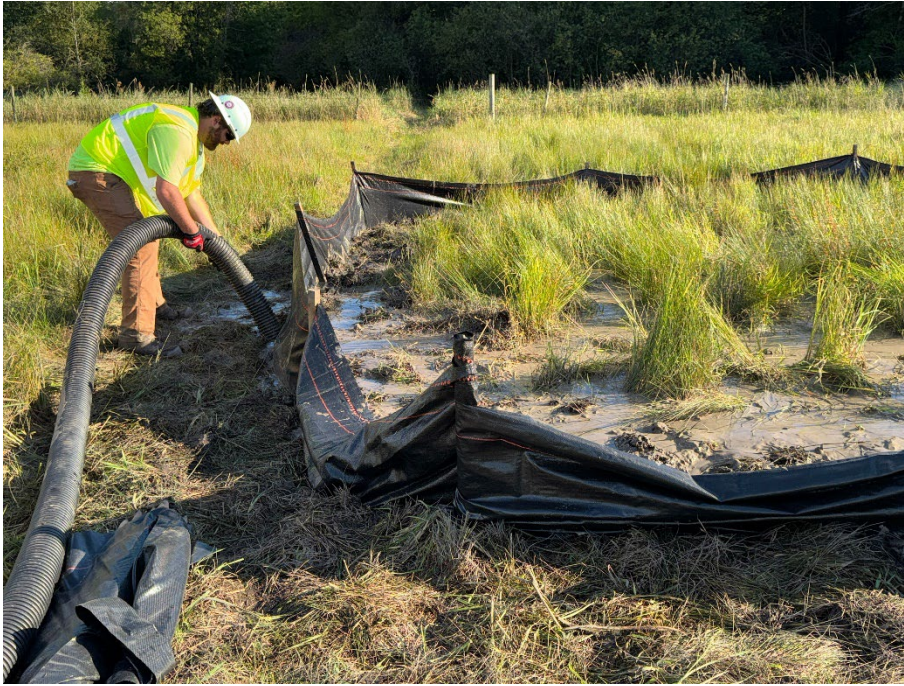
Photo No.: 13

Assessment: Acceptable

Comments: Open ROW, Farmington to Hugo C-Line. An inadvertent release was contained within silt fence. A small amount of drilling mud had breached beneath the silt fence and was being cleaned up.

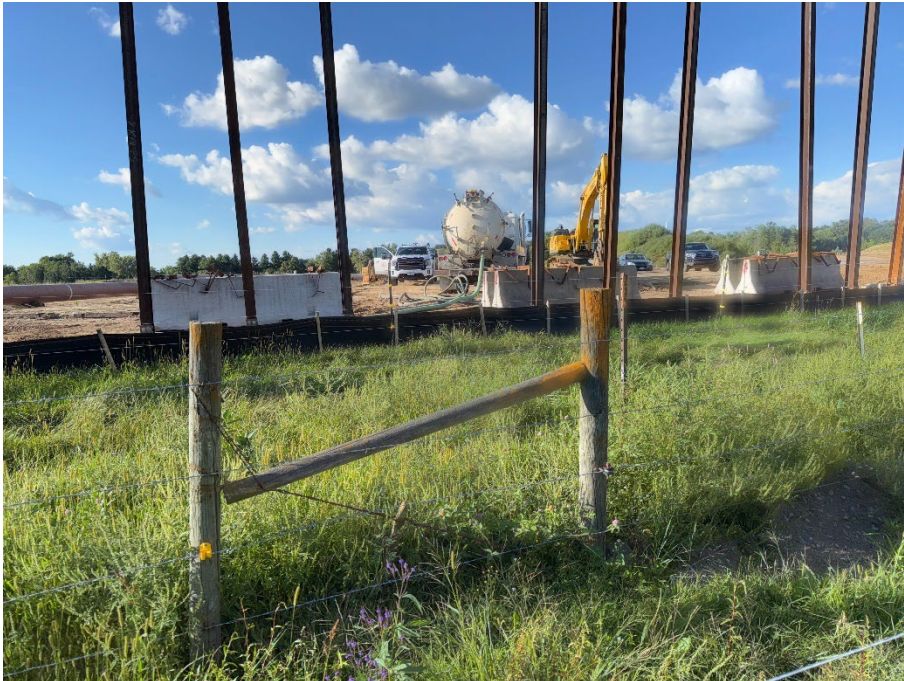
Photo No.: 14

Assessment: Acceptable

Comments: Open and Forested ROW, Farmington to Hugo C-Line. The vacuum truck was parked on equipment mats during cleanup of the inadvertent release. No environmental concerns were identified.

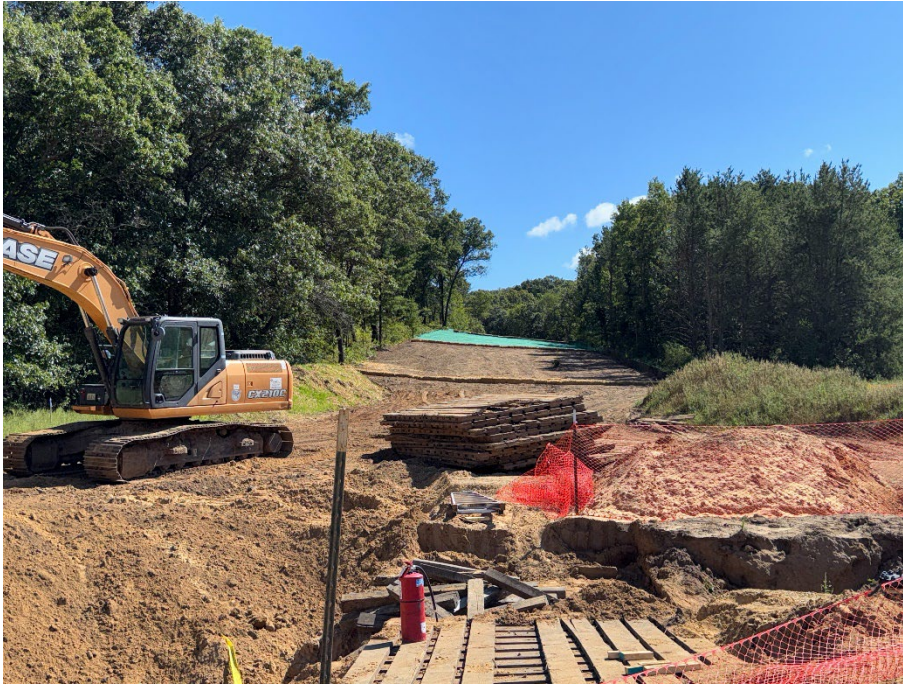
Photo No.: 15

Along the Tomah Branch Line Loop, the pipeline was installed and tied into the mainline. Restoration was in progress from MP 2.25 to MP 2.35 with hydroseed being applied (Photo Nos. 15 and 16). At MP 2.35, due to the sandy soil, which would not hold a slope breaker, a temporary double row of staked straw bales was installed (Photo No. 16). Cleanup was in progress along the remainder of the ROW in preparation for restoration (Photo Nos. 17 through 20). The pipeline had been excavated and exposed in two locations (MP 2.5 and MP 3.15) to install cathodic protection (Photo Nos. 17 and 20, respectively). At all locations inspected, ECDs were properly installed and maintained, topsoil stockpiles were stabilized with vegetation, and the ROW was stable with no erosion, off-ROW impacts, or environmental concerns identified.

Assessment: Acceptable

Comments: Open and Forested ROW, Tomah Branch Line Loop. The ROW was being restored. Equipment mats remained in place at the tie-in site. The ROW was stable with no erosion, off-ROW impacts, or other environmental concerns identified.

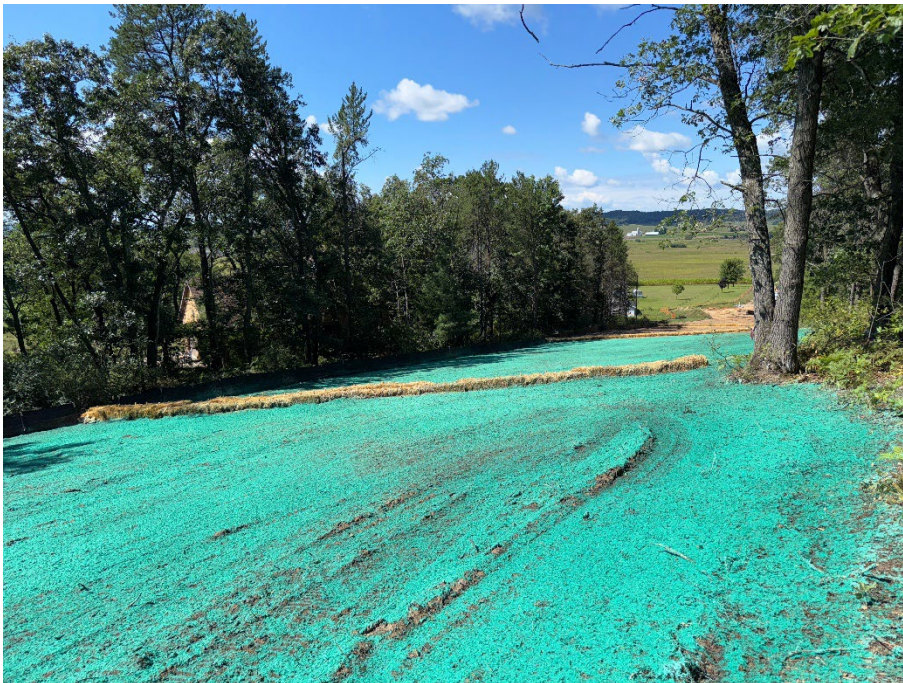
Photo No.: 16

Assessment: Acceptable

Comments: Open ROW, Tomah Branch Line Loop. The ROW was recently sprayed with hydroseed. Due to the sandy soil, which would not hold a slope breaker, a temporary double row of staked straw bales was installed. The ROW was stable with no erosion or environmental concerns identified.

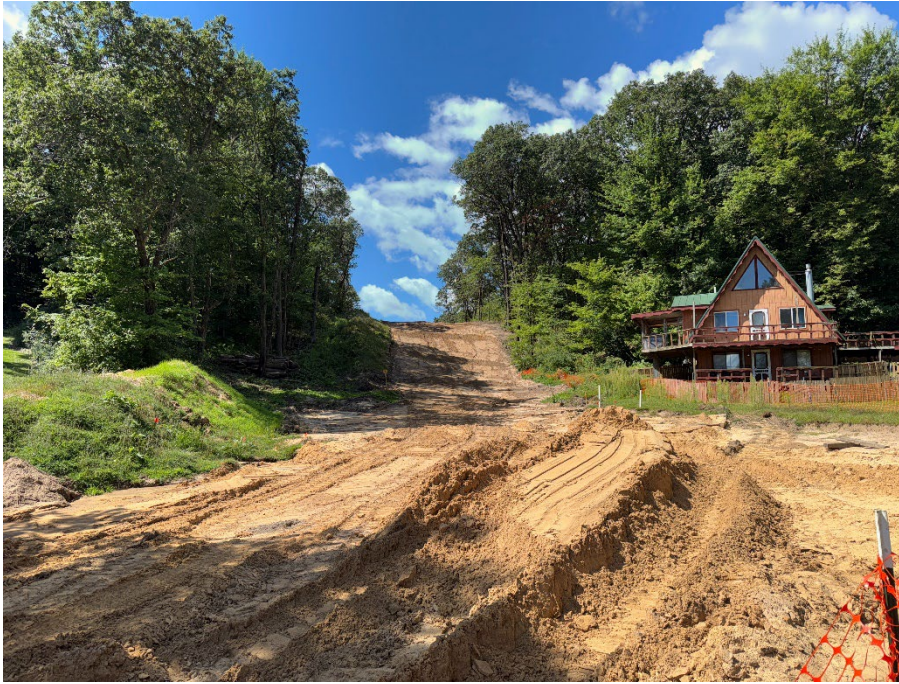
Photo No.: 17

Assessment: Acceptable

Comments: Forested and Residential ROW, Tomah Branch Line Loop. The pipeline was installed down the slope and under the county road. Temporary slope breakers were in place on the slope. Once topsoil is reapplied along the ROW, the slope breakers will be directed away from the house. Topsoil piles remained stabilized with vegetation. A bell hole was excavated to install cathodic protection (foreground). The site was stable with no environmental concerns identified.

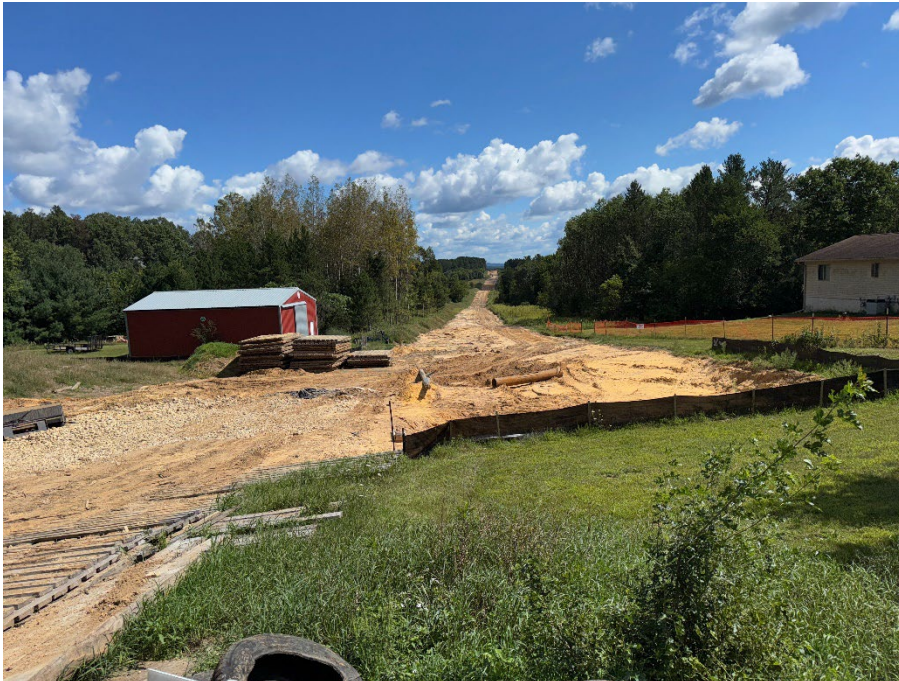
Photo No.: 18

Assessment: Acceptable

Comments: Residential, Open, Forested, and Agricultural ROW, Tomah Branch Line Loop. The pipeline was installed, the trench was backfilled, and the ROW was being cleaned up for restoration. Topsoil piles were stabilized with vegetation. The ROW was stable with no erosion, off-ROW impacts, or other environmental concerns identified.

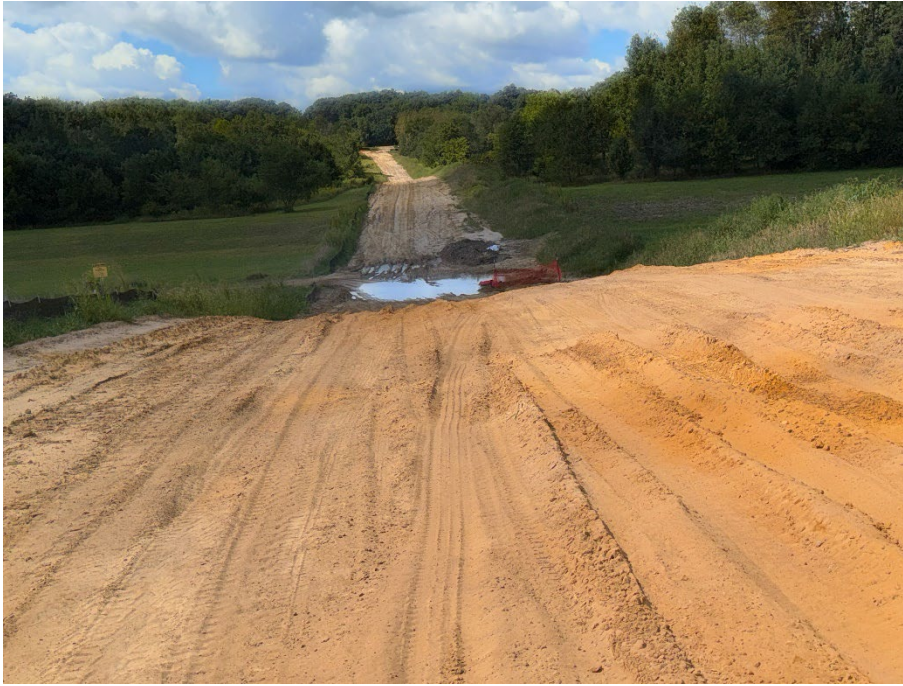
Photo No.: 19

Assessment: Acceptable

Comments: Open, Forested, and Agricultural ROW, Tomah Branch Line Loop. The pipeline was installed, the trench was backfilled, and the ROW was being cleaned up for restoration. The low-lying area of the ROW was holding water. Silt fence remained in place and was functioning as designed on the down-gradient edge of the ROW. The ROW was stable with no erosion, off-ROW impacts, or environmental concerns identified.

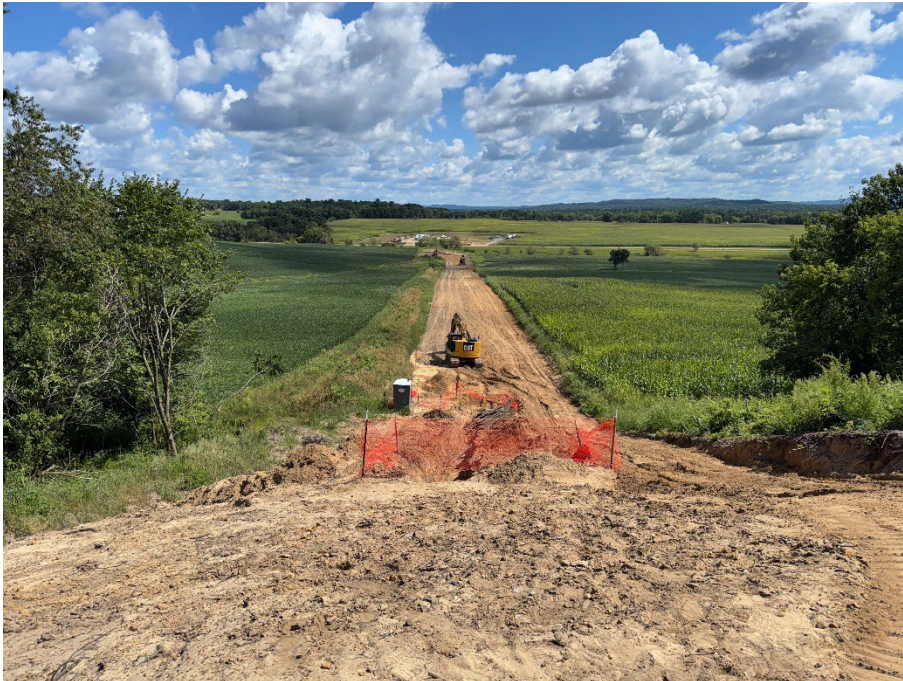
Photo No.: 20

Assessment: Acceptable

Comments: Open and Agricultural ROW, Tomah Branch Line Loop. The east end of the ROW was being cleaned up for restoration. The trench was excavated to install cathodic protection. Topsoil piles remained stabilized with vegetation. The ROW was stable with no erosion, off-ROW impacts, or environmental concerns identified.
