## FEDERAL ENERGY REGULATORY COMMISSION FIELD INSPECTION REPORT

**Date** September 23 and 24, 2025

**Project** Northern Natural Gas Company  
Northern Lights 2025 Expansion Project  
Freeborn, Washington, and Houston Counties, Minnesota; and Monroe  
County, Wisconsin  
Docket No.: CP24-60-000  
Authority: 7(c)

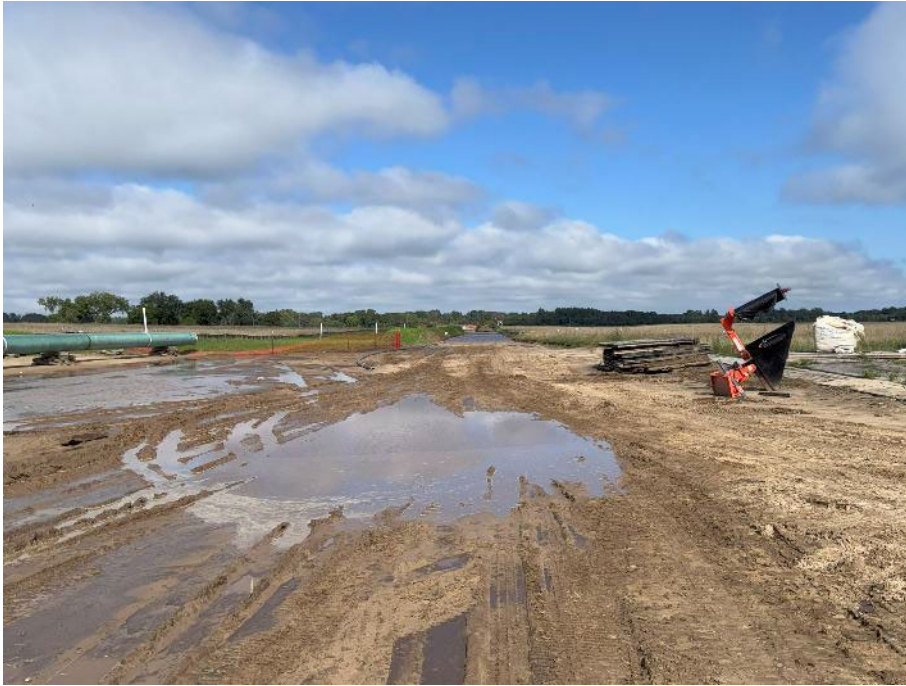
**Photo No.:** 1

At milepost (MP) 31.57, at the southern end of the ROW, rough grading of the subsoil was in progress. The dozer was equipped with a three-tine chisel to drag the ROW to ensure that no equipment mats or skids were left in the muddy subsoil (Photo Nos. 1 and 2). Segregated topsoil remained stabilized with seeded vegetation. At MP 32.15, subsoil had been graded into piles and was being worked to help the ROW dry out (Photo No. 3). At MP 33.85, saturated soils and ponding had temporarily stopped work (Photo No. 4). A drain tile was reinstalled across the ROW at MP 34.0 (Photo No. 5). At the pipe yard and terminus of the ROW, preparations for hydrostatic pressure testing of the line were in progress (Photo No. 6). Overall, the Lake Mills to Albert Lea E-Line ROW was stable, with no erosion, off-ROW impacts, or other environmental concerns were identified.

**Comments:** Agricultural ROW, Lake Mills to Albert Lea E-line. Soils along the ROW remained saturated, with ponding in low-lying areas. The pipeline was installed along this section of ROW, and final grade was established; however, topsoil was not yet returned to the ROW. This will be completed once soil conditions allow. No off-ROW impacts or other environmental concerns were identified.

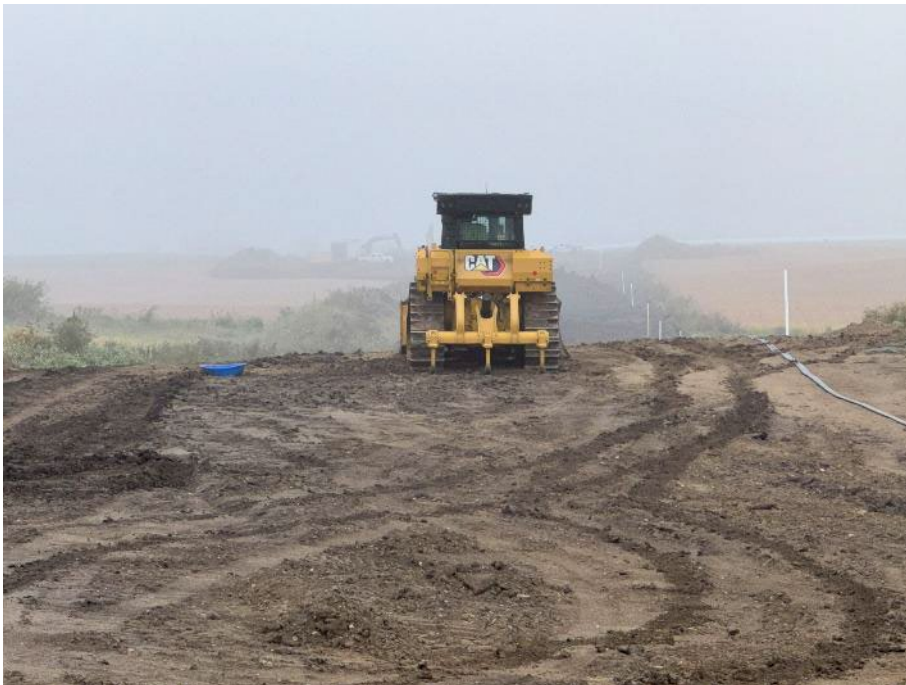
**Photo No.:** 2

**Comments:** Agricultural ROW, Lake Mills to Albert Lea E-line. A bulldozer working on rough-grading the subsoil was equipped with a three-tine chisel that was being used to bring any buried mats or skids to the surface, ensuring no construction debris is left on the ROW. Topsoil piles were well vegetated and stable. No off-ROW impacts or other environmental concerns were identified.

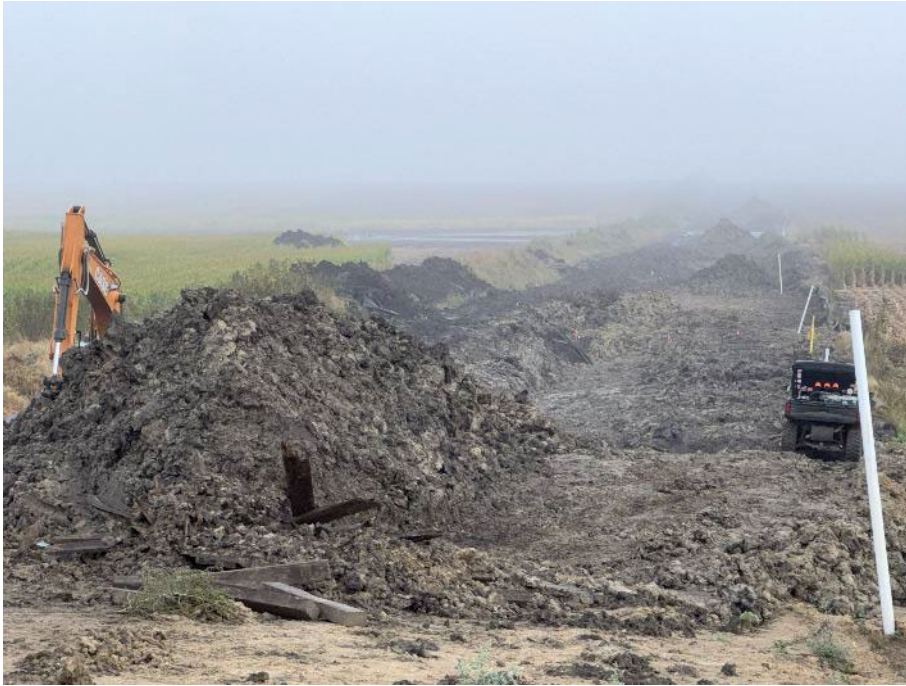
**Photo No.:** 3

**Comments:** Agricultural ROW, Lake Mills to Albert Lea E-line. Subsoil was graded into piles and turned over in an attempt to dry the ROW more quickly. Low-lying areas of ponding remained along the ROW. No off-ROW impacts or other environmental concerns were identified.

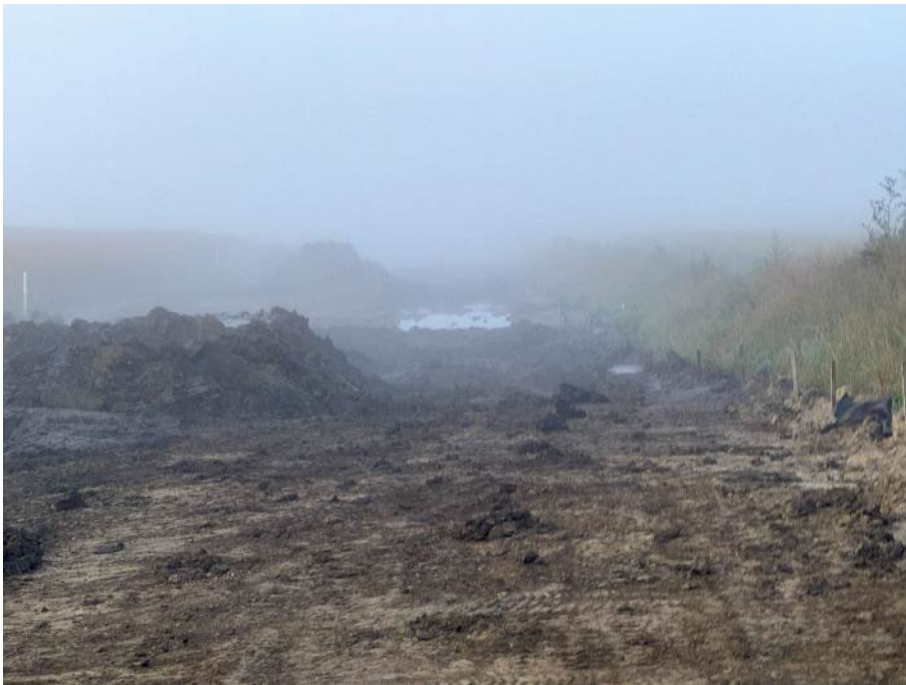
**Photo No.:** 4

**Comments:** Agricultural ROW, Lake Mills to Albert Lea E-line. Soils along higher sections of the ROW were drying; however, ponding remained along low-lying areas. Topsoil piles were stabilized with seeded vegetation. Silt fence on the ROW side of the topsoil piles was slated for removal, as cleanup continues. No off-ROW impacts or environmental concerns were identified.

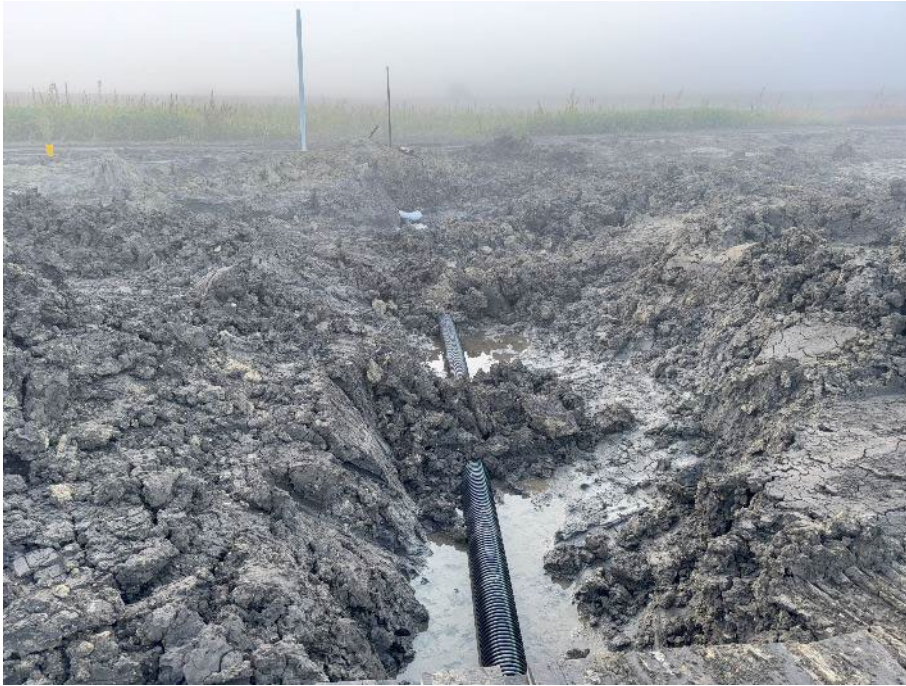
**Photo No.:** 5

**Comments:** Agricultural ROW, Lake Mills to Albert Lea E-line. A drain tile was reinstalled across the ROW. No off-ROW impacts or environmental concerns identified.

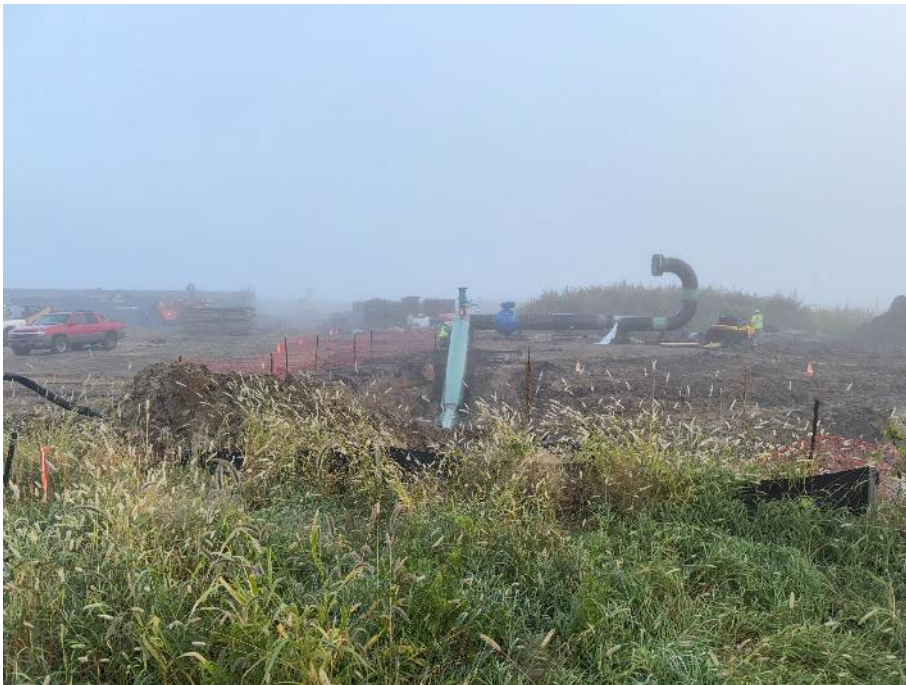
**Photo No.:** 6

**Comments:** Agricultural ROW, Lake Mills to Albert Lea E-line. In the pipe yard, at the terminus of the ROW, preparations for hydrostatic pressure testing of the line were in progress. The ROW and the pipe yard were stable with no erosion, off-ROW impacts, or environmental concerns identified.

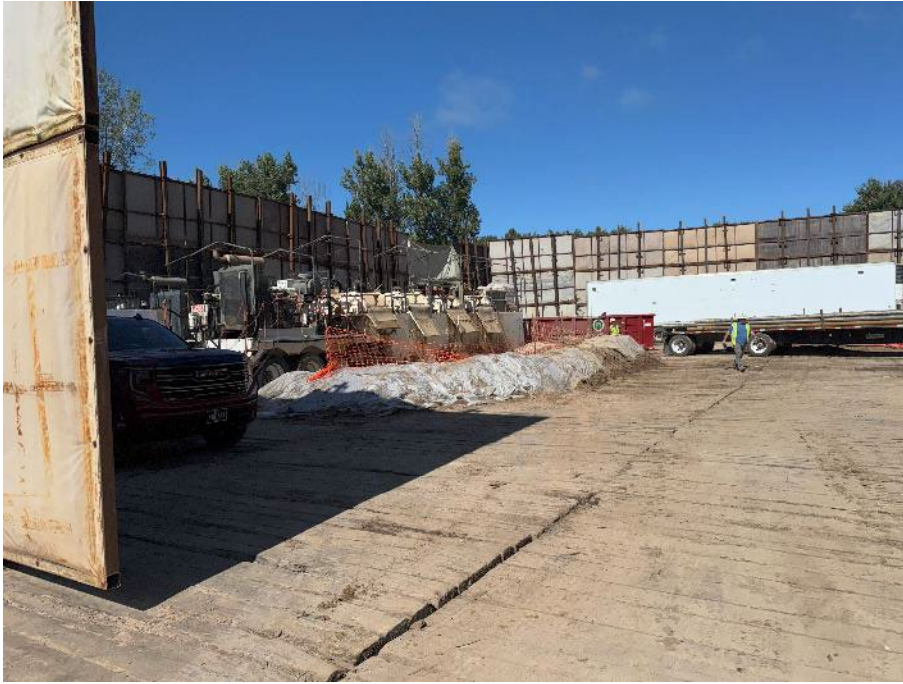
**Photo No.:** 7

At MP 1.0, the horizontal directional drill (HDD) P4-1 crossing was complete (Photo No. 7). The drilling pad was stabilized with equipment mats, and the sound barriers remained in place. Per NNG, sound readings during drilling were below the limit. The drilling site was organized and stable, with no erosion around the pad and no environmental concerns identified. At MP 2.4, two attempts were made to pull the HDD pullback pipe into the bore, with the pipe becoming lodged both times (Photo No. 8). The second pull was able to reach 1,700 feet before becoming lodged. The HDD pad site remained completely stabilized with equipment mats and was well organized. At MP 3.05, the pullback pipe strings were ready for installation, once the lodged string is removed and the borehole is confirmed (Photo No. 9). At MP 3.0, the pullback pipe string was lodged and unable to be moved (Photo No. 10). Overall, the ROW was stable, topsoil piles were well vegetated, and erosion control devices (ECDs) were maintained. No off-ROW impacts or environmental concerns were identified.

**Comments:** Open and Forested ROW, Elk River 3<sup>rd</sup> Branch Line. The HDD P4-1 crossing was complete. The drilling pad was fully stabilized with equipment mats, and the sound barriers remained in place. Per NNG, sound readings during drilling were below the limit. The drilling site was organized and stable, with no erosion around the pad and no environmental concerns identified.

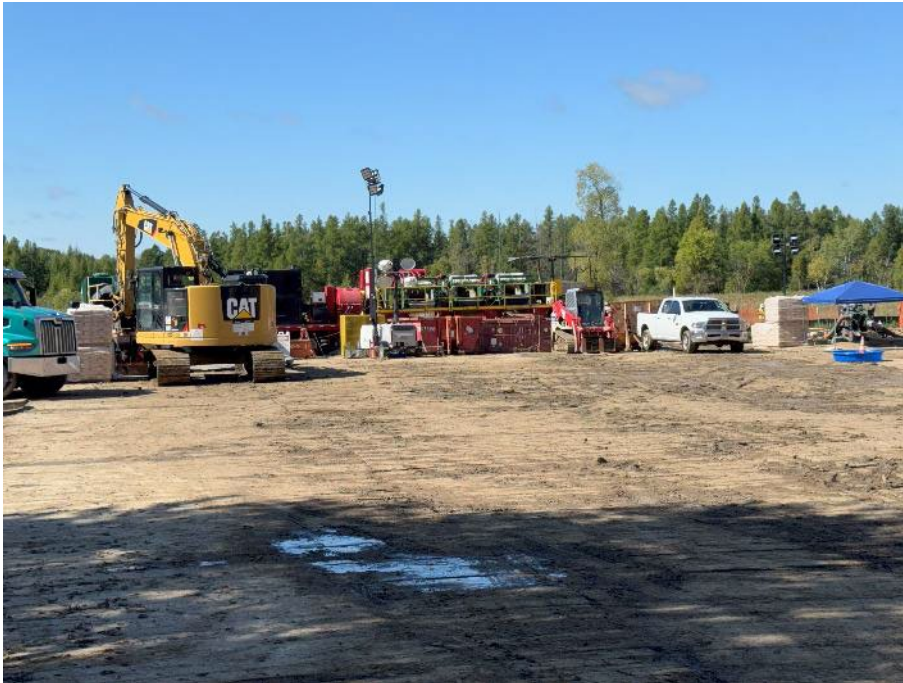
**Photo No.:** 8

**Comments:** Forested and Open ROW, Elk River 3<sup>rd</sup> Branch Line. Two attempts were made to pull the pullback pipe into the bore, with the pipe becoming lodged both times. The second pull was able to reach 1,700 feet before becoming lodged. The HDD pad site was completely stabilized with equipment mats and was well organized. No environmental concerns were identified.

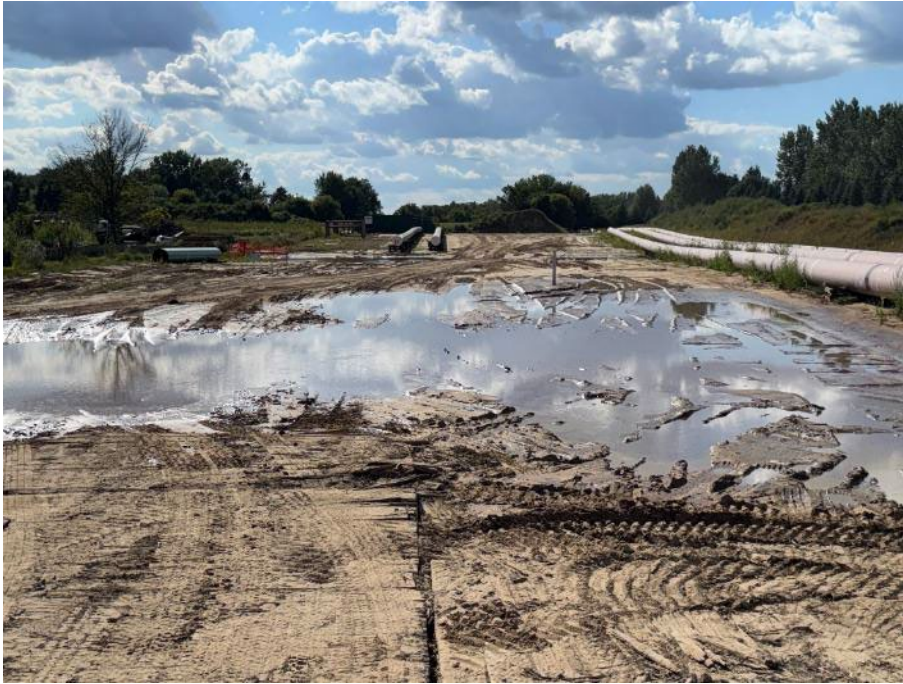
**Photo No.:** 9

**Comments:** Forested and Open ROW, Elk River 3<sup>rd</sup> Branch Line. The pullback pipe strings were ready for installation, once the lodged string is removed and the borehole is confirmed. The ROW was stable, the topsoil piles are well vegetated, and ECDs were maintained. No off-ROW impacts or environmental concerns were identified.

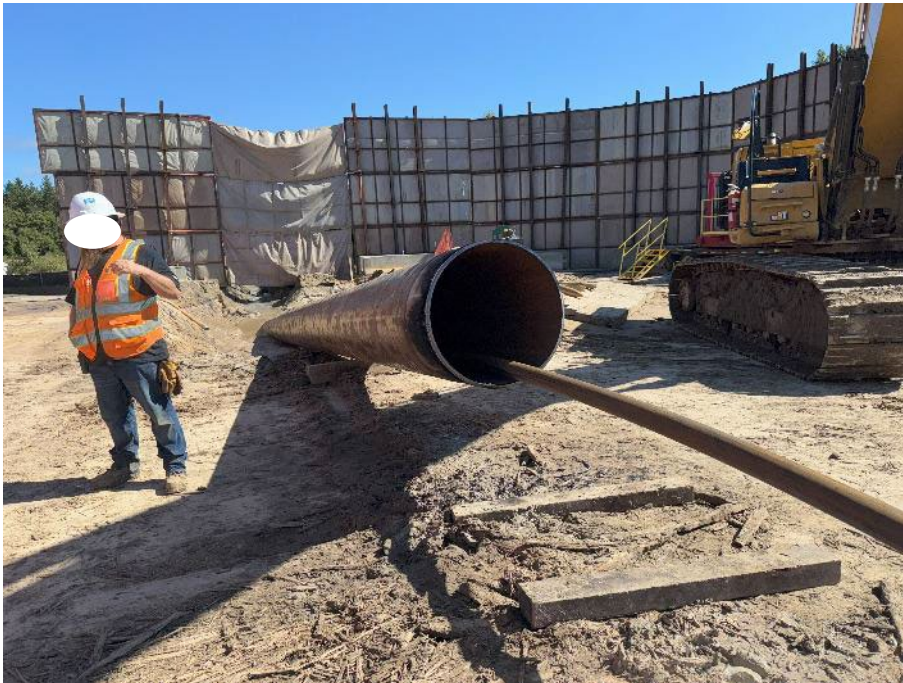
**Photo No.:** 10

**Comments:** Forested and Open ROW, Elk River 3<sup>rd</sup> Branch Line. The pullback pipe string was lodged and unable to be moved. Water was being pumped out of the pipe. No off-ROW impacts or environmental concerns identified.

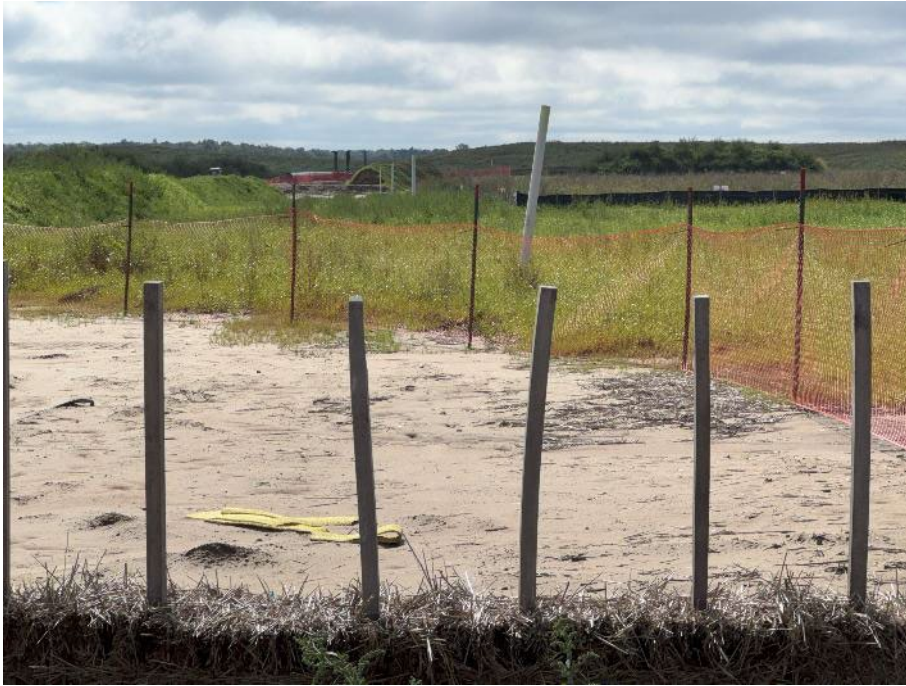
**Photo No.:** 11

**Comments:** Open ROW, Farmington to Hugo C-Line. The kickoff of the ROW is visible in the distance. The western side of the ROW was restored, with well-established vegetation. The eastern side of the ROW was being used as a travel lane. Topsoil piles remained stabilized with seeded vegetation. ECDs remained in place and were maintained. The ROW was stable, with no environmental concerns identified.

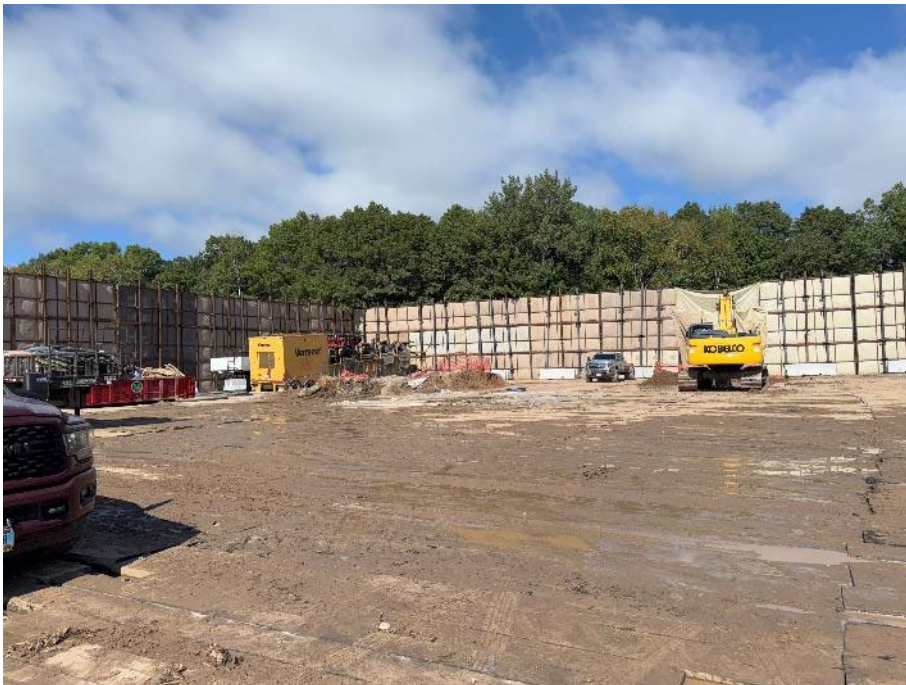
**Photo No.:** 12

**Comments:** Forested and Open ROW, Farmington to Hugo C-Line. The HDD crossing was complete. The drill pad equipment mats and sound barrier wall remained in place. The site was stable, with no environmental concerns identified.

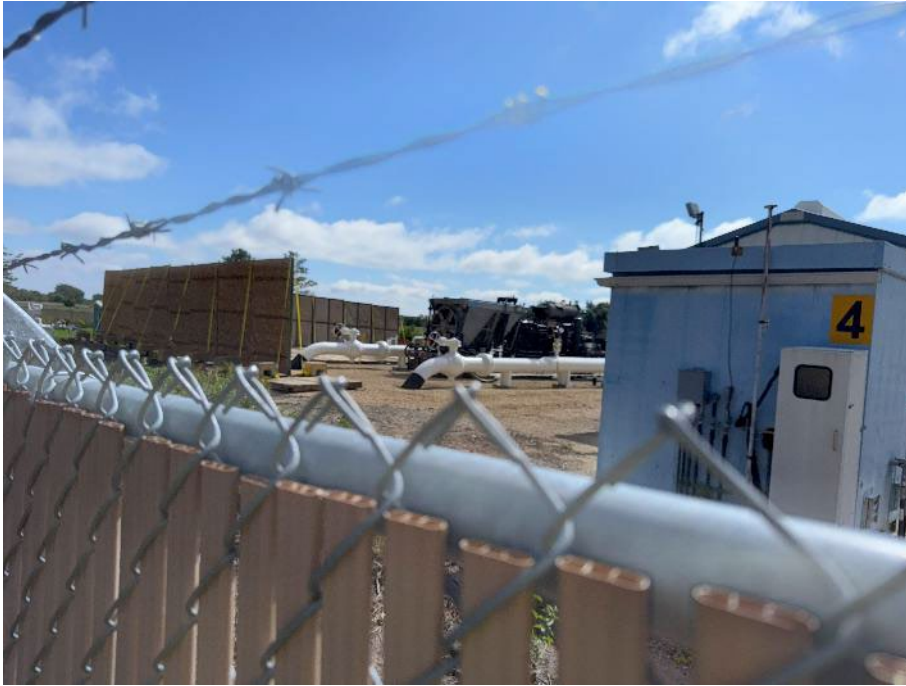
**Photo No.:** 13

**Comments:** Aboveground Facility, Farmington to Hugo C-Line. At the compressor station, preparations for tie-in were in progress. No environmental concerns were identified.

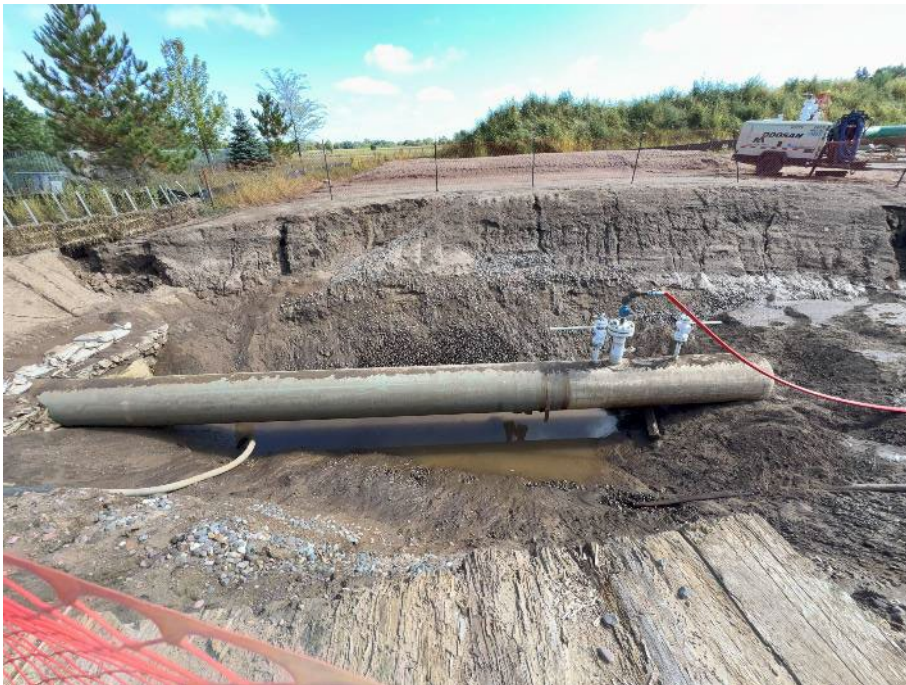
**Photo No.:** 14

**Comments:** Open and Forested ROW, Farmington to Hugo C-Line. The existing pipeline was exposed, in preparation for tie-in. Water from the excavation was being pumped onto the ROW through a filter bag. No environmental concerns were identified.

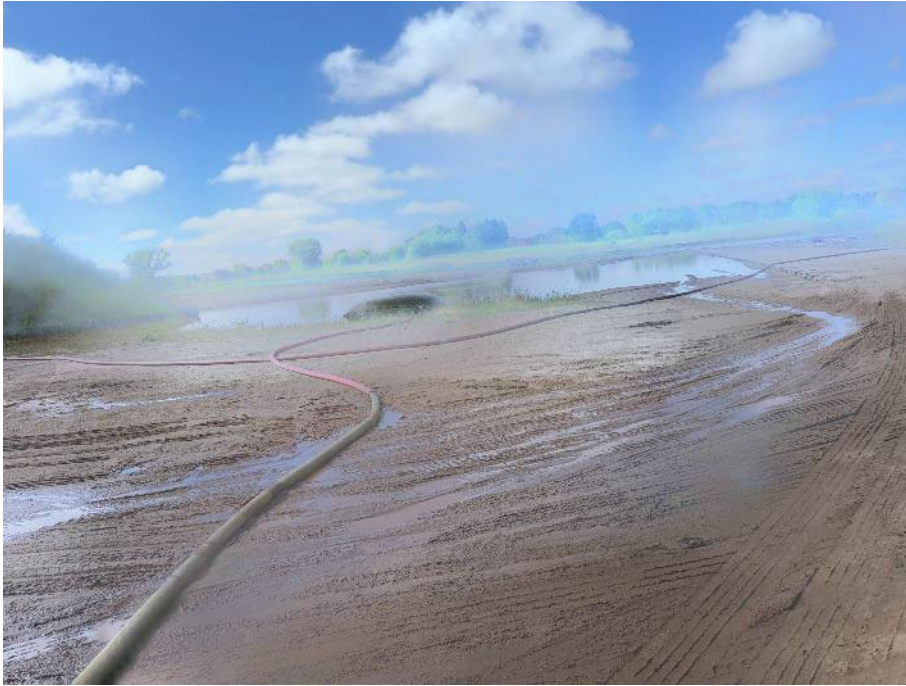
**Photo No.:** 15

**Comments:** Open and Forested ROW, Farmington to Hugo C-Line. Water from the nearby excavation (Photo No. 14) was being pumped onto the ROW through a filter bag. Pumping was stopped, so the filter bag could be changed. The water pumped through the filter bag was ponding, but was contained within the ROW. The ROW and extra workspace were stable, with no off-ROW impacts or other environmental concerns identified.

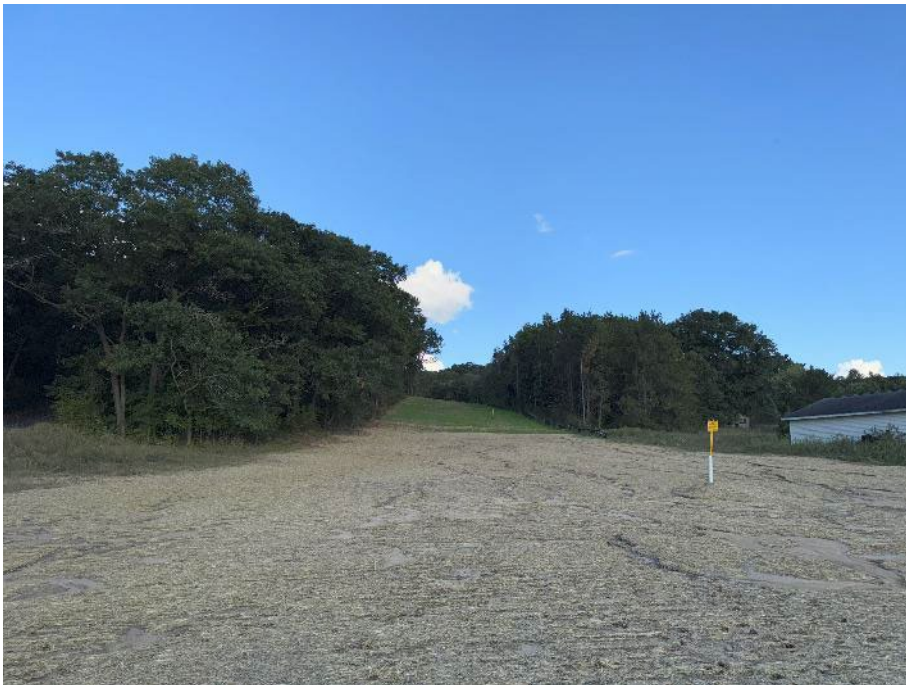
**Photo No.:** 16

The Tomah Branch Line Loop ROW was in the process of final restoration, with the majority of the ROW becoming stabilized with revegetation and no erosion or environmental concerns identified (Photo Nos. 16 through 19). However, minor rill erosion was identified at MP 2.25 and MP 2.2 (Photo Nos. 16 through 18). Although seed and mulch were recently applied to these areas, the ROW received approximately 6.0 inches of rain the previous week, before vegetation was established. These sections of ROW were scheduled to be reworked within the week. Across the steep slope near MP 2.2, shallow trench slope breakers lined with staked-in strawbales were installed across the ROW (Photo No. 17). Mounded slope breakers would not hold because of the sandy soil. The slope had been sprayed with hydroseed, with grass becoming established. At the MP 3.15 pipe yard, the tie-in to the existing pipeline was completed, and the ROW was being restored (Photo No. 20). Trailers and equipment were scheduled to be demobilized in the next week. ECDs remained in place throughout the ROW and will be removed once revegetation is successful.

**Comments:** Open and Forested ROW, Tomah Branch Line Loop. Revegetation was progressing along the upper hydroseeded portion of the ROW. The recently seeded area along the lower portion of the ROW had developed minor rill erosion, due to approximately 6.0 inches of rain over the previous week. This section of ROW was scheduled to be reworked within the next two days. Overall, the ROW was stable, with no other environmental concerns identified.

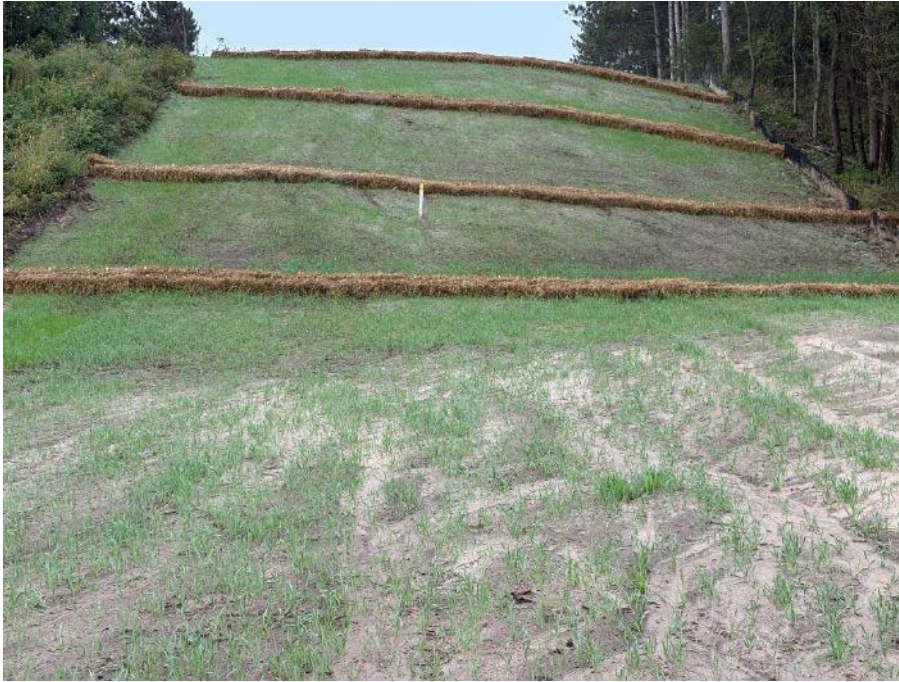
**Photo No.:** 17

**Comments:** Forested and Residential ROW, Tomah Branch Line Loop. Shallow trench slope breakers lined with staked-in strawbales were installed across the ROW. Mounded slope breakers would not hold because of the sandy soil. The slope had been sprayed with hydroseed, with grass becoming established. The approximately 6.0 inches of rain over the previous week had caused minor rill erosion. These areas were scheduled to be reworked. No other environmental concerns were identified.

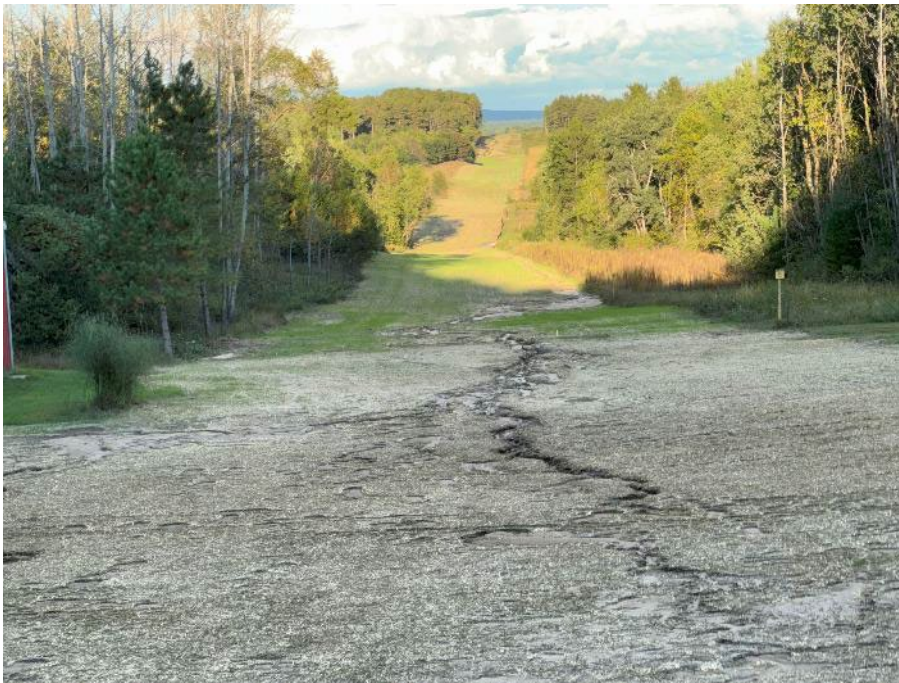
**Photo No.:** 18

**Comments:** Residential, Open, Forested, and Agricultural ROW, Tomah Branch Line Loop. This section of ROW (foreground) was recently seeded and stabilized with mulch. Minor erosion developed, due to approximately 6.0 inches of rain during the previous week. This area was scheduled to be reworked. Revegetation along the ROW beyond was established and progressing well. No off-ROW impacts or other environmental concerns were identified.

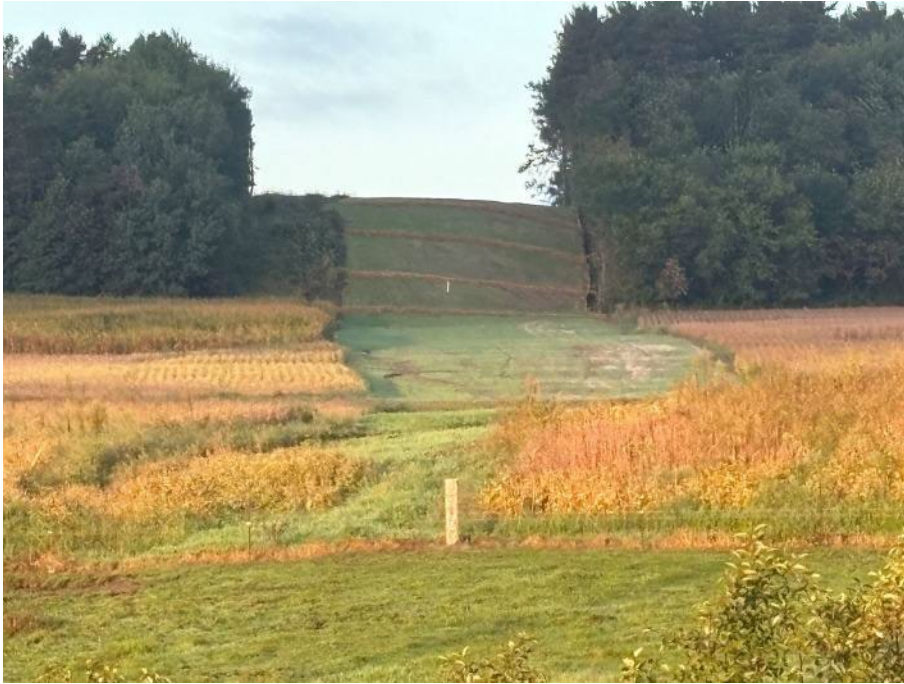
**Photo No.:** 19

**Comments:** Open, Forested, and Agricultural ROW, Tomah Branch Line Loop. The ROW was stabilized with slope breakers and revegetation. No erosion, off ROW impacts, or other environmental concerns were identified.

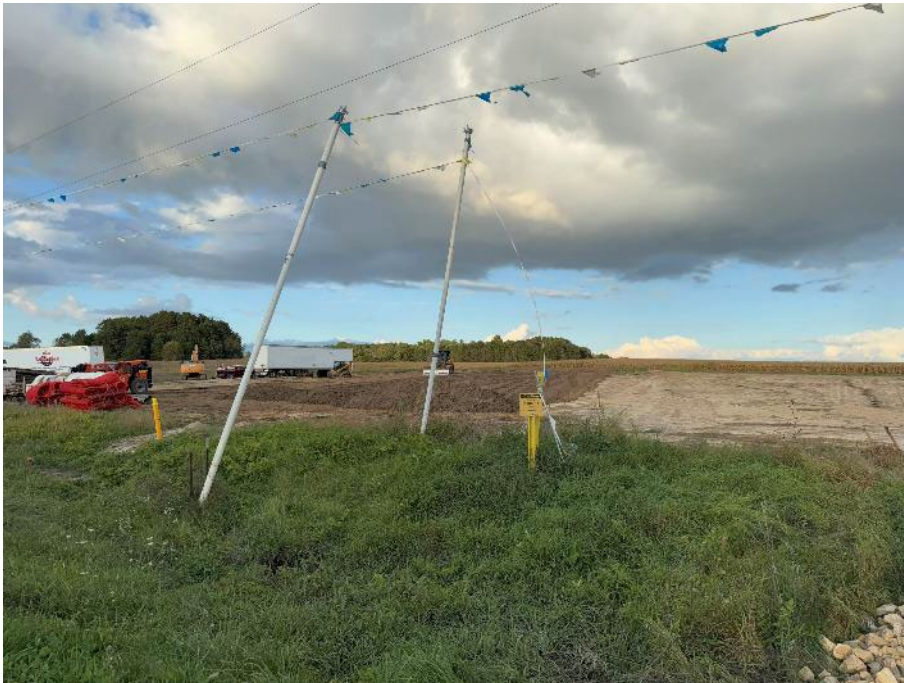
**Photo No.:** 20

**Comments:** Open and Agricultural ROW, Tomah Branch Line Loop. The pipe yard, where the tie-in to the existing pipeline was completed, was being restored. Trailers and equipment were scheduled to be demobilized in the next week. The ROW and pipe yard were stable, with no erosion, off-ROW impacts, or other environmental concerns identified.
