RE: Northern Natural Gas Company
Docket No. CP18-534-000
Northern Lights 2019/Rochester Expansion Project
Request for In-service – New Prague Branch Line Loop

Final Photos

**Northern Lights 2019 New Prague Branch Line Loop
New Prague, Minnesota**

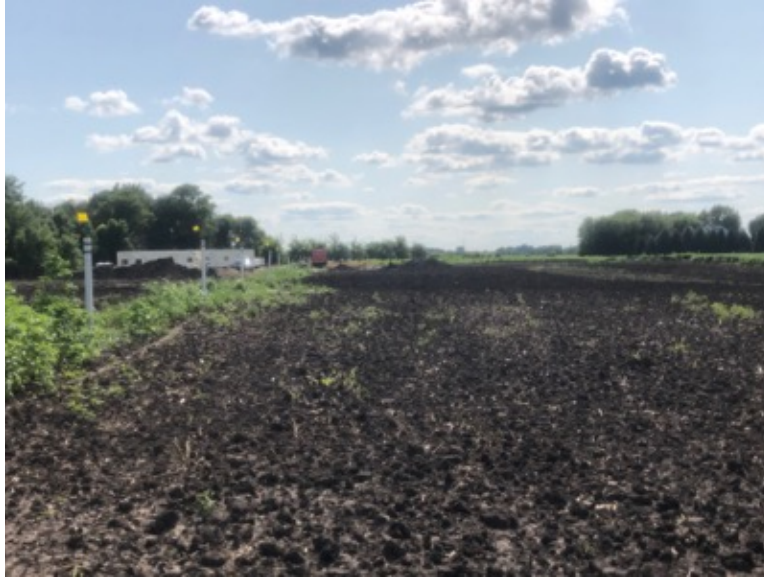
Facing southwest at MP 0.1 north of 290th Street, topsoil has been restored

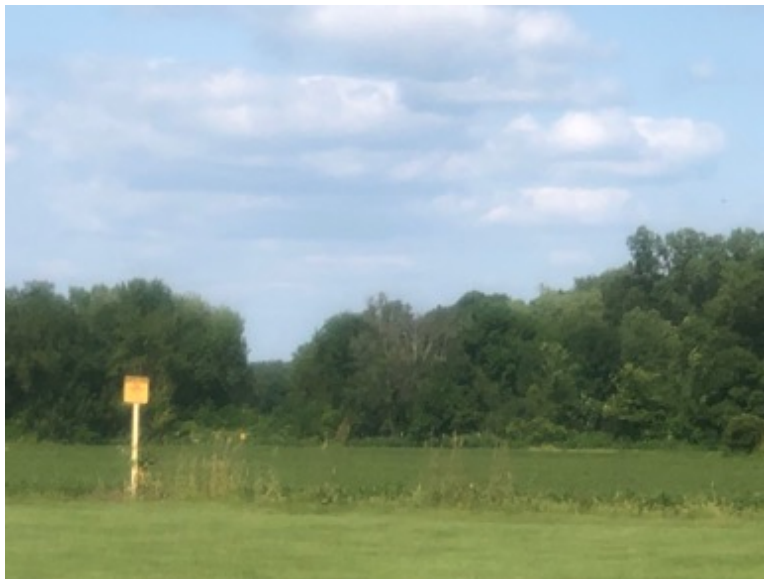
Facing northeast at MP 0.1 east of private drive, landowner has planted soy beans in previous workspace

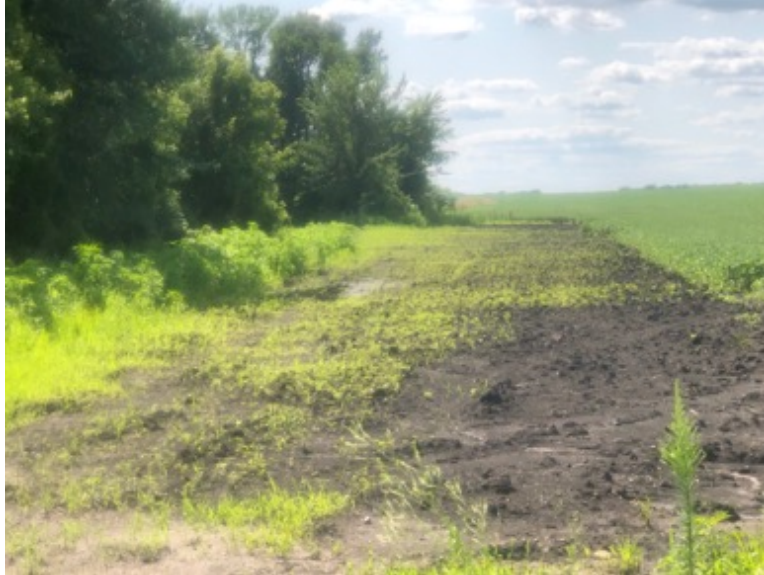
Facing west at MP 0.45, temporary access road west of CR-143 returned to agriculture; native grasses are coming in voluntarily

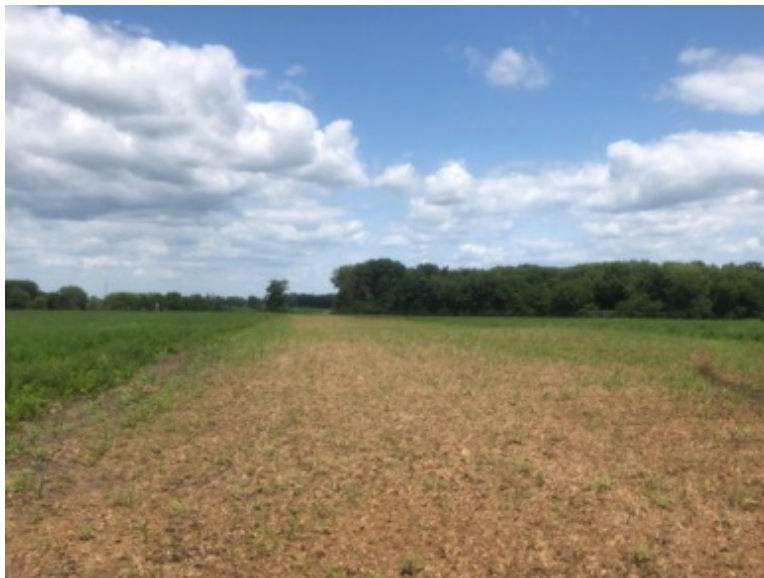
Facing northeast at MP 0. east of CR-143, landowner has applied cow manure onto the field

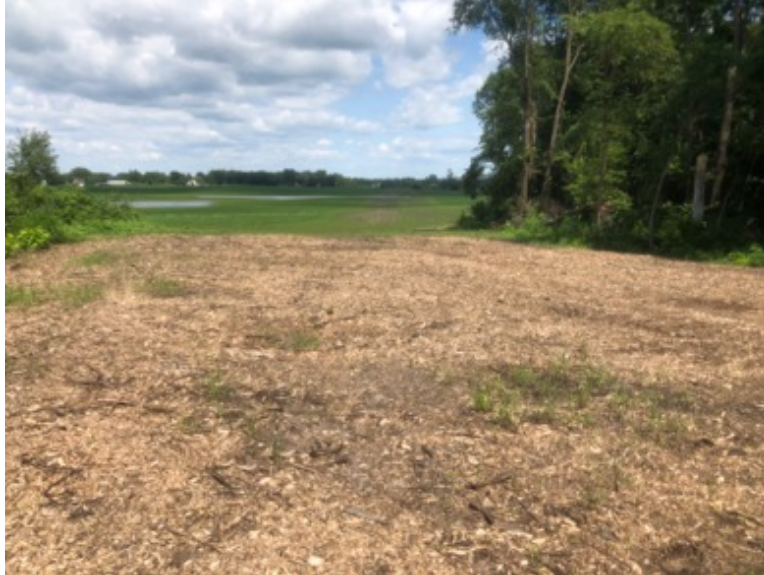
Facing northeast at MP 0.8, area cleared of trees, seeded and wood mulched; field in background planted with soy beans by landowner

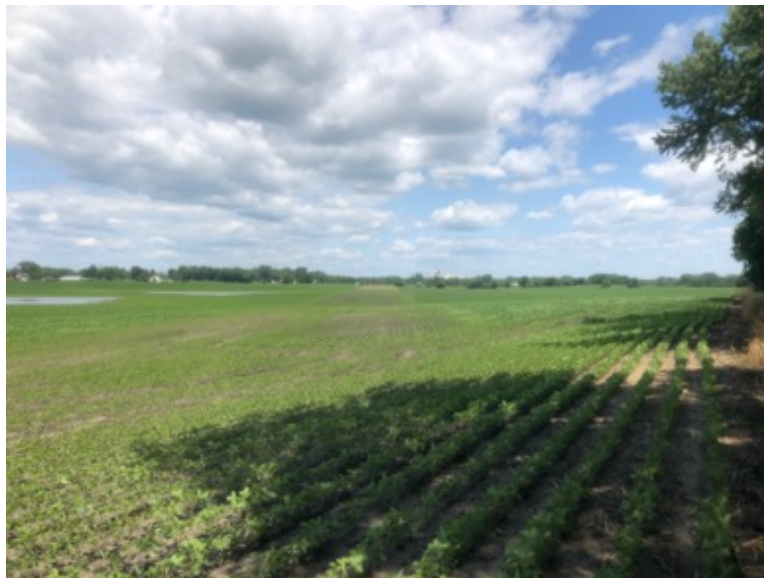
Facing northeast at MP 0.85, landowner has planted soybeans within previous workspace

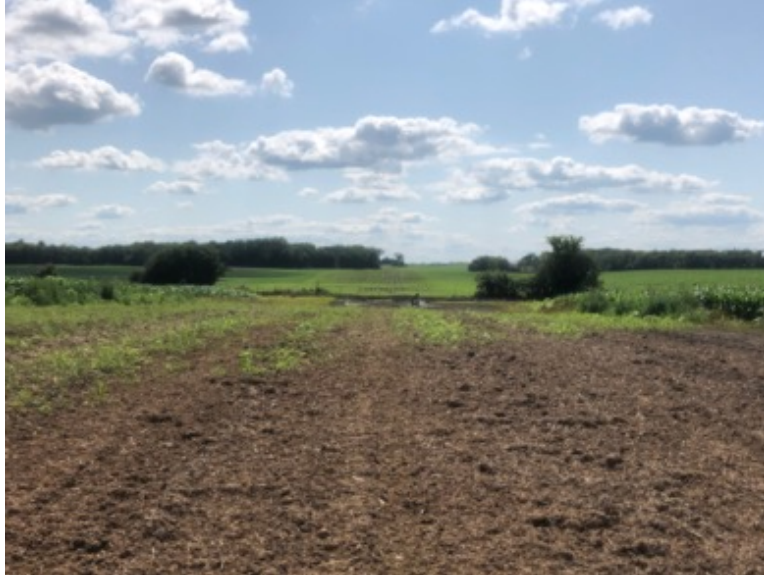
Facing southwest at MP 1.4, landowner has applied cow manure and planted soybeans in previous workspace

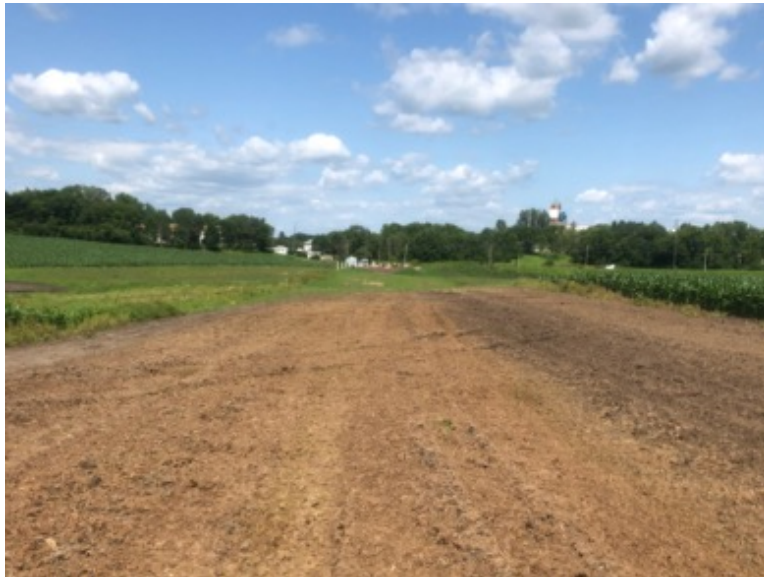
Facing northeast at MP 1.4, contractor restored topsoil; landowner has applied cow manure
