Re: Northern Natural Gas Company  
Northern Lights 2025  
Docket No. CP24-60-000  
Bi-weekly Status Report No. 17

**Northern Natural Gas Company**  
**Northern Lights 2025 (CP24-60-000)**  
**Biweekly Status Report No. 17**  
**Period Ending October 12, 2025**

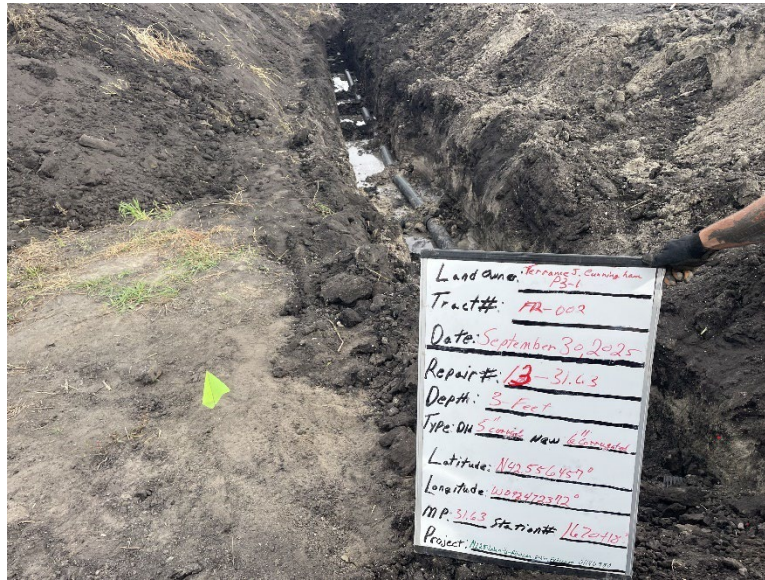
Facing west at MP 31.63, completed a drain tile repair

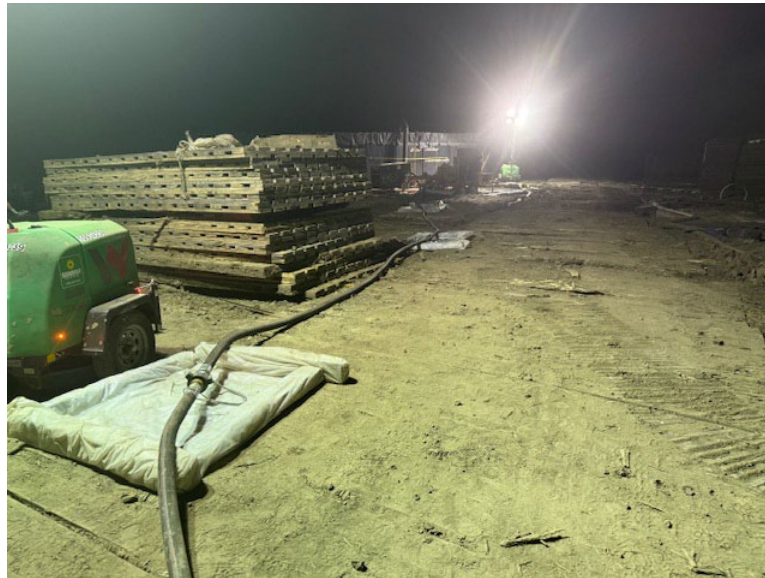
Facing north at MP 34.2, hydrostatic test in progress with secondary containment in place for dewatering line connection

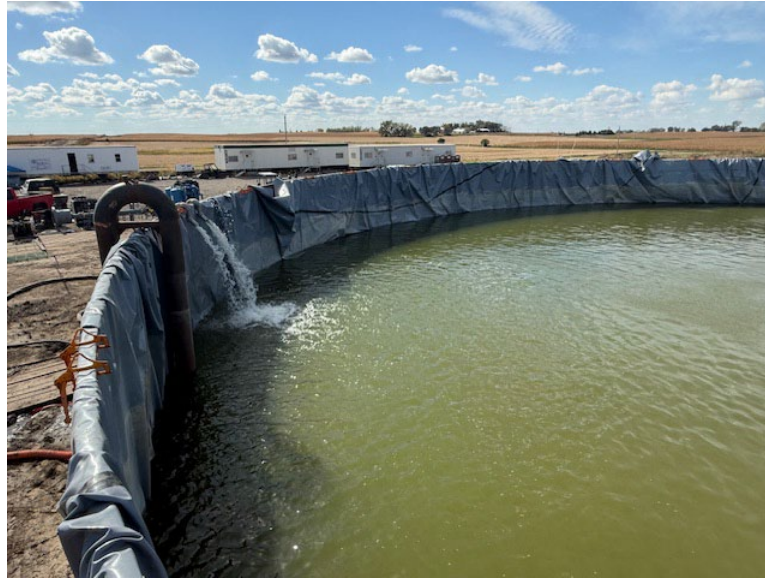
Facing southwest at MP 34.2, dewatering hydrostatic test water to lake tank

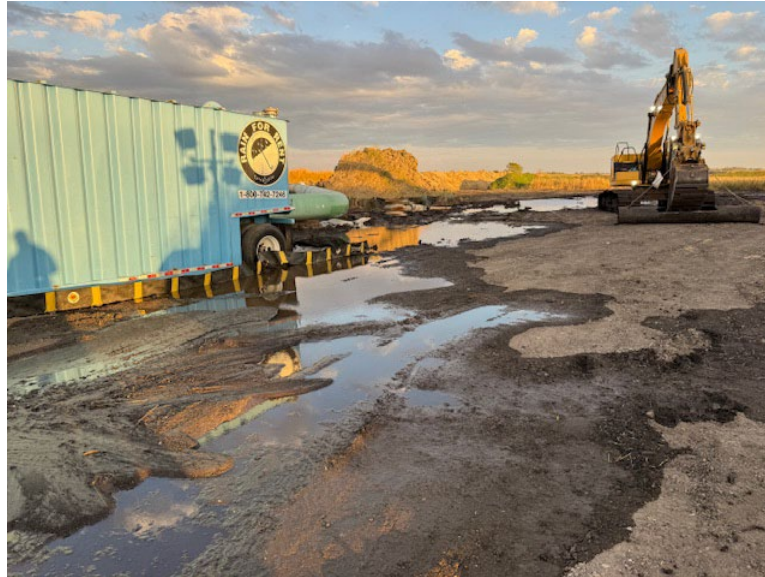
Facing north at Milepost 31.2, north of County Highway 9/135th Street, spilled hydrostatic pressure test water within the topsoiled ROW, did not leave silt fenced perimeter, October 5, 2025

K&K had two hydrostatic pressure test spills during this reporting period. On October 5, 2025, K&K spilled approximately 500 gallons of hydrostatic pressure test water to the subsoil. K&K was in the process of

filling the newly installed pipe with water for a hydrostatic pressure test. While pushing water and a pig from north to south, K&K added a fire hose to direct water into a frac tank and failed to secure the hose to the hatchway at the top of the tank. The pressure from the water and air ahead of the pig caused the hose to come out of the tank. It took approximately one minute to shut down the pumps at the north end.

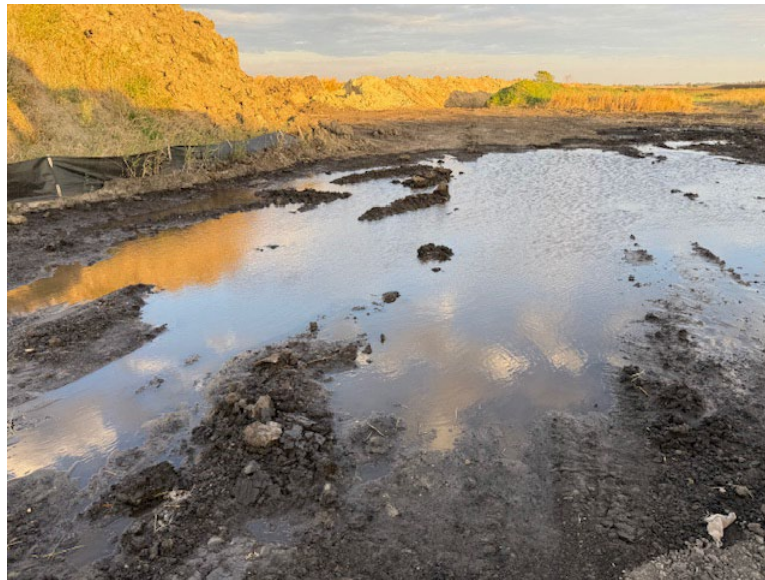
Facing north at Milepost 31.2, north of County Highway 9/135th Street, closer view of spilled hydrostatic pressure test water within the topsoiled ROW, recently excavated and stabilized subsoil piles in background, October 5, 2025

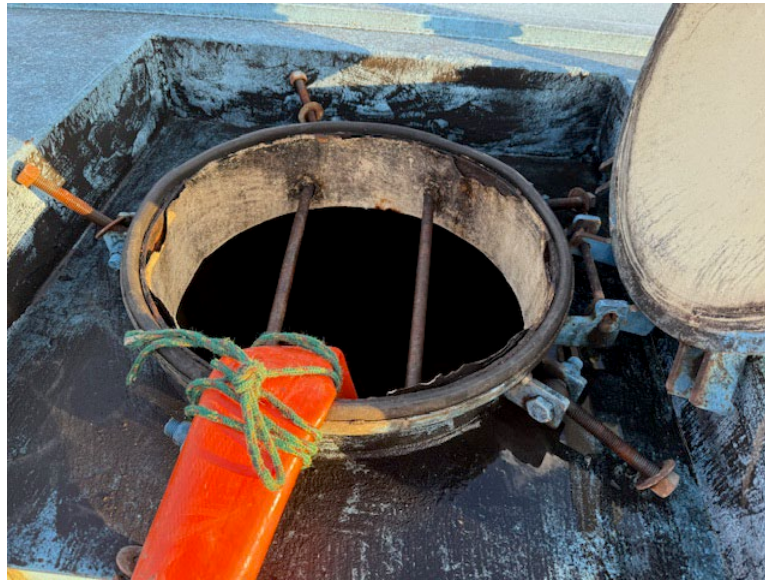
Hose that came out of frac tank has been secured to the hatch

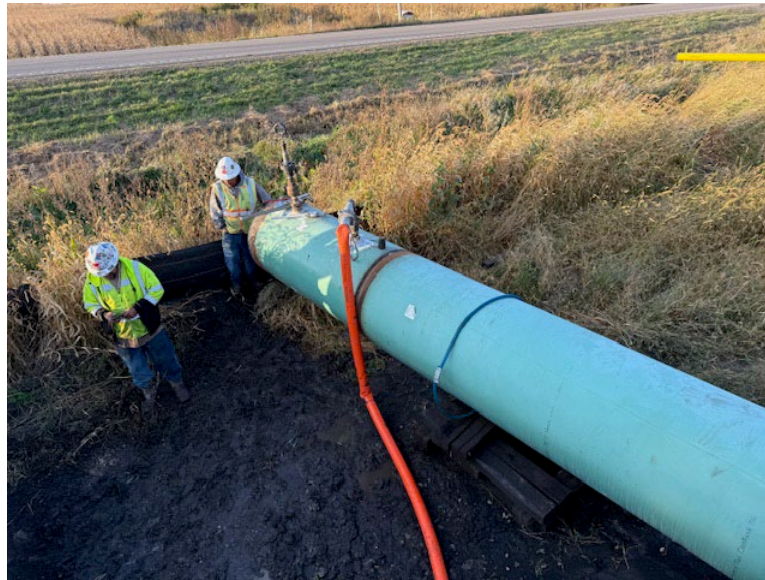
Facing south at Milepost 31.2, north of County Highway 9/135th Street, origin point of the hose that came out of the tank, during filling of the pipe October 5, 2025

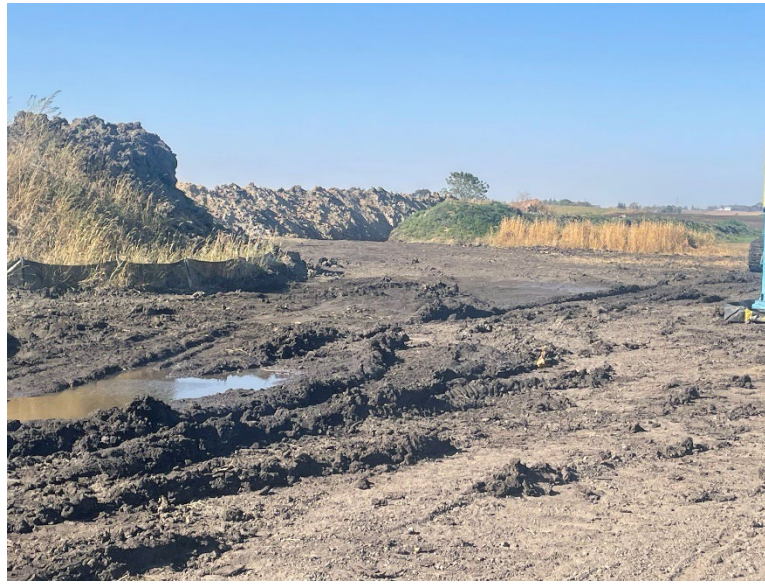
Facing north at MP 31.2, north of County Highway 9/135th Street, majority of the water has infiltrated into the ground and the frac tank relocated

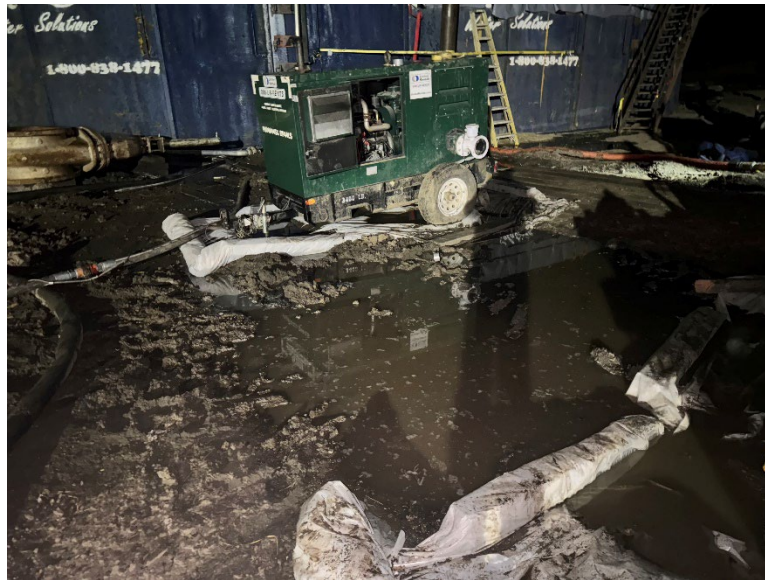
Facing northwest at MP 34.2, north of 165th Street, spilled hydrostatic pressure test water within the topsoiled ROW, did not leave silt fenced perimeter, during draining of the pipe October 7, 2025

On October 7, 2025, K&K spilled approximately 160 gallons of hydrostatic pressure test water to subsoil. K&K was in the process of draining the pipe after a successful hydrostatic pressure test. While pushing water and a pig from south to north, the fill pipe hanging on the side of the lake tank came off following the burst of air when the pig reached the north end. The hose fill pipe has been secured. The water infiltrated into the soil within the workspace. The spills were reported to the Minnesota Duty Officer and photos have been provided to the Minnesota Pollution Control Agency (MPCA). The photos provided to the MPCA are included at the end of the Lake Mills photo section of this report.

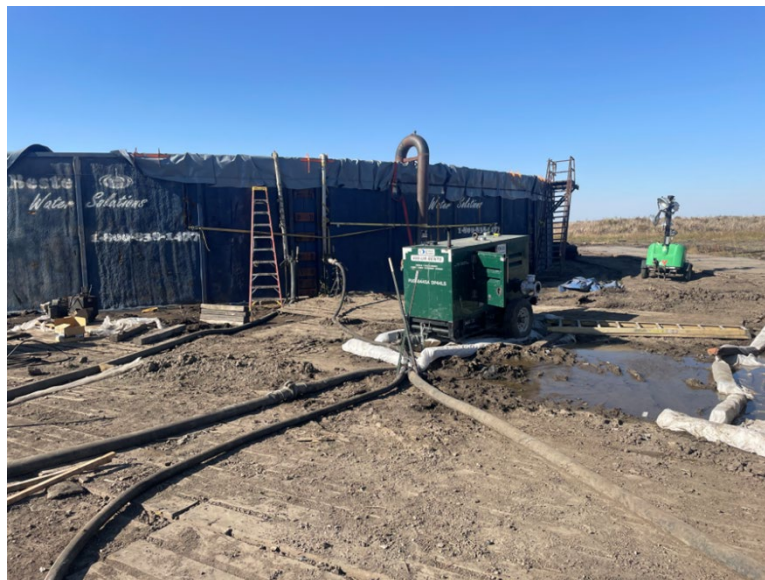
Facing northwest at Milepost 34.2, north of 165th Street, majority of water has infiltrated into the ground, contractor has lashed discharge piping to lake tank

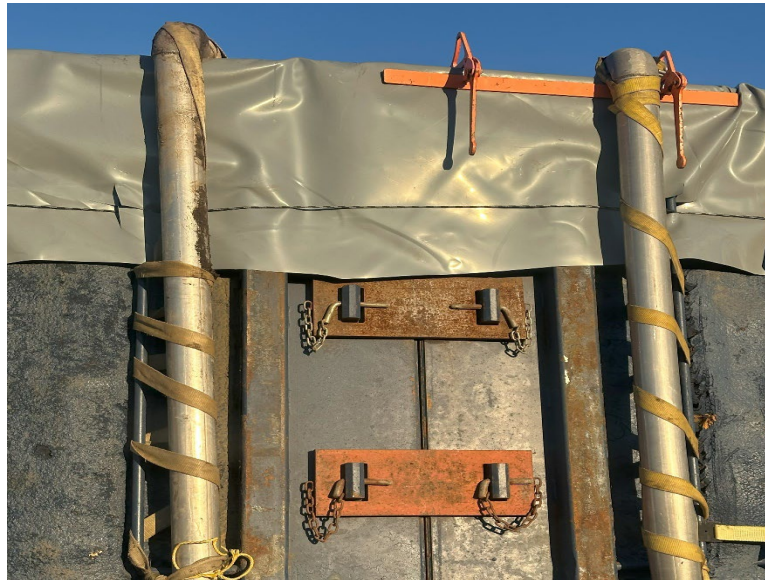
Facing northwest at Milepost 34.2, north of 165th Street, contractor has lashed discharge piping to lake tank

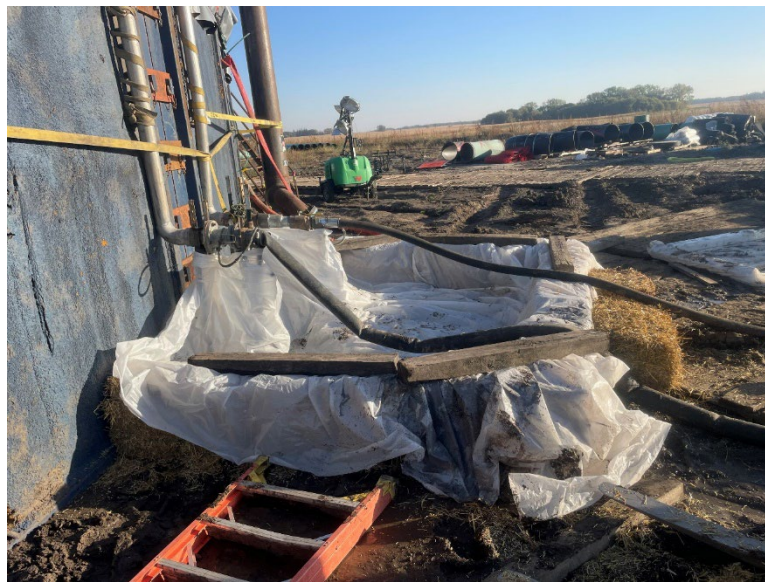
Facing northeast near milepost 34.2, secondary containment build under fill pipes and hose connections

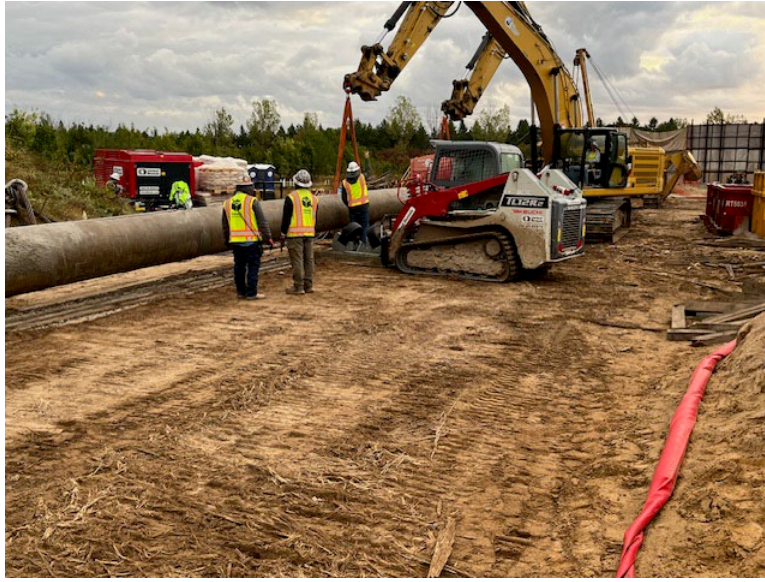
Facing east HDD P4-5 bore pipe extraction was completed

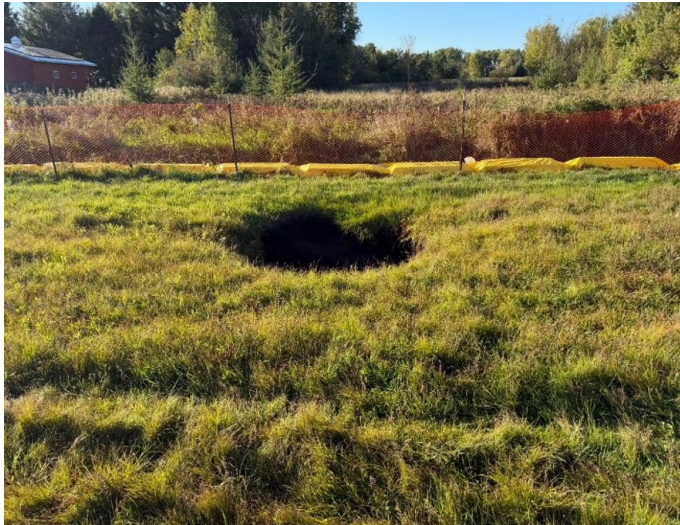
During the HDD drilling activities, several small subsidence features formed on the exit side of the drill (west side) and one subsidence feature formed near the entry side (east side). All HDD activities have been halted and the HDD pipe has been removed from the ground. The subsidence features have stabilized and no additional features have formed.

All subsidence areas are in an upland with the exception of one approximately 11-foot by 8-foot area in ERT-W34, which is MDNR public water wetland 82020700. Due to safety concerns, personnel have not been able to determine the depth of the subsidence. The subsidence in this wetland formed on October 7, 2025 as the stuck HDD pipe was removed. Below is a screenshot of the subsidence in the wetland area.

Northern has a two-step plan to stabilize and restore this area before resuming any construction and is asking for MDNR to review and approve the summary below.

1. Step one will be to stabilize the current HDD hole as the pipe has been removed. The onsite contractor will install approximately 400 feet of tremie pipe from both the entry and exit sides; they will use a high-viscosity drilling
