## FEDERAL ENERGY REGULATORY COMMISSION FIELD INSPECTION REPORT

**Date** May 12, 2026

**Project** Northern Natural Gas Company  
Northern Lights 2025 Expansion Project  
Freeborn, Washington, and Houston Counties, Minnesota; and Monroe  
County, Wisconsin  
Docket No.: CP24-60-000  
Authority: 7(c)

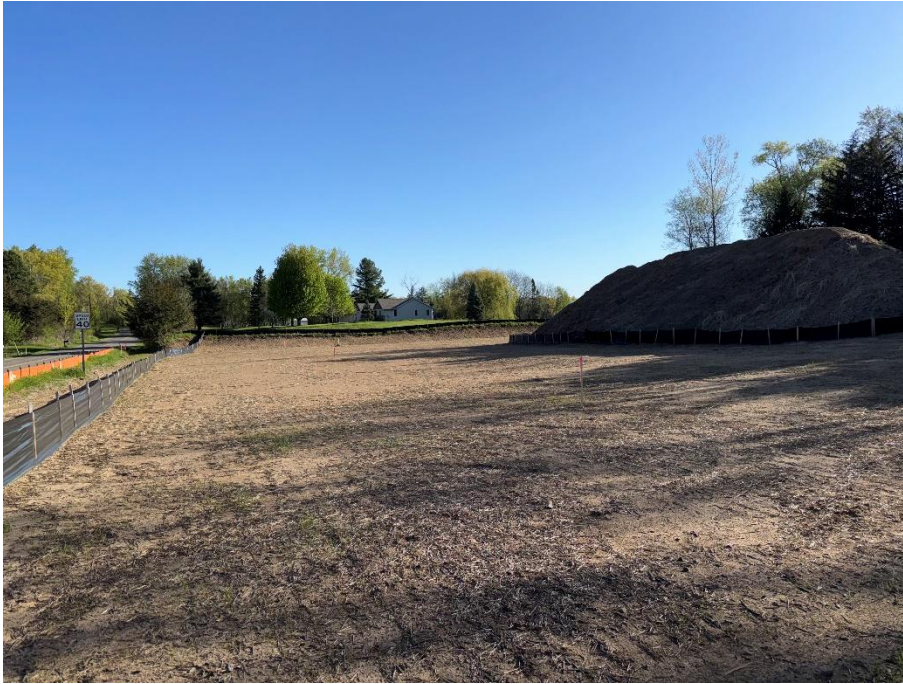
**Photo No.:** 1

**Assessment:** Acceptable

**Comments:** Agricultural, Open, and Forested ROW, Elk River 3<sup>rd</sup> Branch Line, Kickoff. The ROW was stable, with no erosion noted. The topsoil pile was stable and was recently reseeded. No environmental concerns were identified.

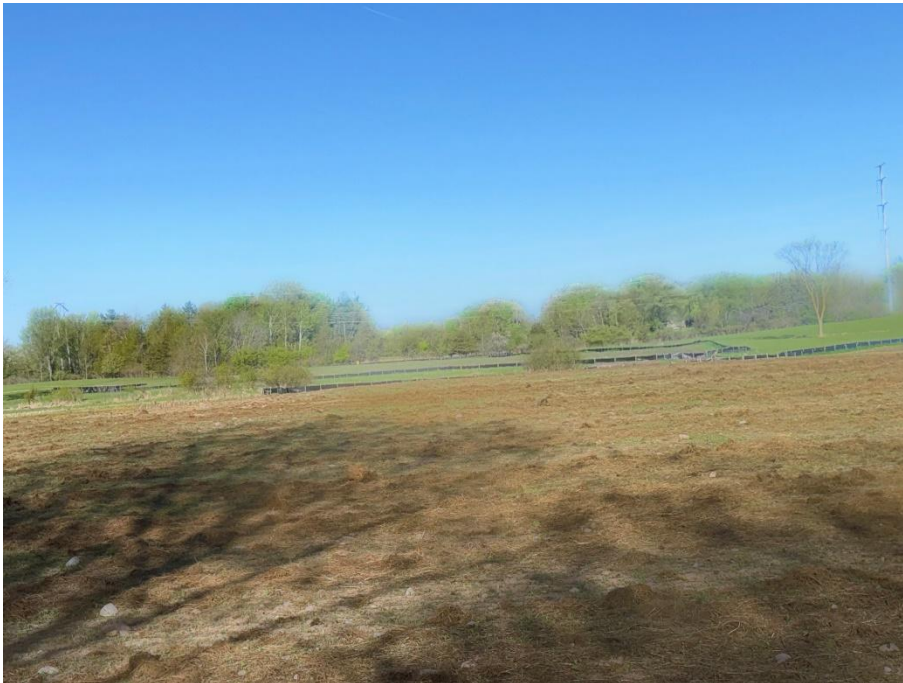
**Photo No.:** 2

**Assessment:** Acceptable

**Comments:** Agricultural, Open, and Forested ROW, Elk River 3<sup>rd</sup> Branch Line. The agricultural ROW was stable and recently amended with manure. Grass was emerging along the low-lying area between the sections of silt fence – which was in good repair. No environmental concerns were identified.

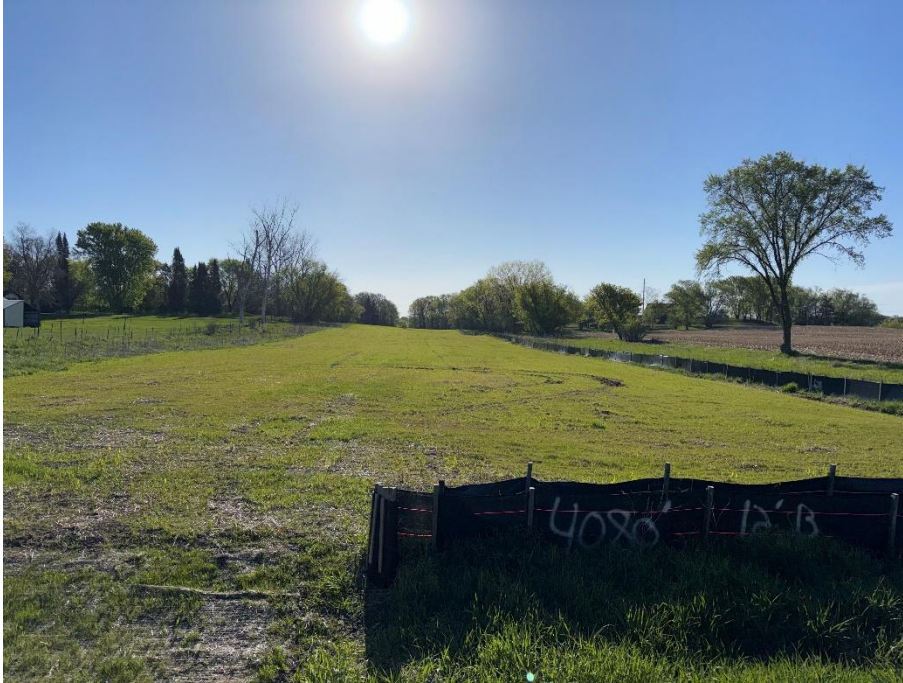
**Photo No.:** 3

**Assessment:** Acceptable

**Comments:** Agricultural, Open, and Forested ROW, Elk River 3<sup>rd</sup> Branch Line. Grass was emerging along the ROW and roadside ditch, matching off-ROW conditions. Silt fence was in good repair. No environmental concerns were identified.

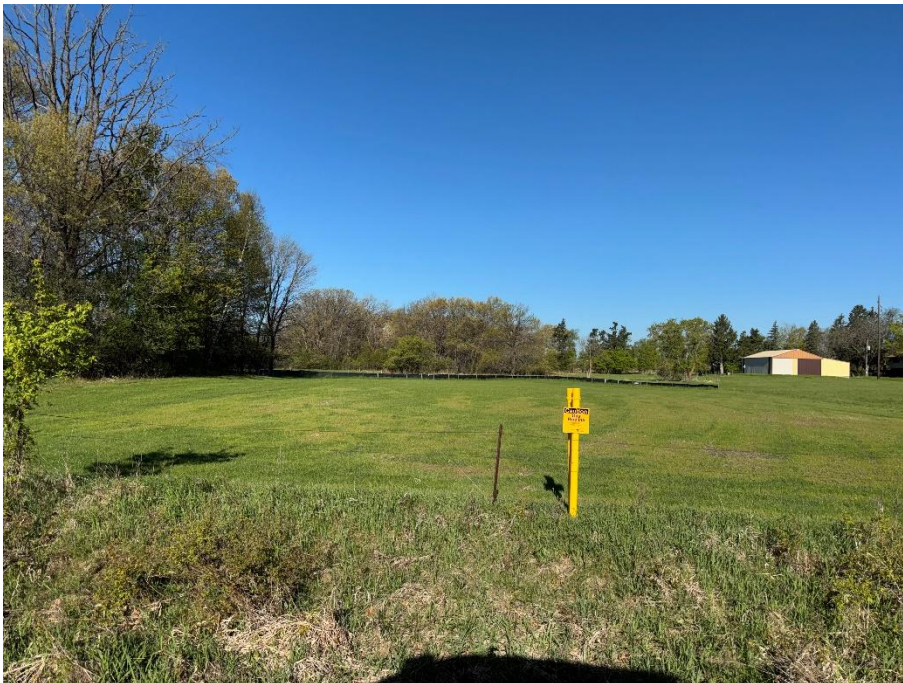
**Photo No.:** 4

**Assessment:** Acceptable

**Comments:** Agricultural, Open, and Forested ROW, Elk River 3<sup>rd</sup> Branch Line. Revegetation was progressing along the ROW, matching off-ROW conditions. Silt fence was in good repair. No environmental concerns were identified.

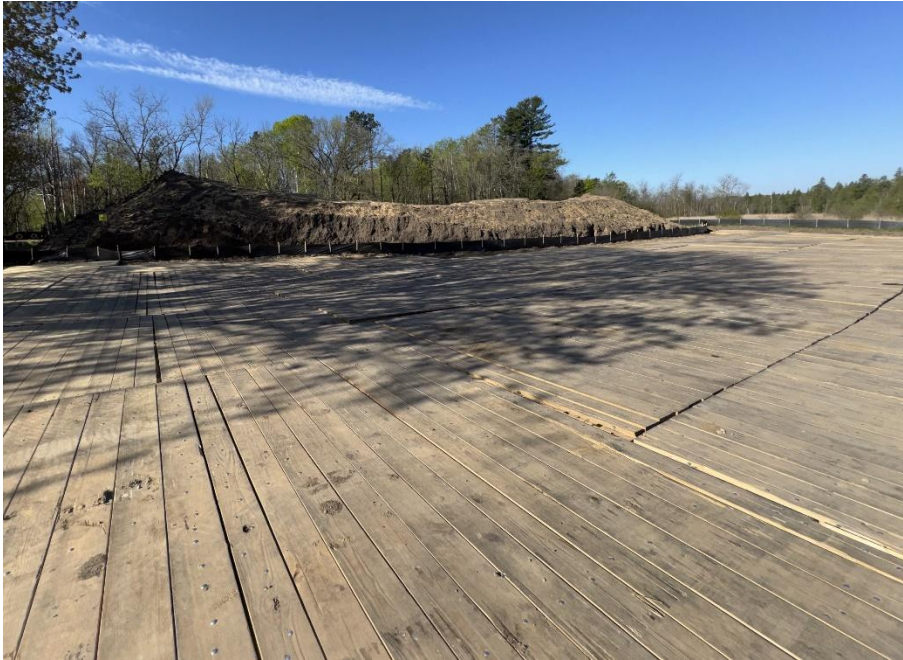
**Photo No.:** 5

**Assessment:** Acceptable

**Comments:** Agricultural, Open, and Forested ROW, Elk River 3<sup>rd</sup> Branch Line. The equipment mat drill pad for the HDD crossing was installed. The topsoil pile was stabilized with mulch, with no erosion noted. The silt fence surrounding the topsoil pile and drill pad was in good repair. No environmental concerns were identified.

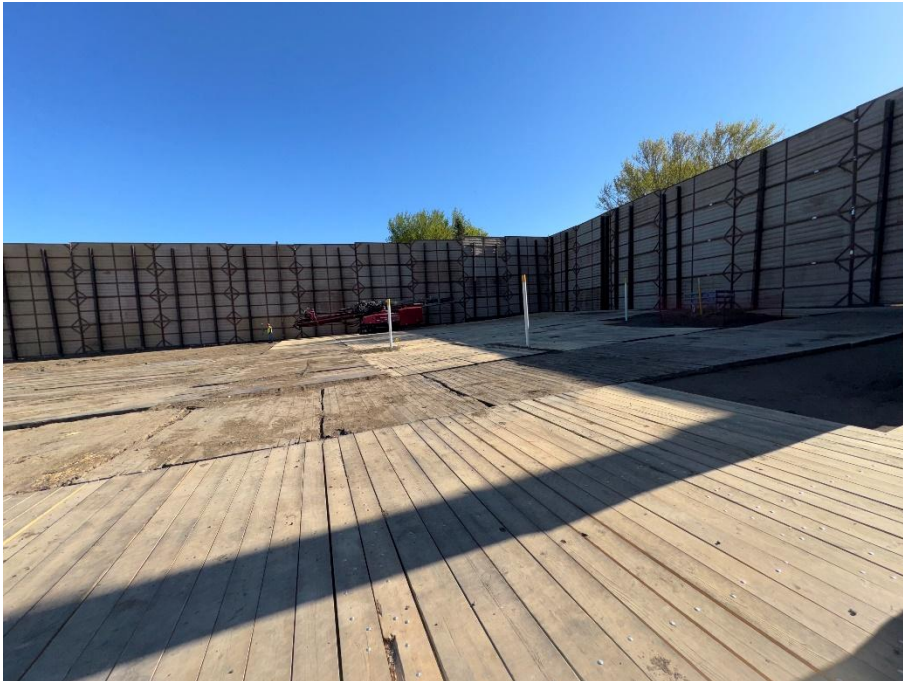
**Photo No.:** 6

**Assessment:** Acceptable

**Comments:** Agricultural, Open, and Forested ROW, Elk River 3<sup>rd</sup> Branch Line. The equipment mat drill pad was stable, and the sound barrier was installed. No environmental concerns were identified.

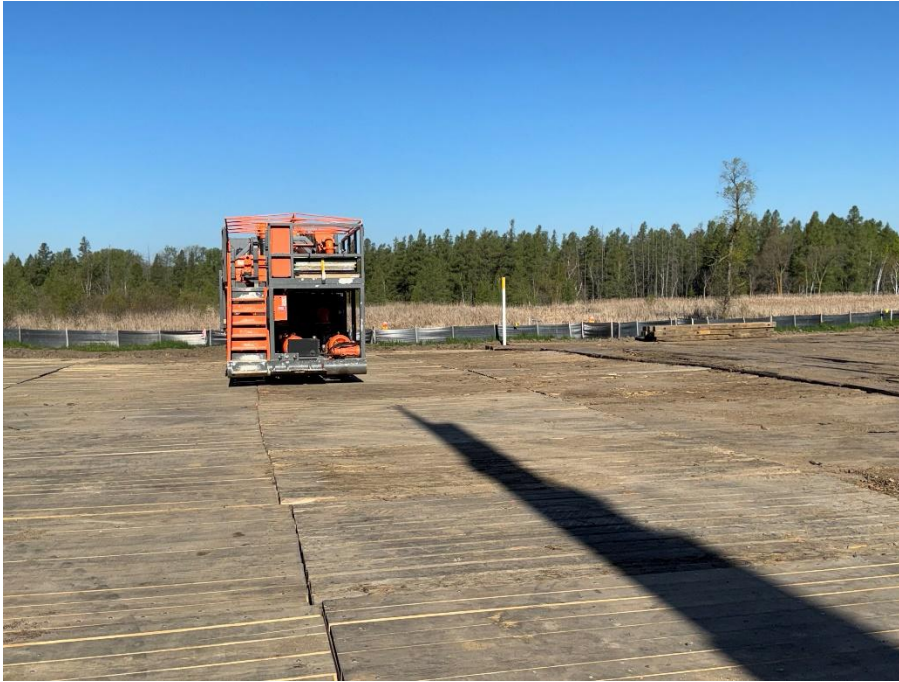
**Photo No.:** 7

**Assessment:** Acceptable

**Comments:** Agricultural, Open, and Forested ROW, Elk River 3<sup>rd</sup> Branch Line. The drill rig arrived on site the day before the inspection. Crews were preparing the site to begin drilling the pilot hole within one week. No environmental concerns were identified.

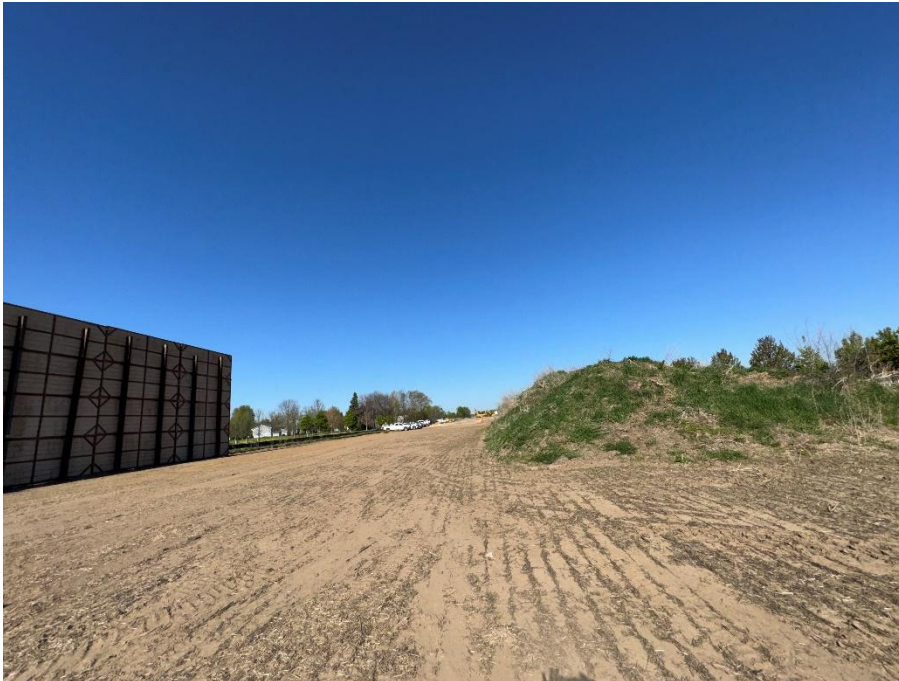
**Photo No.:** 8

**Assessment:** Acceptable

**Comments:** Agricultural, Open, and Forested ROW, Elk River 3<sup>rd</sup> Branch Line. At the HDD exit site, the sound barrier was installed. The topsoil pile was stabilized with vegetation, and silt fence along the edge of the ROW was in good repair. No environmental concerns were identified.

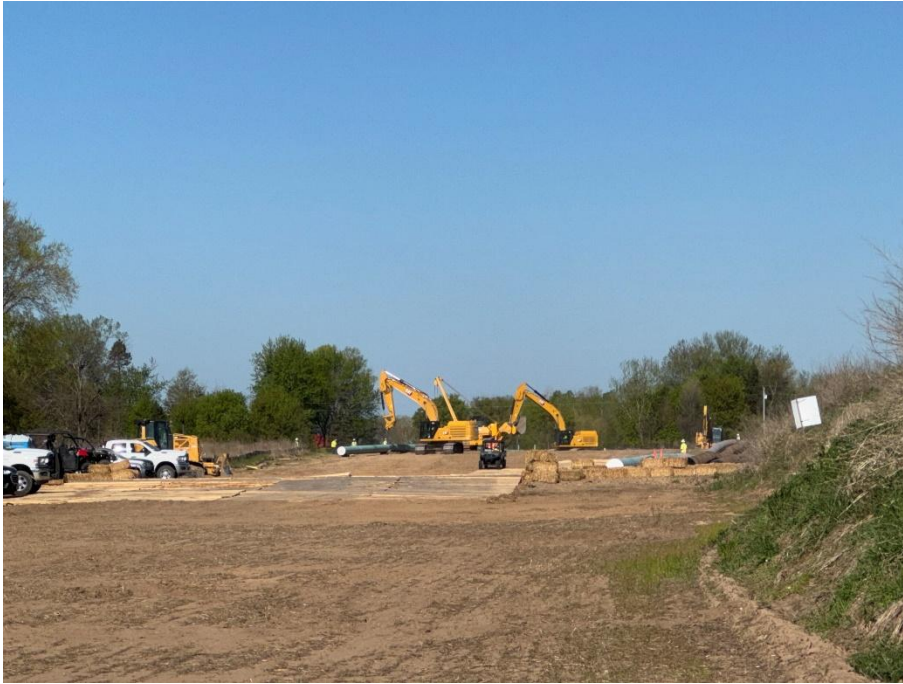
**Photo No.:** 9

**Assessment:** Acceptable

**Comments:** Agricultural, Open, and Forested ROW, Elk River 3<sup>rd</sup> Branch Line. A crew was cutting last year's HDD pipe into sections that will be transported off the ROW. The pipe was removed from the failed HDD attempt in 2025 and will not be used again. New pipe was being brought in for the 2026 HDD installation. No environmental concerns were identified.

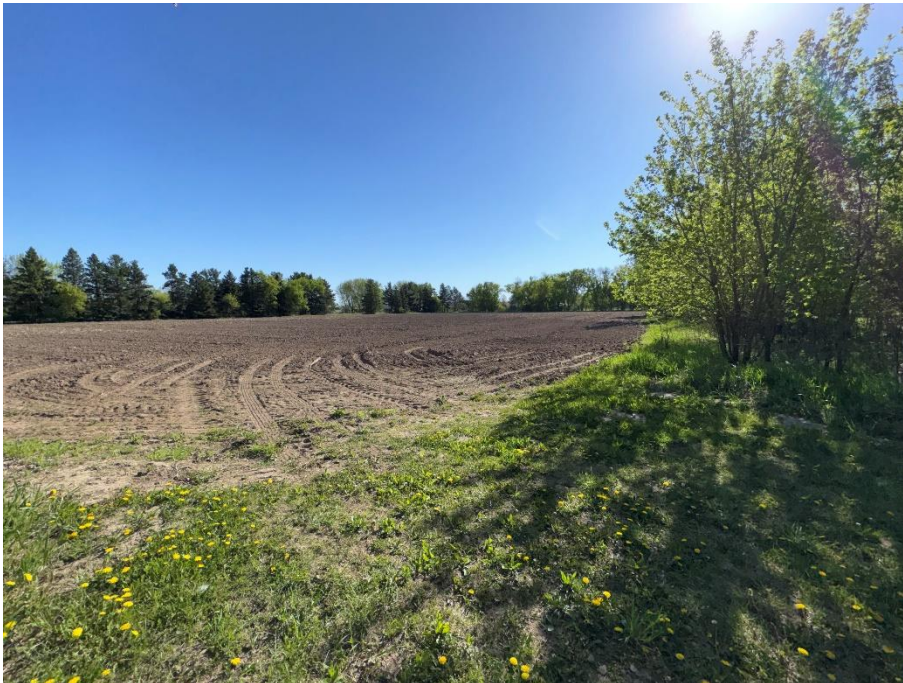
**Photo No.:** 10

**Assessment:** Acceptable

**Comments:** Agricultural, Open, and Forested ROW, Elk River 3<sup>rd</sup> Branch Line, Terminus. At the terminus of the line, across from the construction yard, silt fence was removed, with the ROW turned back over to the landowner. On- and off-ROW, the agricultural parcel was disced and ready for planting. No environmental concerns were identified.
