## FEDERAL ENERGY REGULATORY COMMISSION FIELD INSPECTION REPORT

**Date** July 7, 2026

**Project** Northern Natural Gas Company  
Northern Lights 2025 Expansion Project  
Freeborn, Washington, and Houston Counties, Minnesota; and Monroe  
County, Wisconsin  
Docket No.: CP24-60-000  
Authority: 7(c)

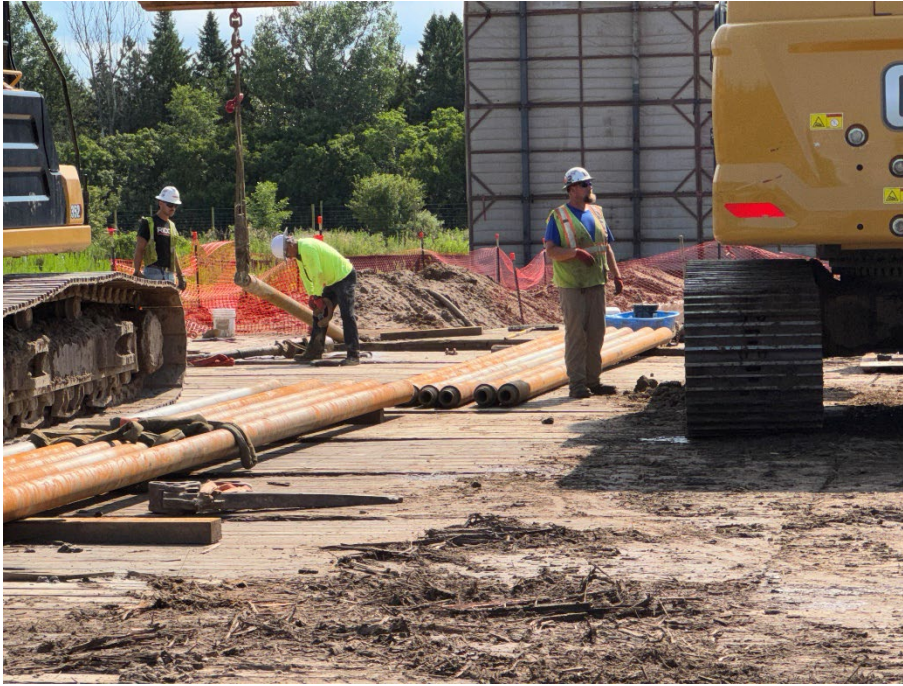
**Photo No.:** 1

At milepost (MP) 3.0 along the Elk River 3<sup>rd</sup> Branch Line, the HDD exit site was stable and buffered by a sound barrier wall. The silt fence along the edge of the ROW was well maintained (Photo No. 1). At the MP 2.4 drill pad site, the reamer was freed from being stuck and started turning. The crew began setting up for the final ream pass of the bore (Photo No. 2). The edge of the pad was stable, and silt fence was in good repair and functioning as designed (Photo No. 3). The topsoil pile at the edge of the workspace was stable, surrounded by silt fence and well vegetated (Photo No. 4). Overall, the drill entrance and exit pads were stable and well maintained, and no environment concerns were identified.

**Comments:** Agricultural, Open, and Forested ROW, Elk River 3<sup>rd</sup> Branch Line. The HDD exit site pad was stable, with the sound buffer wall remaining in place. The silt fence at the edge of the ROW was well maintained and functioning as designed. No erosion or environmental concerns were identified.

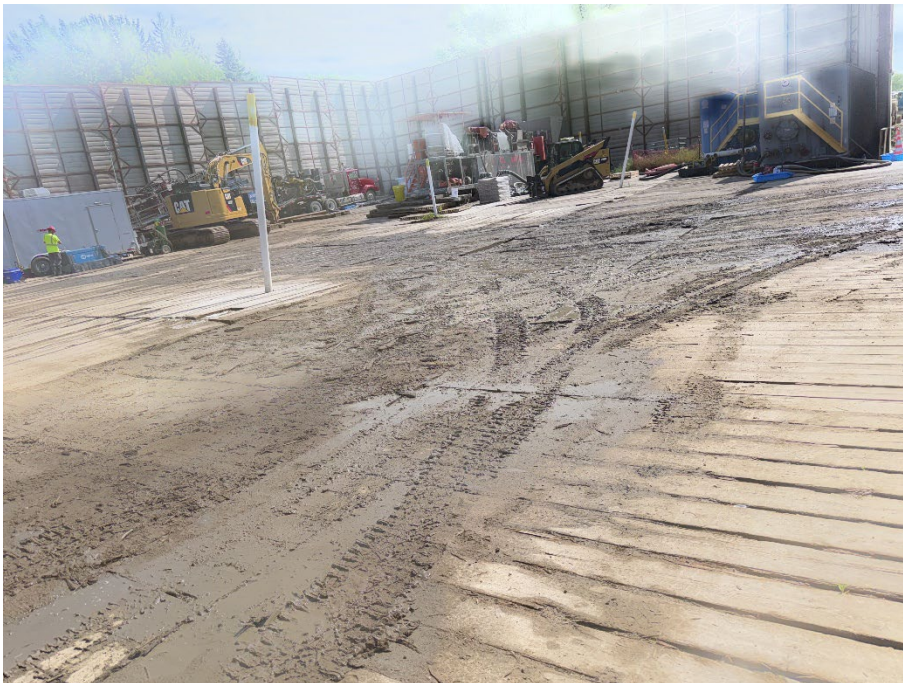
**Photo No.:** 2

**Comments:** Agricultural, Open, and Forested ROW, Elk River 3<sup>rd</sup> Branch Line. The HDD drilling pad site was stable and maintained. The reamer was freed from being stuck and started to turn. No environmental concerns were identified.

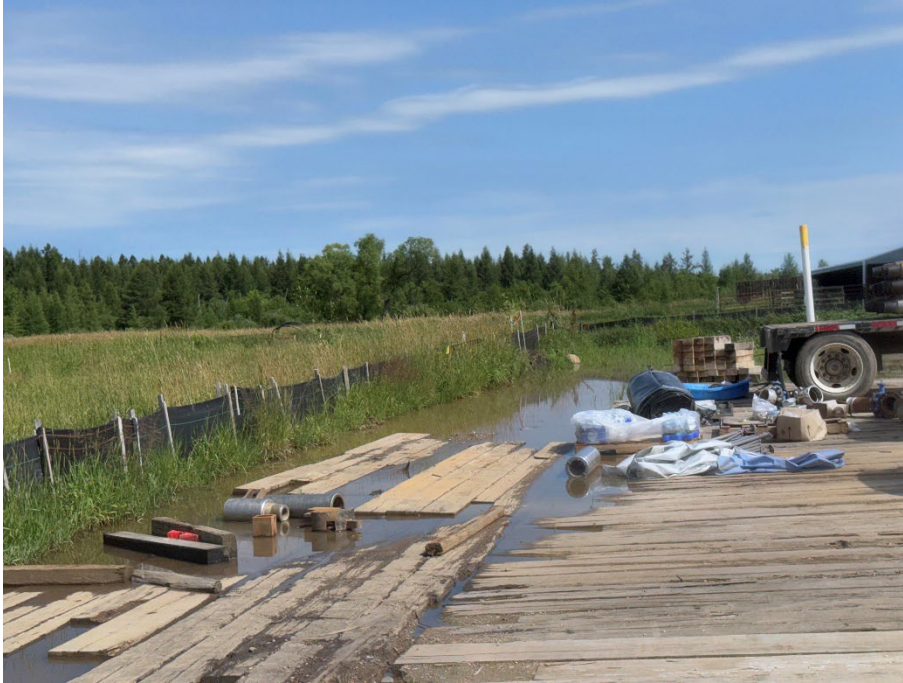
**Photo No.:** 3

**Comments:** Agricultural, Open, and Forested ROW, Elk River 3<sup>rd</sup> Branch Line. Stormwater flow off the drill pad had collected between the edge of the pad and the workspace boundary. The double row of silt fence was well maintained and functioning as designed to prevent off-ROW impacts. No environmental concerns were identified.

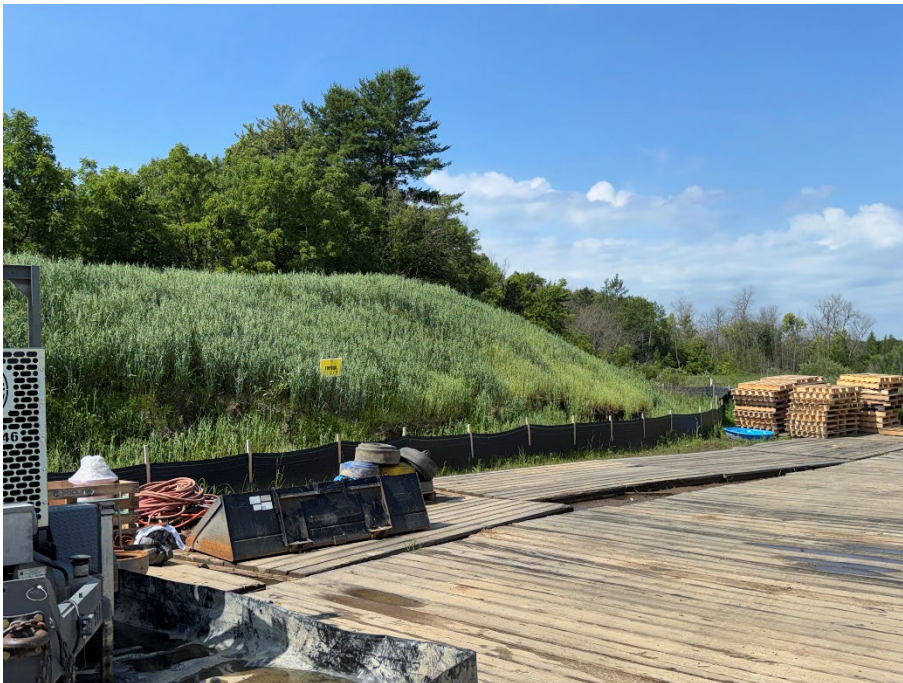
**Photo No.:** 4

**Comments:** Agricultural, Open, and Forested ROW, Elk River 3<sup>rd</sup> Branch Line. The pad site was stable, the trailered generator was staged within containment, and silt fence was in place between the pad and the topsoil pile. The topsoil pad was stabilized well with vegetation, with no erosion observed. No environmental concerns were identified.

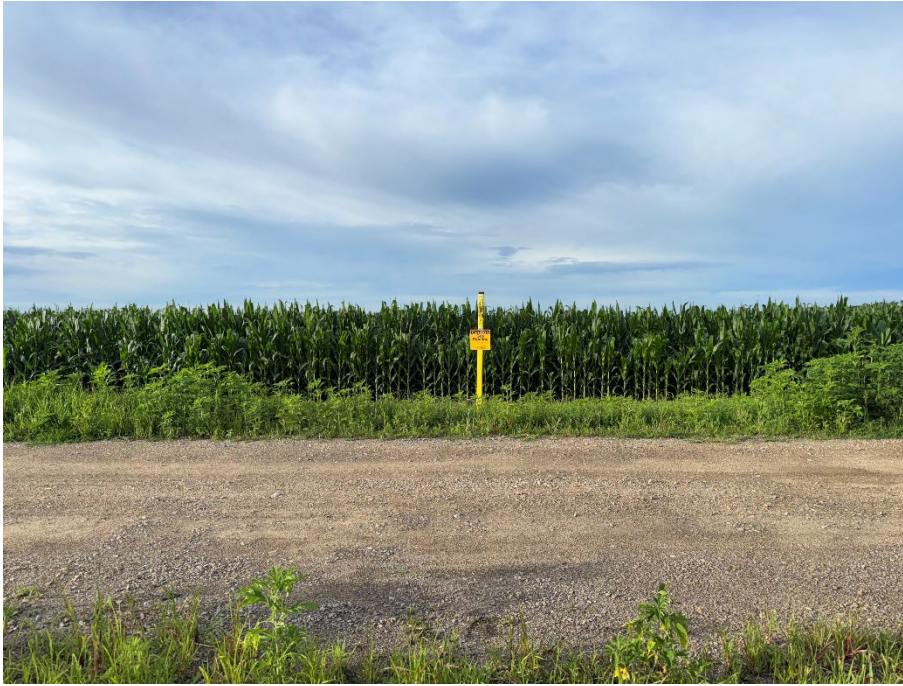
**Photo No.:** 5

The entire ROW was returned to agricultural use, primarily corn crops. The corn crop growth along the ROW showed no difference to the off-ROW corn growth (Photo Nos. 5 through 7). The roadside ditches were well vegetated and stable, with no erosion observed. Overall, restoration along the ROW was returned to pre-construction conditions, with no erosion or environmental concerns identified.

**Comments:** Agricultural ROW, Lake Mills to Albert Lea. The ROW was returned to agricultural use, and corn crop growth along the ROW matched off-ROW crop growth. The roadside ditch was stabilized with vegetation. No environmental concerns were identified.

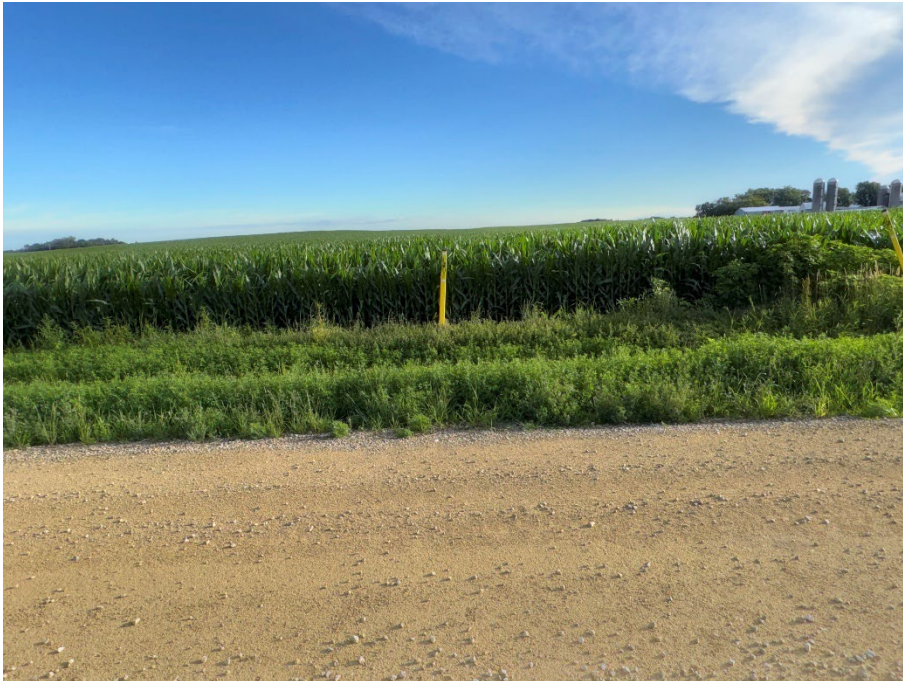
**Photo No.:** 6

**Comments:** Agricultural ROW, Lake Mills to Albert Lea. The ROW was returned to agricultural use, and corn crop growth along the ROW matched off-ROW crop growth. The roadside ditch was stabilized with vegetation. No environmental concerns were identified.

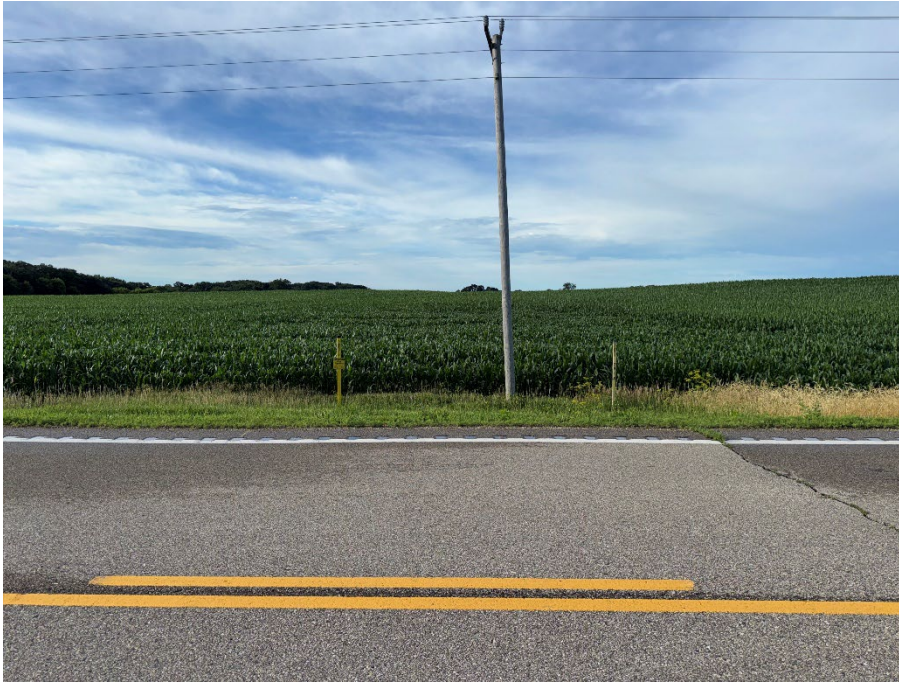
**Photo No.:** 7

**Comments:** Agricultural ROW, Lake Mills to Albert Lea. The ROW was returned to agricultural use, and corn crop growth along the ROW matched off-ROW crop growth. The roadside ditch was stabilized with vegetation. No environmental concerns were identified.

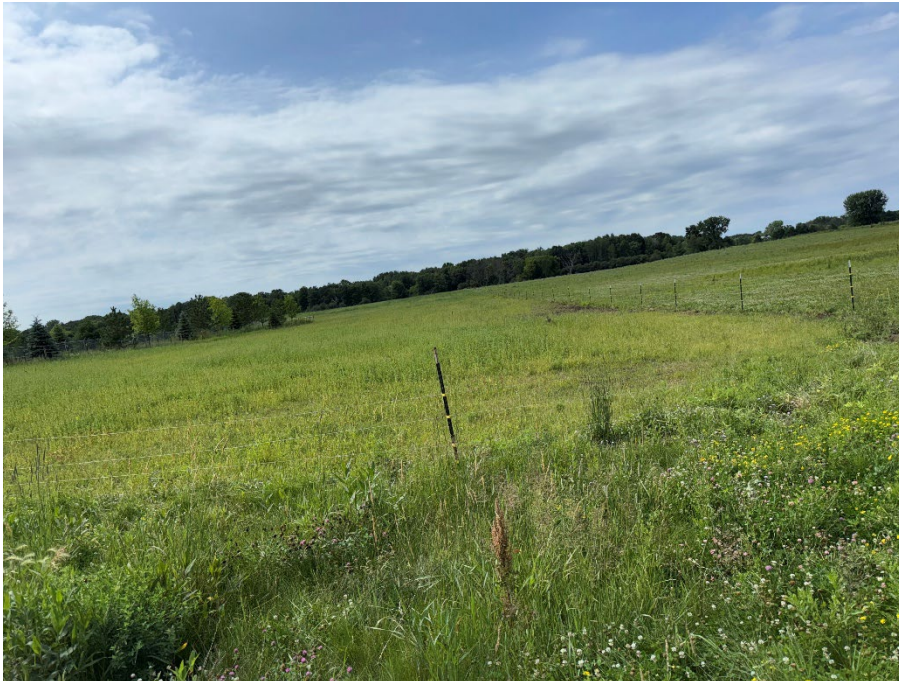
**Photo No.:** 8

**Comments:** Agricultural, Open, and Forested ROW, Farmington to Hugo C Line (Kickoff). Revegetation was successful along on the stabilized ROW, and ECDs were removed. No environmental concerns were identified.

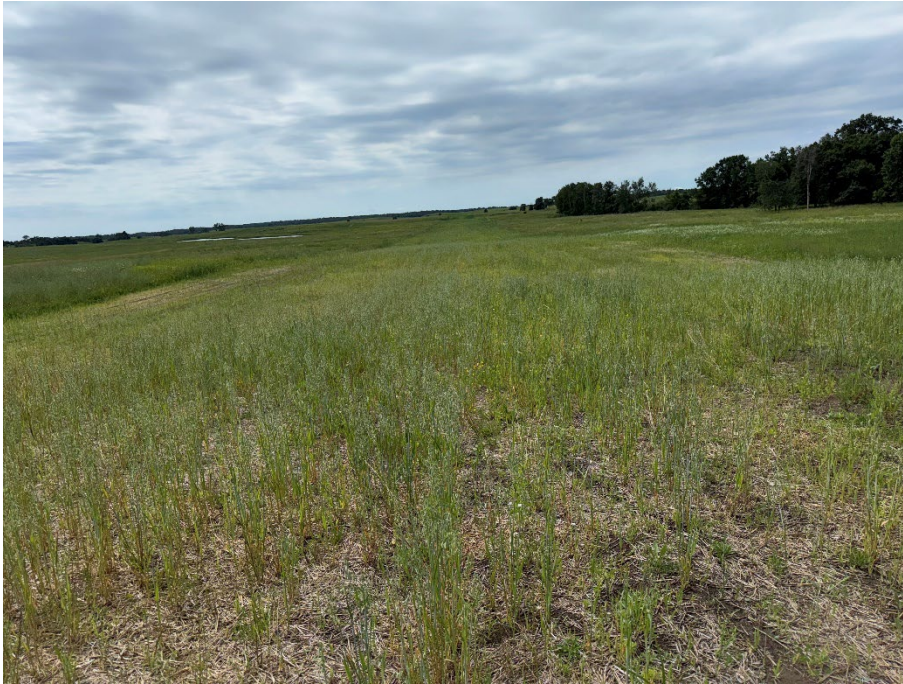
**Photo No.:** 9

**Comments:** Agricultural, Open, and Forested ROW, Farmington to Hugo C Line. The ROW was stable, with revegetation progressing well. Reseeded during the recent spring, the dominant species was oats, with perennial vegetation emerging beneath the oat cover. No environmental concerns were identified.

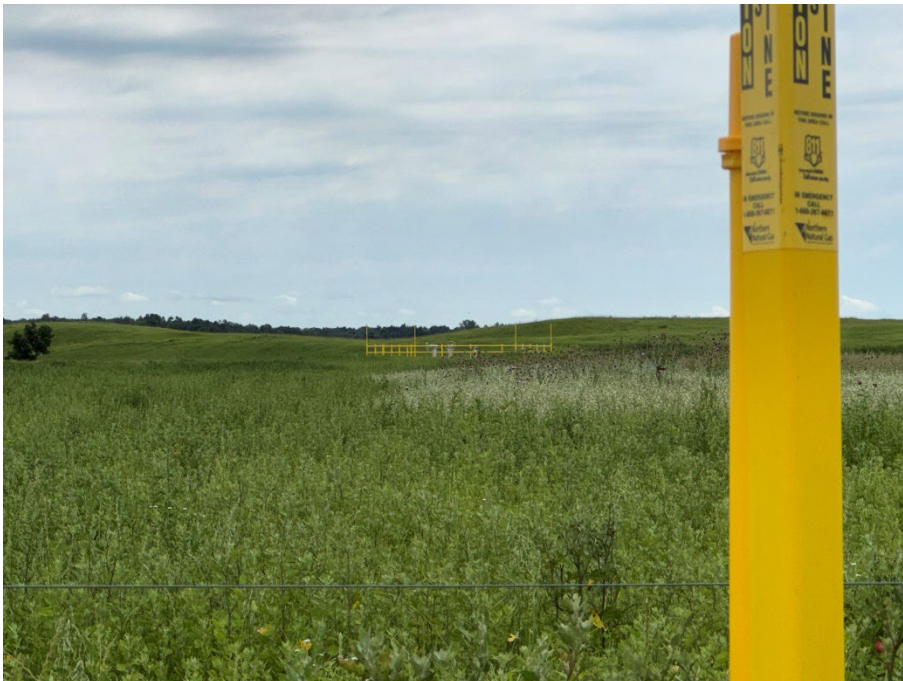
**Photo No.:** 10

At MP 0.0, revegetation was successful along the stabilized ROW, and erosion control devices (ECDs) were removed (Photo No. 8). At MP 1.0, the ROW was replanted during the Spring of this year. Vegetation was progressing, dominated by oats, and perennial vegetation was emerging beneath the oat cover (Photo No. 9). Revegetation along the ROW terminus (MP 1.75) was successful (Photo No. 10). Overall, restoration along the ROW was progressing well, and some remaining ECDs could be removed.

**Comments:** Agricultural, Open, ROW, Farmington to Hugo C Line (Terminus). Revegetation was successful along on the stabilized ROW, and ECDs were removed. No environmental concerns were identified.
